Address: 133 Babcock Street

Description of Work: This property appeared before the commission in January 2021, where the applicant requested approval to rebuild the front porch that had been demolished without permits. The approved plans included drawings showing the proposed design of the porch, that largely matched the previous design (Attached). Zoning Enforcement officer Jim Tanner Issued a citation for failure to follow the conditions of the HPC approval. Some features in the approved drawings are not present on the current porch (running trim and brackets have been removed).

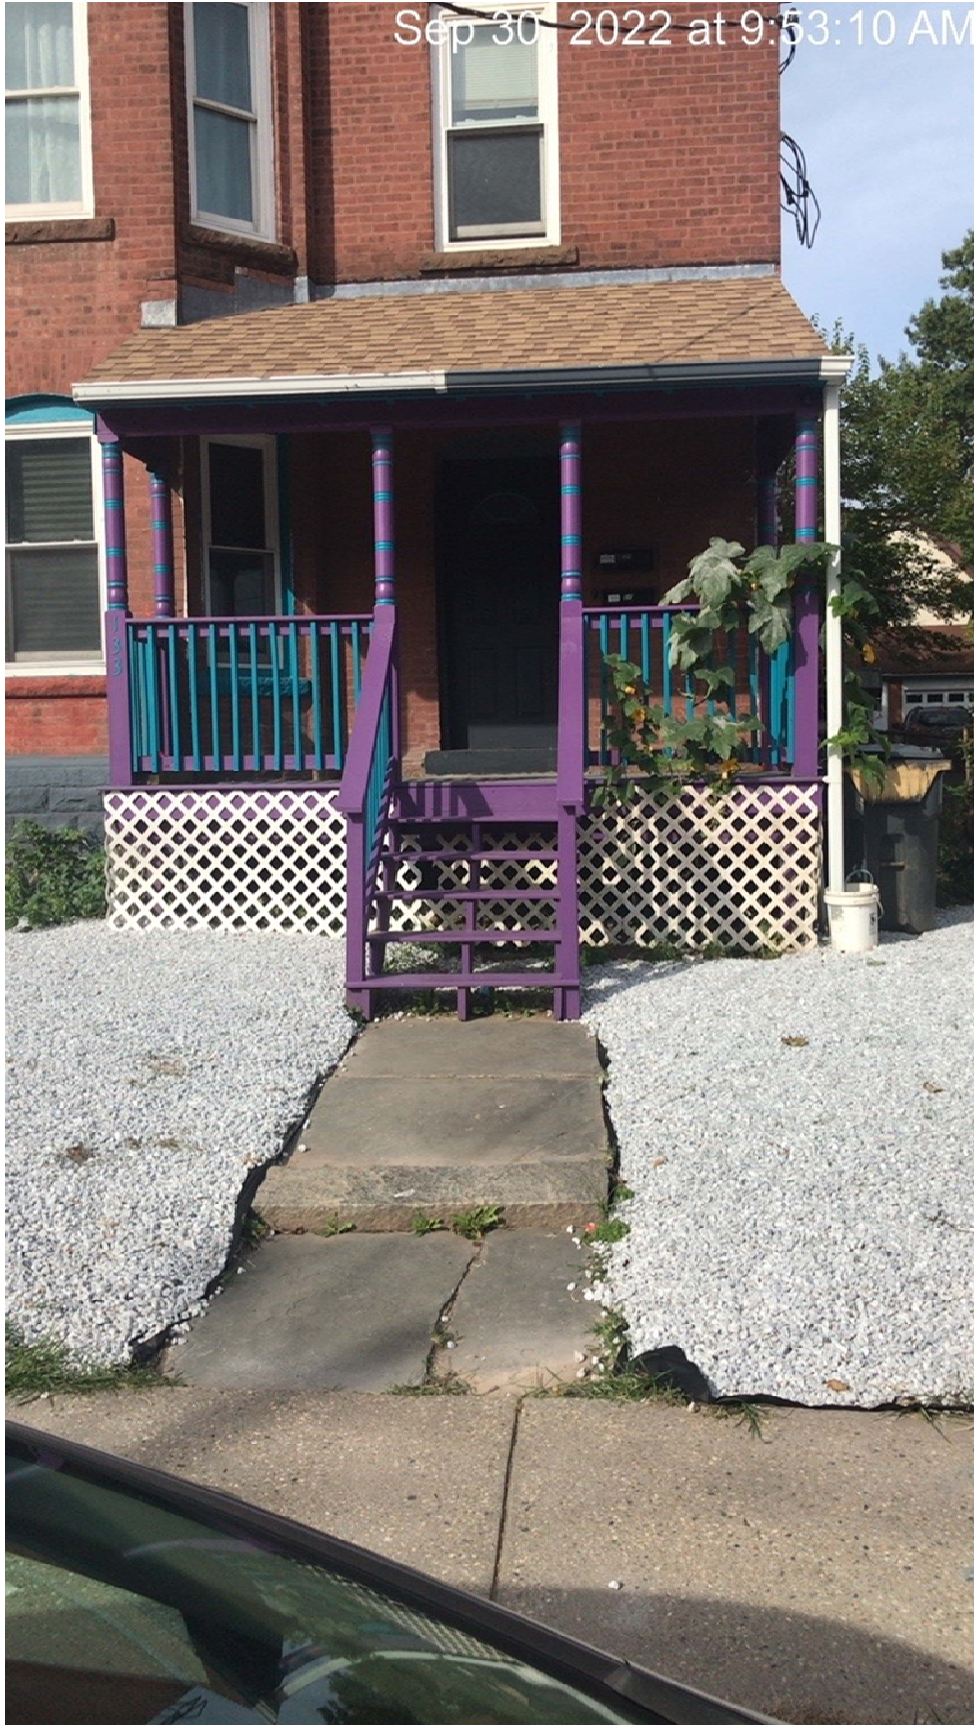
<-Missing
running trim
and brackets

<-Column posts
are of a
different design
to the original

<-Step posts
are of a
different
design to the
proposed

<-3 inch wood
trim missing
around what
appears to be
vinyl lattice

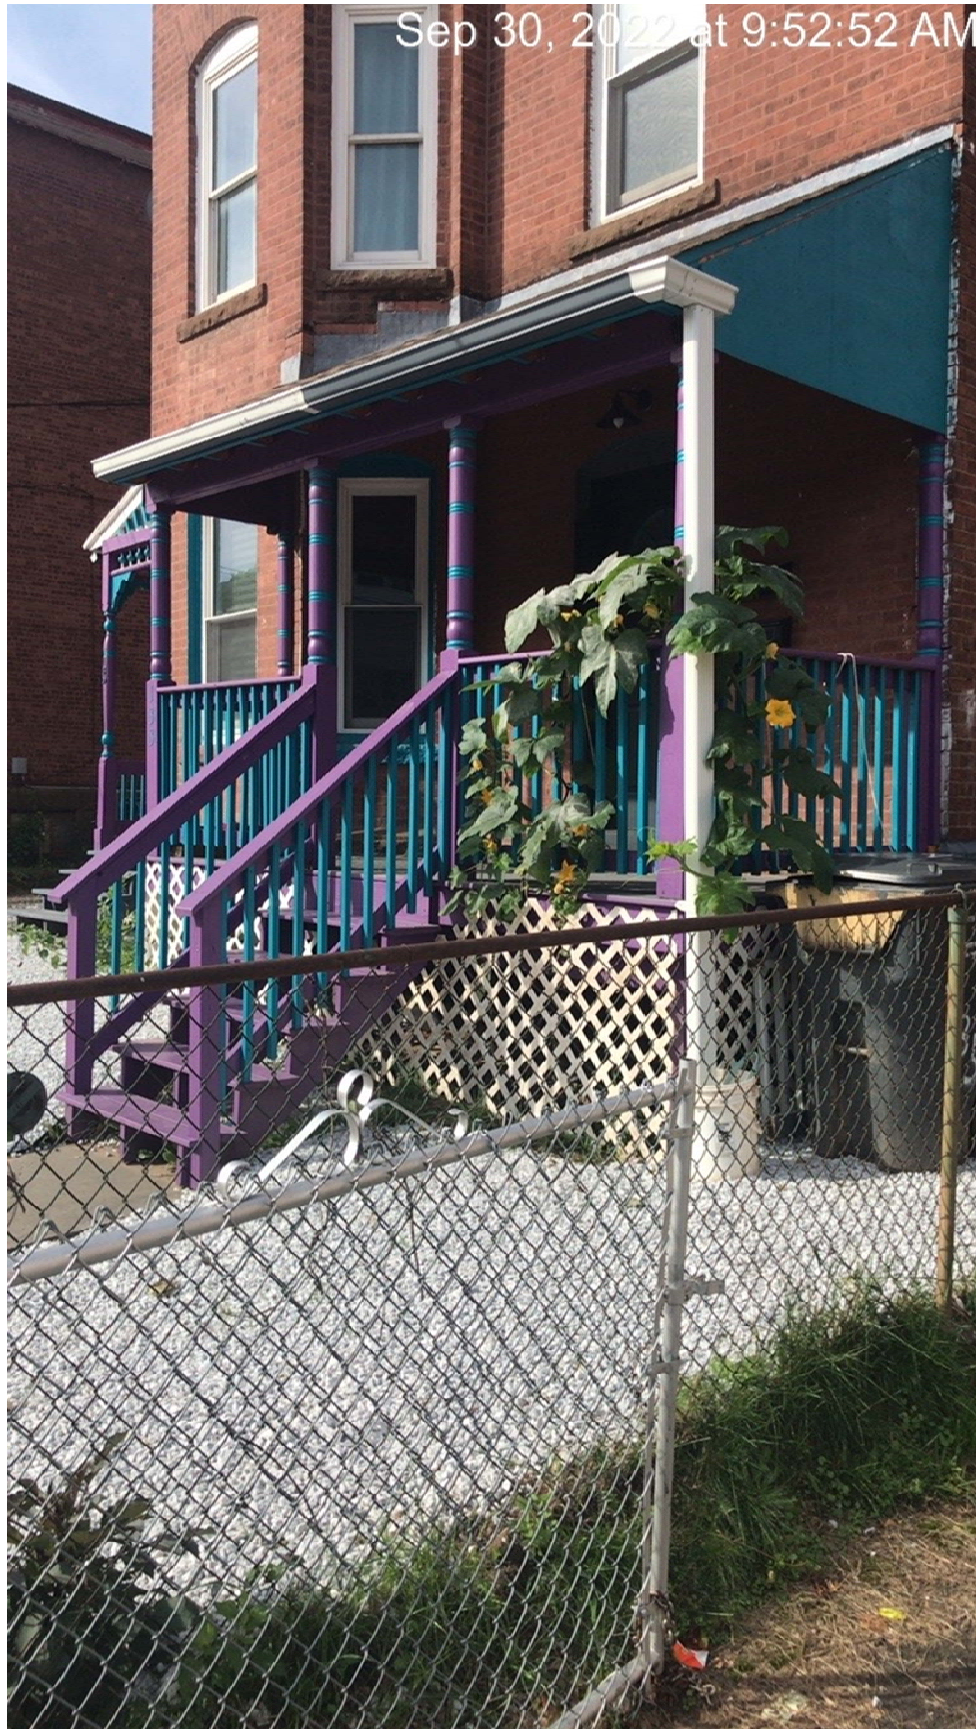
<-Removed or
obscured
Feature
