RE: 623-27 Park Street
Structural Risk Mitigation

RE: Structural Condition Assessment
623 Park Street, Hartford, Connecticut
Fuss & O'Neill Reference No. 20201166.A10

623 Park Street – Structural Condition Assessment

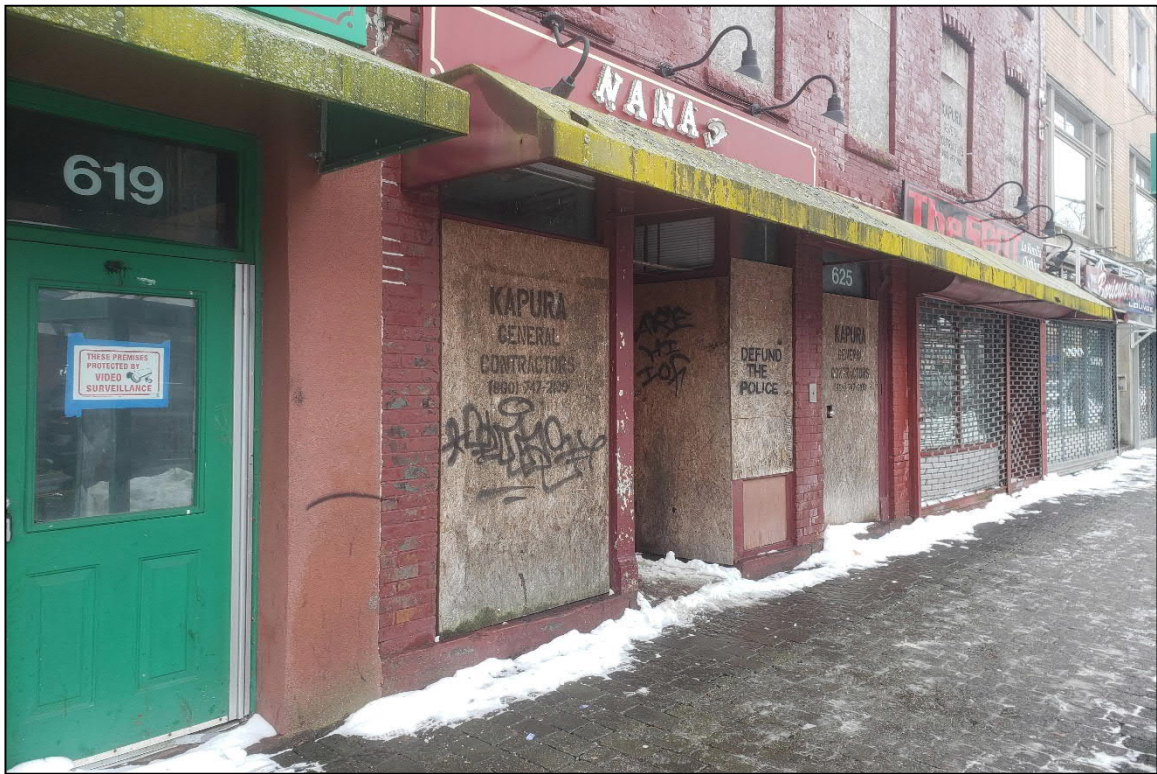
Photo 1: Overview of 623 Park Street

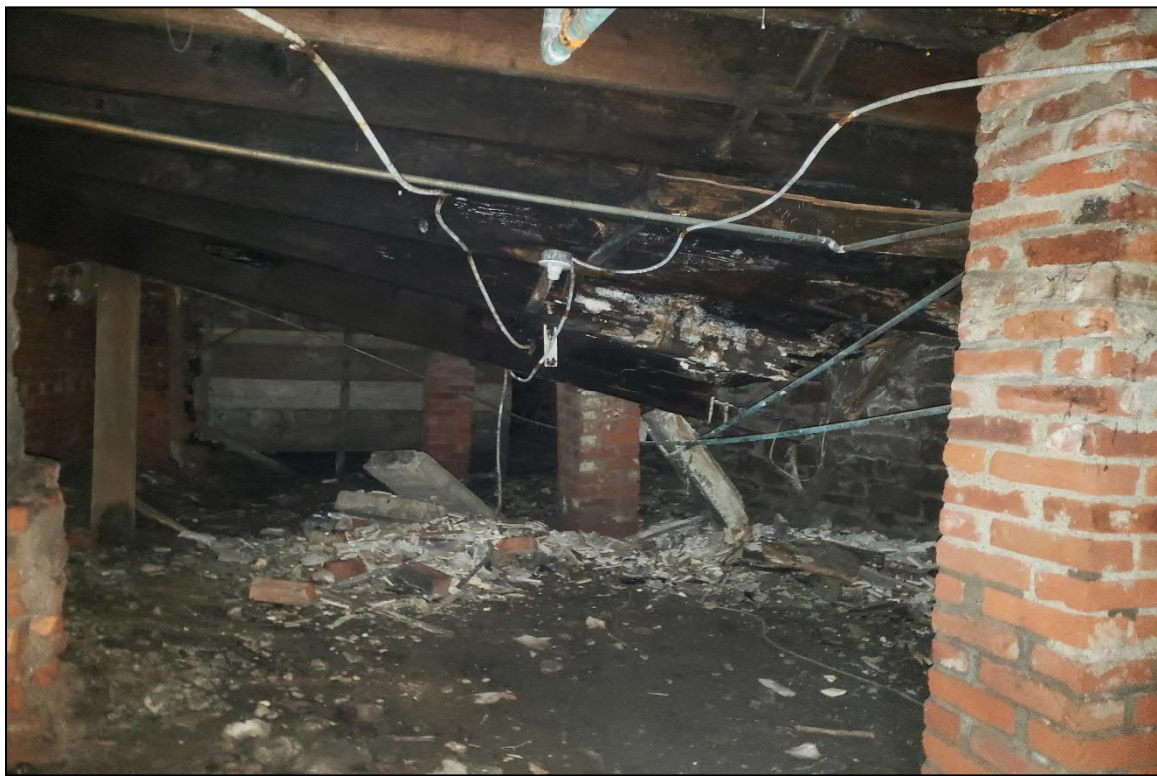
The accessible interior portions of the crawl space basement revealed that 40% to 50% of the existing 1st floor framing members are in poor condition and failing in isolated locations. There is also evidence of fire damage to some of the timber girders, joists, and decking which has reduced their load carrying capacities. The interior faces of the foundation walls appear to be fair condition with some evidence of minor water infiltration, cracking, and deterioration. It appears that portions of the foundation walls are shared with the adjoining buildings.

- Multiple failed or severely compromised timber framing members (girders and joists) for portions of the 1st floor that sustained fire damage. These members are charred and, in some cases, detached from their surrounding supporting elements.

Photo 2: Deteriorated/fire Damaged 1st Floor Framing Members

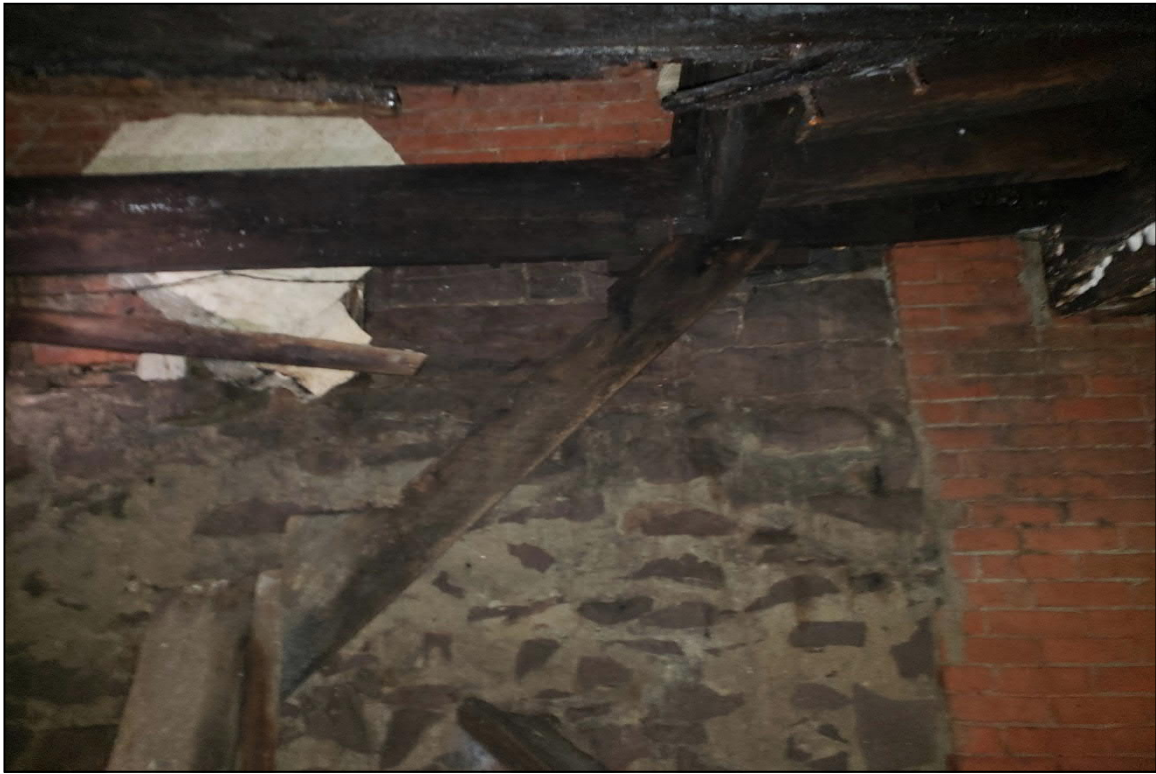
Photo 3: Fire Damaged 1st Floor Framing Members

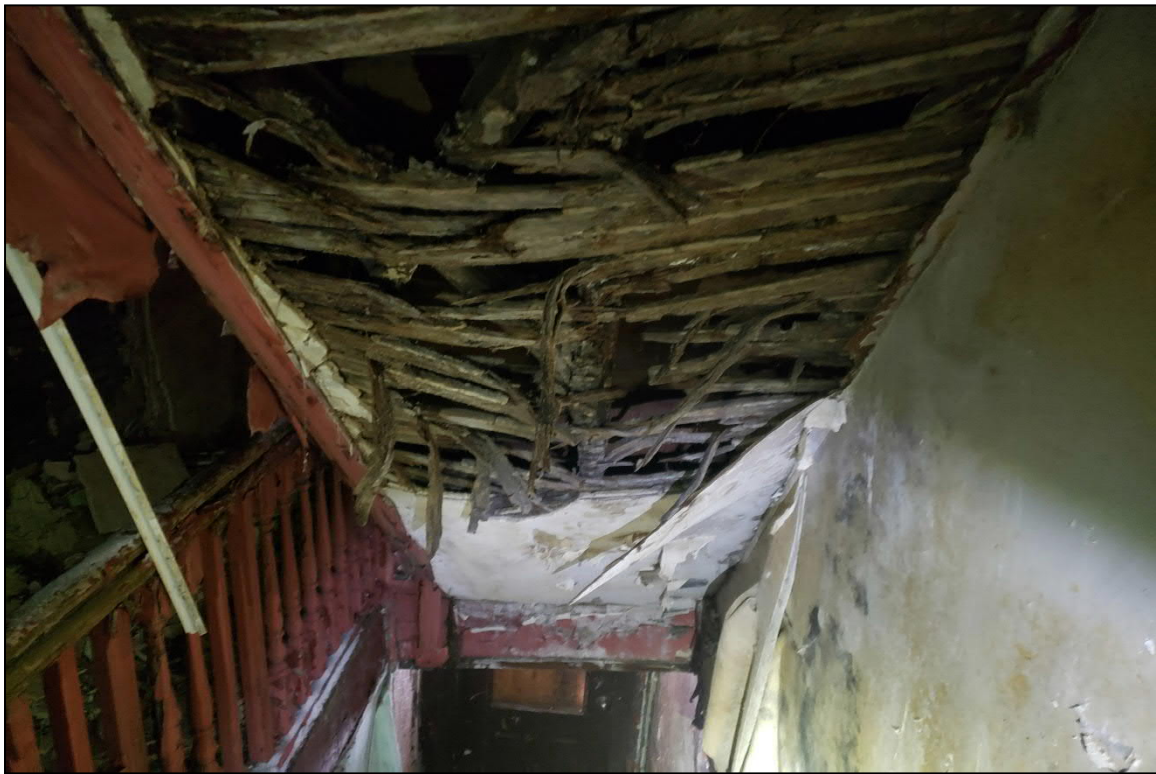
- The existing interior stairway has collapsed in several locations. The damage to the timber framing members has prevented access to each level of the building via these stairs.

Photo 4: Stair Framing Deterioration

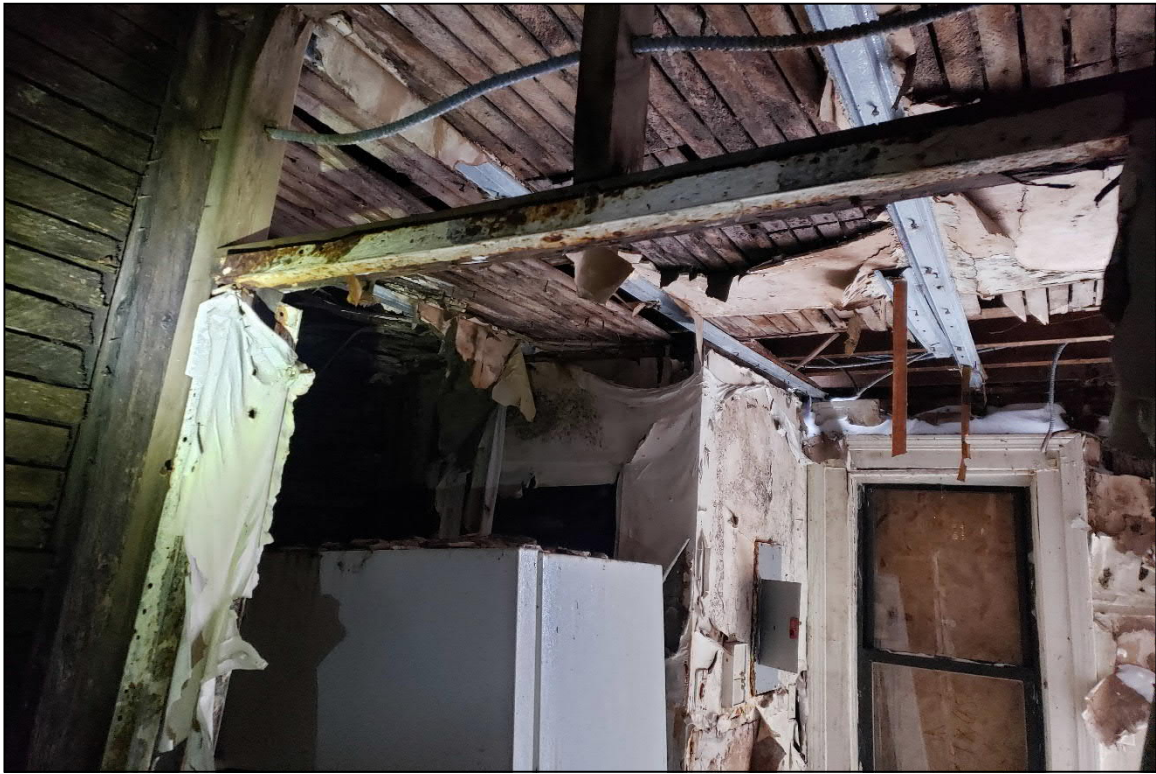
- Virtually 100% of the interior finishes (wall coverings, flooring, and ceilings) are damaged, missing, or otherwise unsalvageable. With much of the finishes no longer intact, we were able to observe the condition of the floor framing members and observe some locations where the water infiltration has compromised their structural integrity.

Photo 5: Typical Deterioration to Interior Finishes and Partition Walls

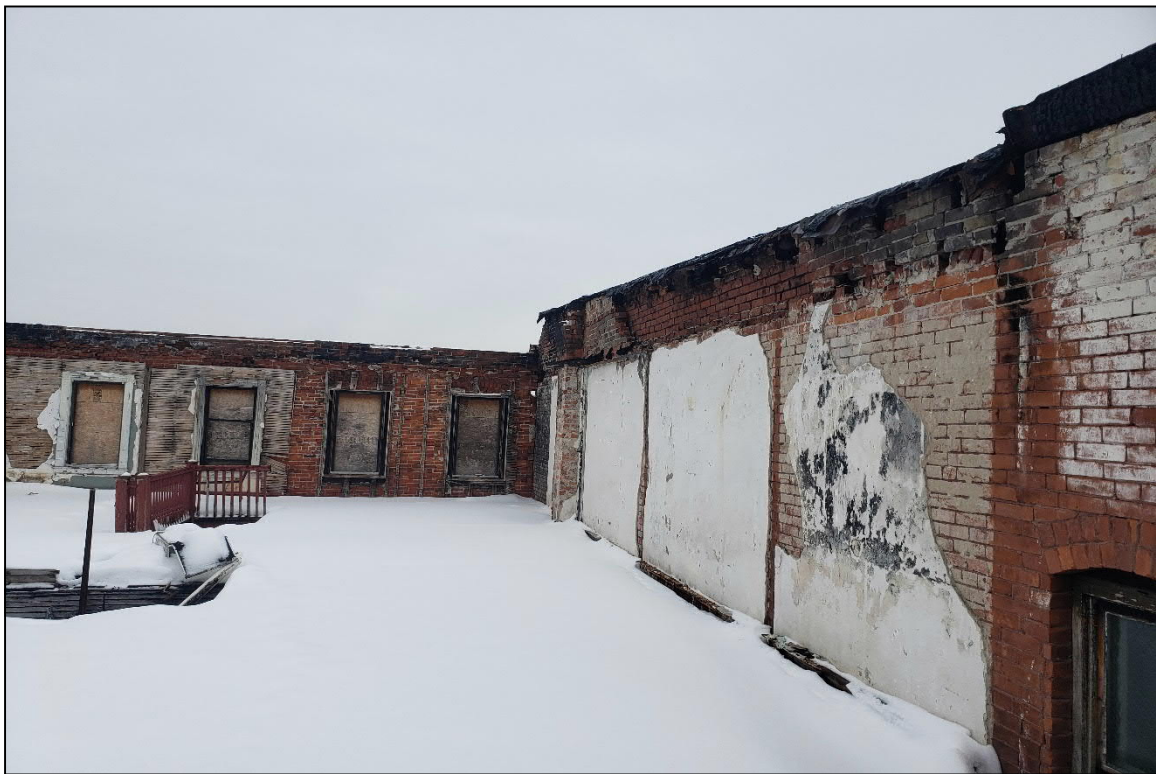
- Since the roof was completely collapsed, the 4th floor the building was virtually inaccessible; however, we were able to make limited observations from the existing steel fire escape on the backside of the structure. From this location the existing perimeter masonry walls were found to be in fair condition; however, they are now unbraced where the roof framing members were formally located. The top portions of these masonry walls are not safe in their current condition.

Photo 6: Typical 4th Floor Perimeter Walls

- Remove the unbraced portions of the perimeter masonry walls from the top of the former parapet at the roof level to within a foot of the top of the existing 4th floor of the structure.
- Provide a temporary membrane/covering on the topside of the 4th floor framing members to act as a weatherproof barrier to significantly reduce water infiltration. Any unsecured window openings should be boarded up or otherwise made weathertight.
- Remove the existing roofing material that has collapsed onto the 4th floor framing members.
- Repair/shore the existing interior stair framing members such that they are usable for the continued rehabilitation of the structure and to restore support to the surrounding existing framing members.

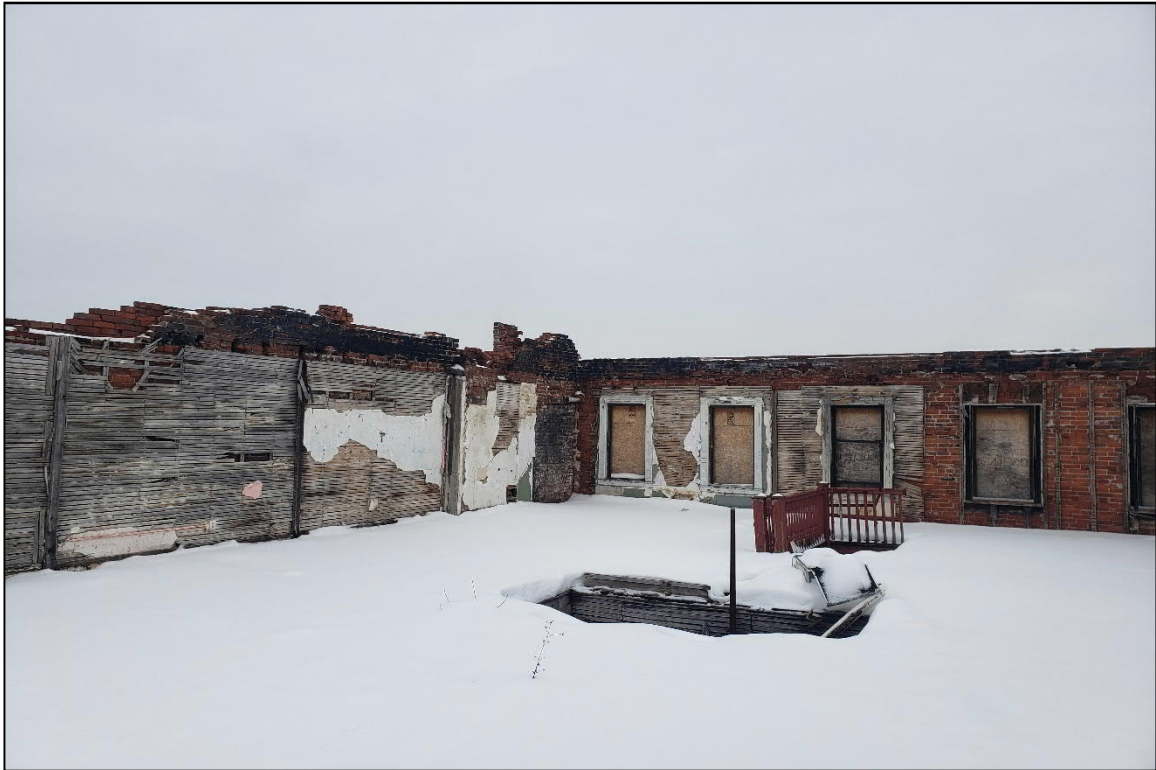
Photo 7: Typical Parapet and 4th Floor Perimeter Walls

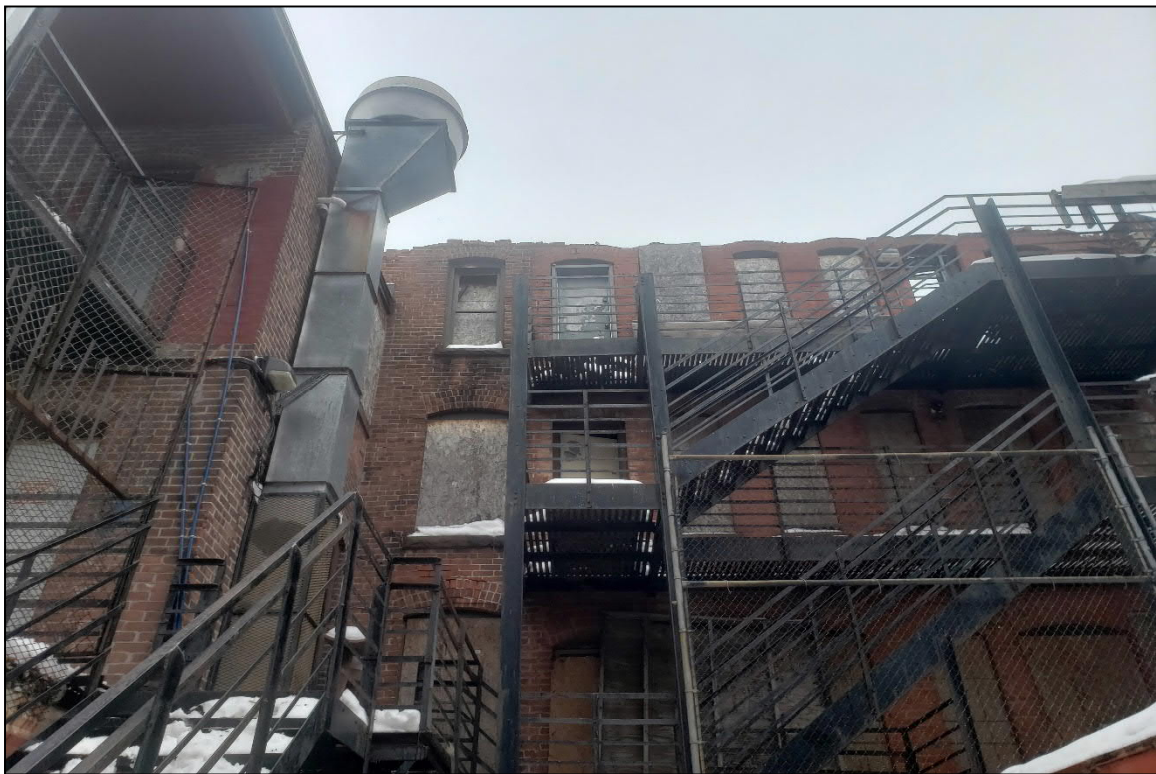
Photo 8: Rear Fire Escape Stairs
