DDS- Planning & Zoning: Historic Review Application

Comm. 6403-62

Re: #100 Cedar Street, Hartford

**100 CEDAR STREET
PARCEL ID: 247-447-003
PROPOSED DEMOLITION**

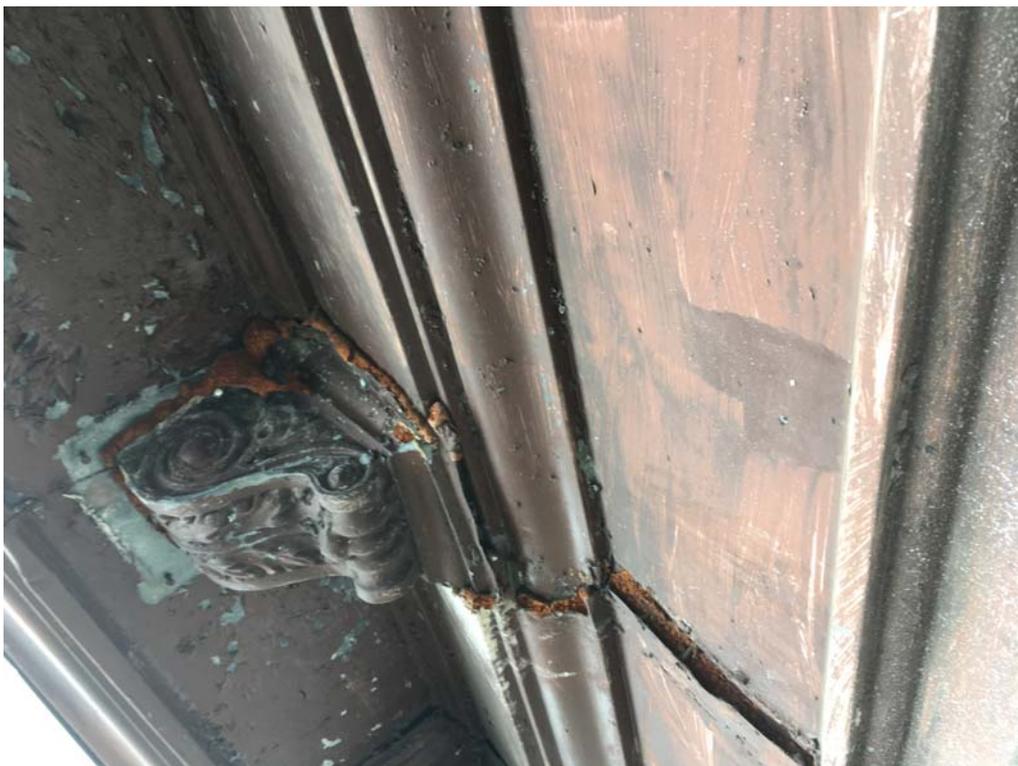
The cornice is constructed of stamped galvanized sheet metal fastened to a wooden sub-structure, not cast iron as suggested earlier. The condition of the cornice as a whole is poor, it has pulled away from the face of the building along a large portion of its length, there are framing spikes driven through the face of the sheet metal that appear to be an earlier attempt to refasten it to the backing structure. Several of the nails have partially pulled out or are missing. There are two areas that exhibit excessive movement as shown in the following photographs:

Corbel appears to have fallen off and been refastened. Gaps created by movement have been filled with expanding foam insulation. Soft wood behind the metal was observed in this area

While much of the galvanized sheet metal components of the cornice appear to be in decent condition the general alignment of the cornice along the face of the building is a concern. I feel the alignment issues and evidence of excessive movement are caused by deterioration of the structural components under the metal covering. For this reason, I suggest you monitor the cornice for any additional movement and remove it if any becomes evident.

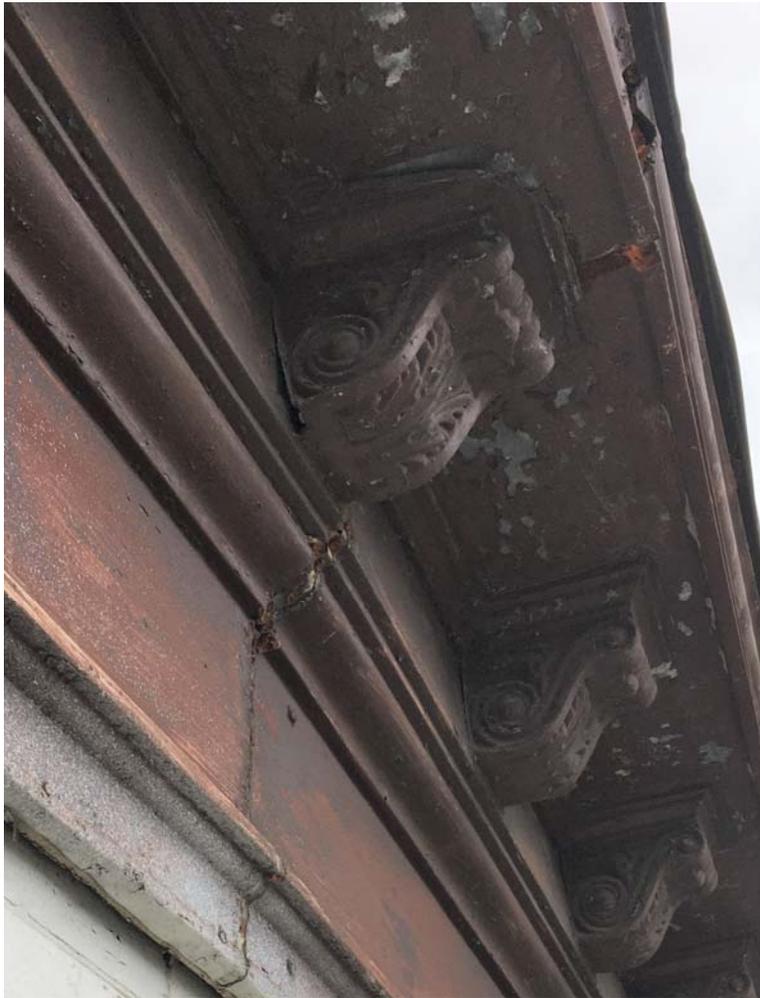
Another joint with excessive movement where the gap has been filled with expanding foam insulation. Note the gaps at the corbel and between the wall and the cornice.
