# Talcott Street Pedestrian Bridge

*Hartford, CT*

## Mitigation Plan

December 2020

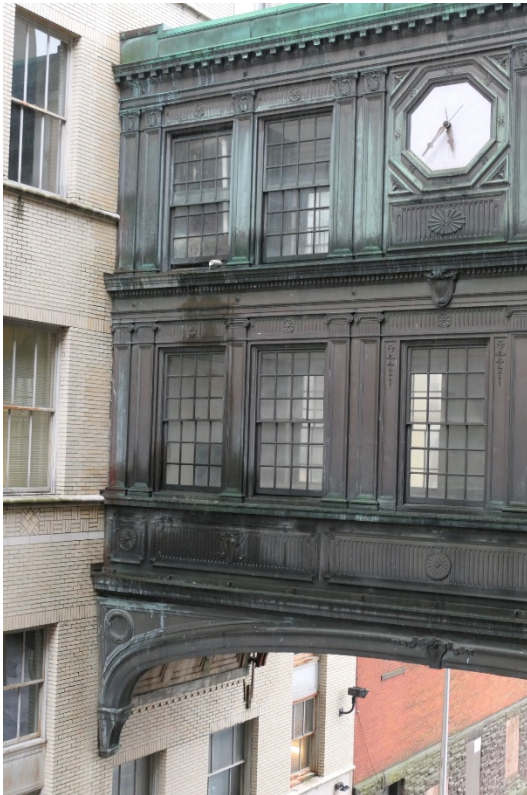
The copper sheet-metal cladding at both primary facades of the bridge exhibits general atmospheric soil deposition and water staining (Figures 3 and 4). Water staining is particularly concentrated at each of the two cornice levels where water is able to collect (Figure 5). Bird matter is present on upward-facing surfaces at isolated locations (Figure 6). Heavy soil deposition is present at the copper gutter (Figure 7). A verdigris patina is present on copper surfaces and is particularly concentrated at the parapet level on the west elevation, while on the east elevation the verdigris patina occurs more uniformly (Figures 8 and 9).

Figure 3. General atmospheric soil deposition and water staining on copper surfaces.

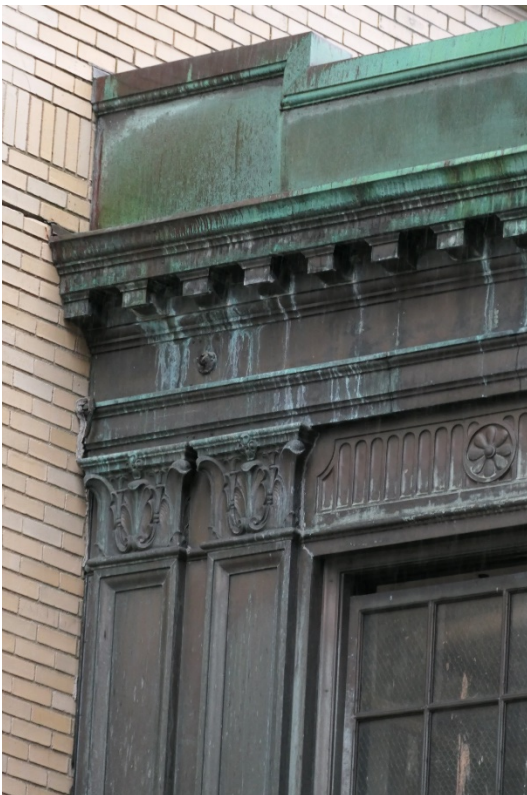
Figure 4. Detail, general atmospheric soil deposition and water staining on copper surfaces.

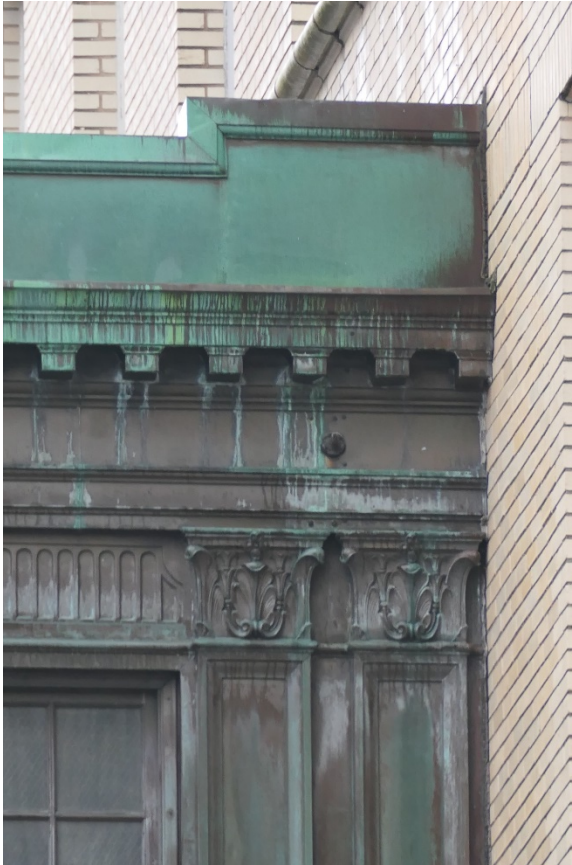
Figure 5. Water staining on copper surfaces at upper-level cornice.

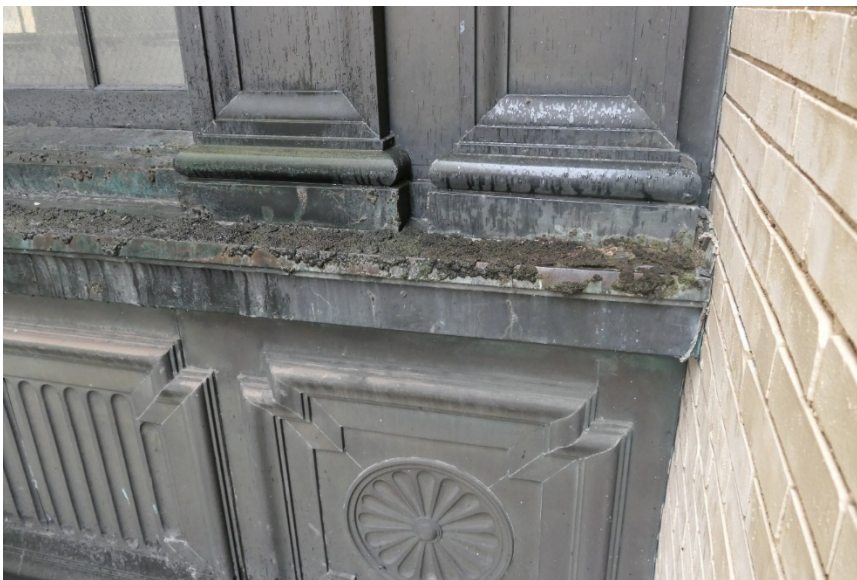
Figure 6. Bird matter on upward-facing surfaces.

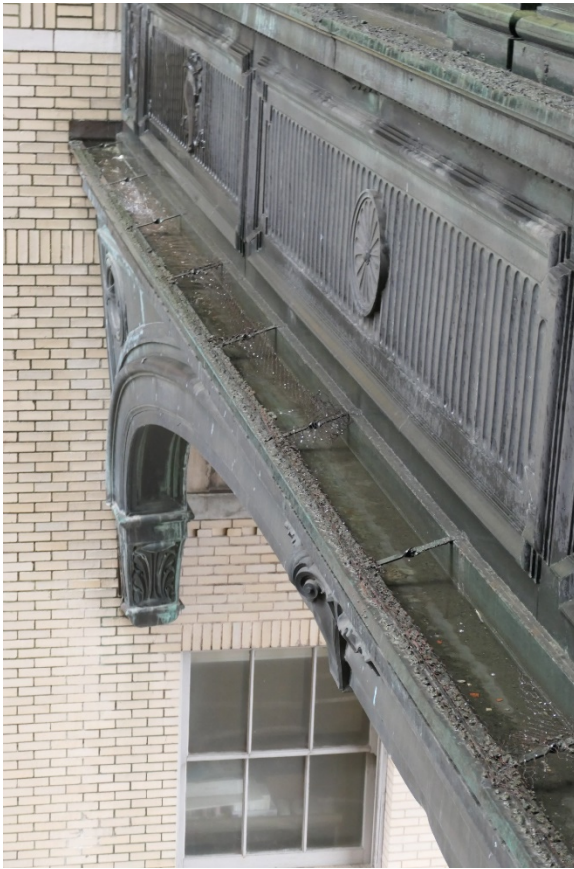
Figure 7. Heavy soil deposition and bird matter at the copper gutter.

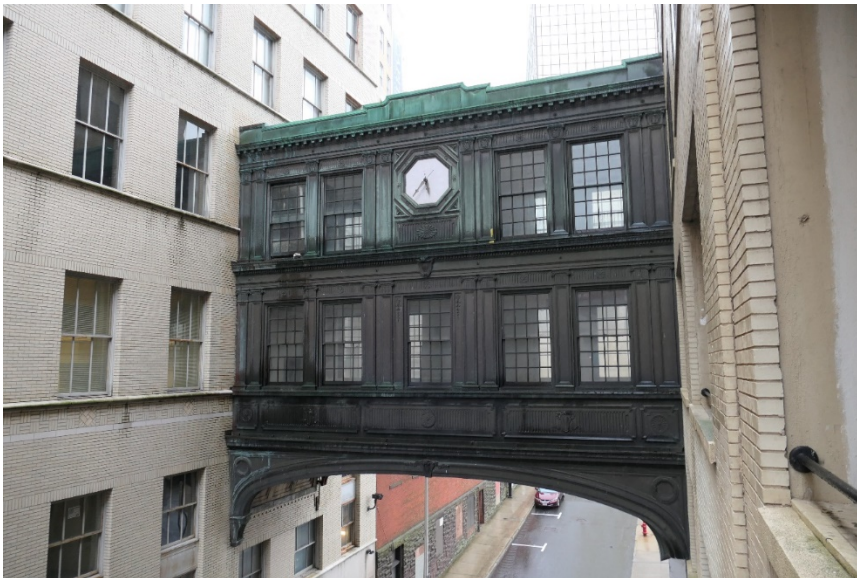
Figure 8. Verdigris patina on copper surfaces is concentrated at the parapet level on the west elevation.

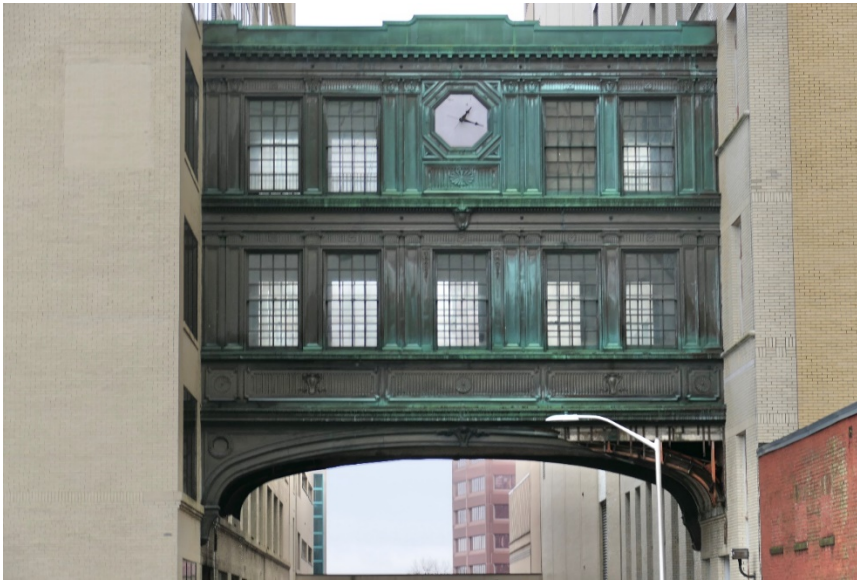
Figure 9. Verdigris patina on copper surfaces occurs throughout each level of the bridge on the east elevation.

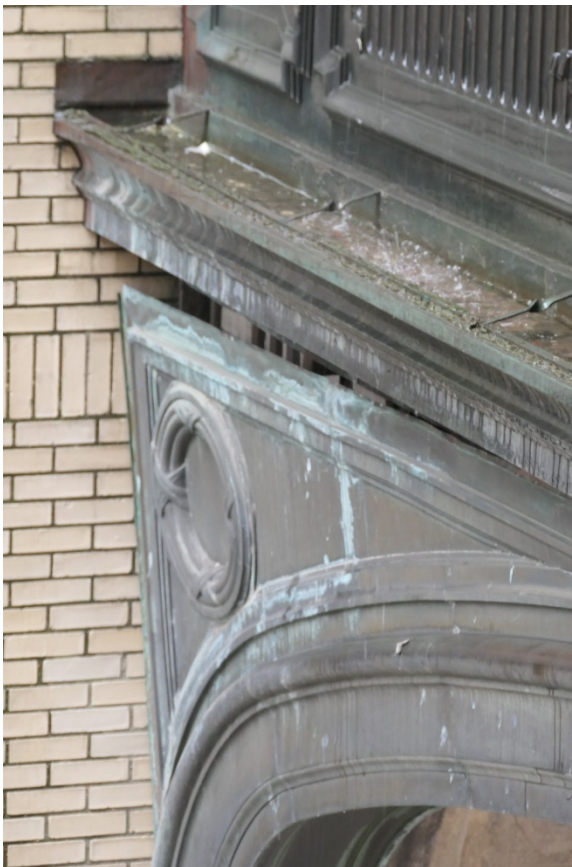
At isolated locations, sections of copper cladding appear loose, bent, and detached from the cladding armature (Figure 10). At one location on the west elevation, a section of copper cladding is missing, leaving the underlying structure exposed (Figure 11). At the interior of the bridge, original copper surfaces are visible behind the wall access panels where these surfaces were not exposed to weathering (Figure 12). A hands-on inspection was not performed to evaluate the performance of joints and fasteners holding the copper cladding in place, or of other attachments, as part of this investigation.

Figure 10. Bent and loose copper cladding is detached from its metal armature at isolated locations.

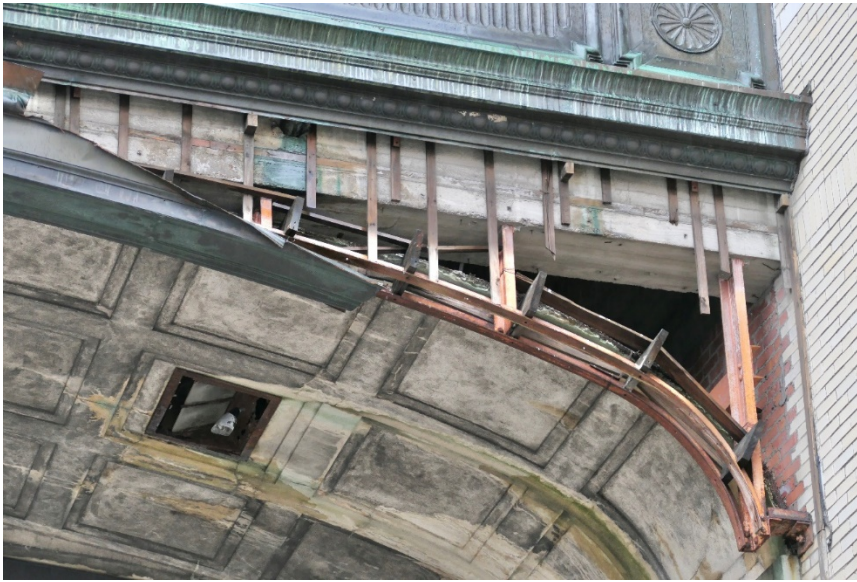
Figure 11. Missing copper cladding section and exposed underlying metal framing and concrete encasing of the steel structure on the west elevation.

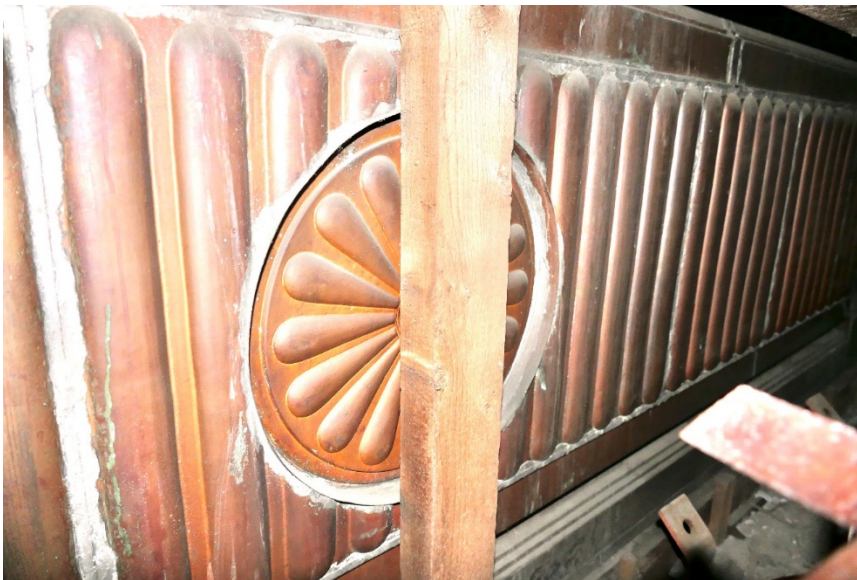
Figure 12. Original copper surfaces are visible behind interior wall access panels, on the first level, on the interior of the bridge where these surfaces were not exposed to weathering.

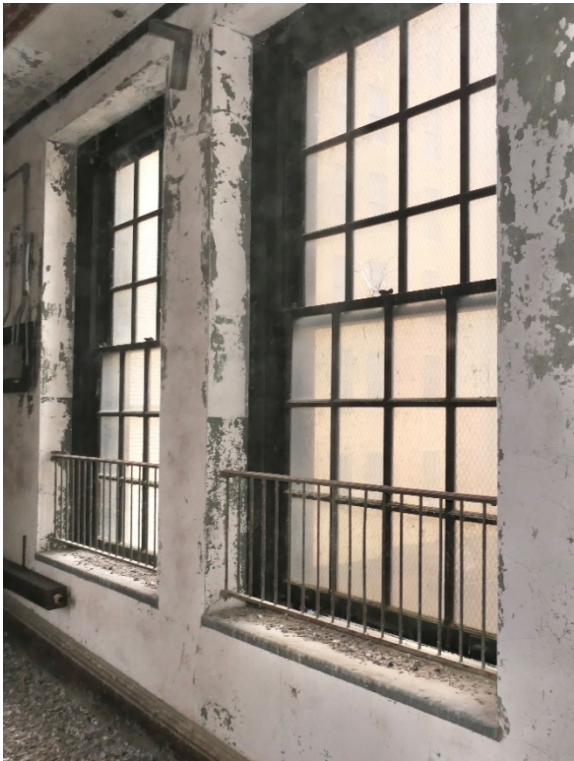
The kalamein window sash, frames, sills, and stools exhibit pigeon guano, general atmospheric soil deposition, surface losses, and overall loss of finishes (Figure 13). The metal window guards at the second level of the bridge exhibit overall loss of finishes in isolated locations (Figure 14). A detailed window-by-window survey to evaluate the performance of window hardware and operability was not conducted as part of this report.

Figure 13. General atmospheric soil deposition, surface losses, and loss of finishes are typical at the kalamein windows. Extensive amounts of pigeon guano are extant on all surfaces especially on the floor at the second level of the bridge.

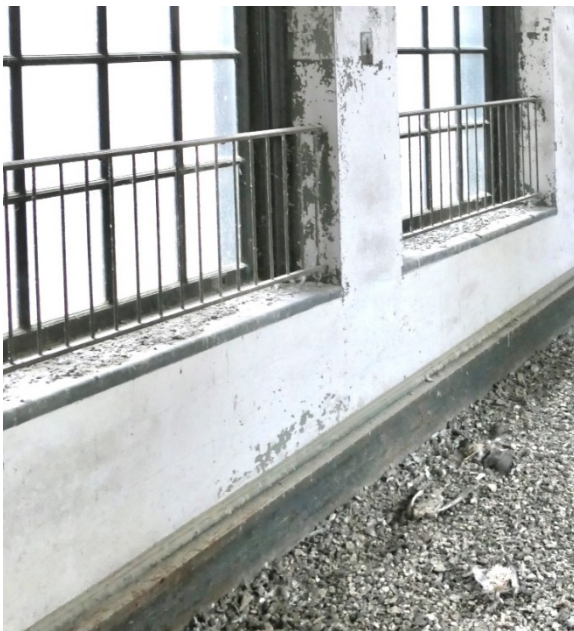
Figure 14. Loss of finishes at metal window guards at the second level of the bridge.

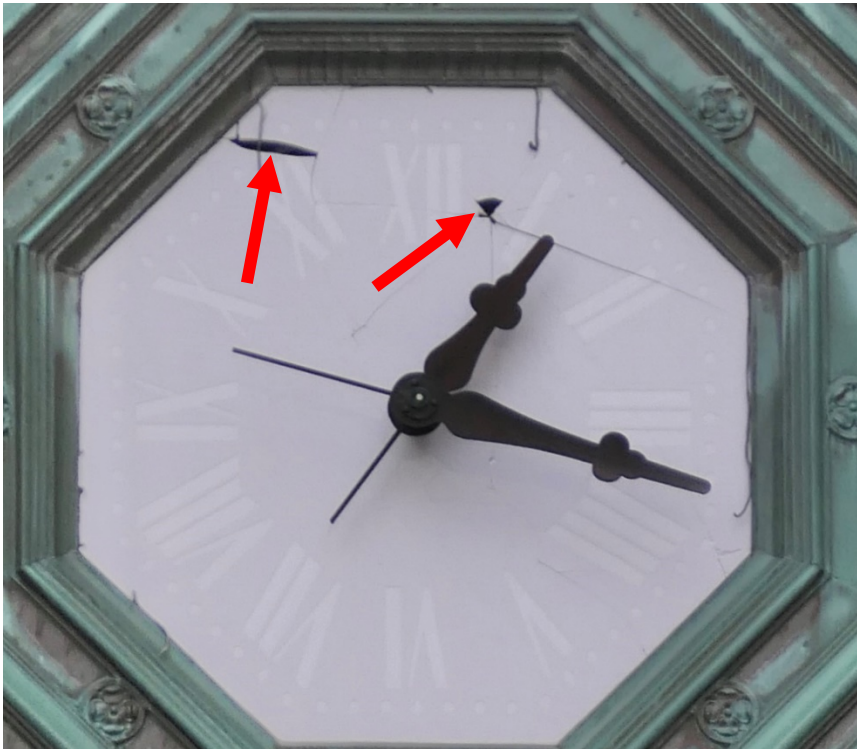
The glass clock face on the west façade exhibits surface cracks and broken glass (Figure 15).

15. Multiple cracks and missing glass at the ornamental clock face on the west elevation. Arrows indicate locations of missing glass.

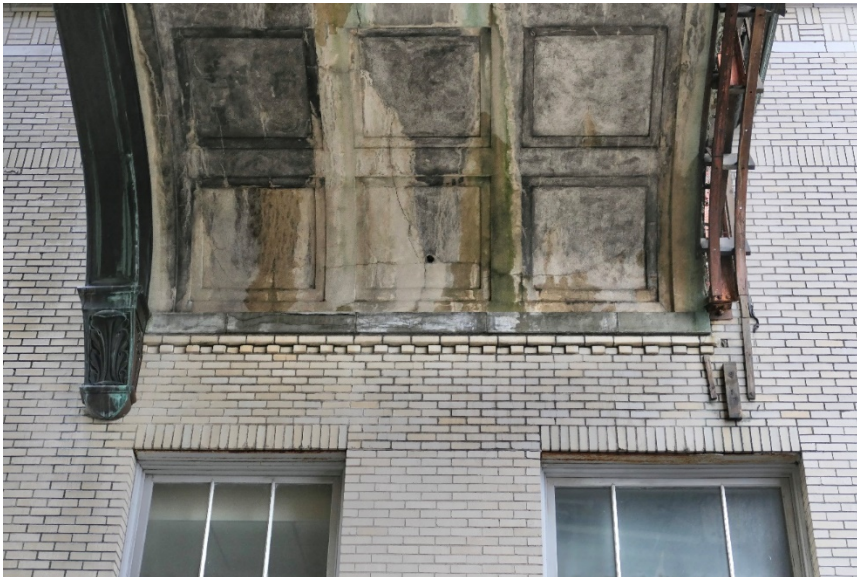
The cement plaster soffit at the bridge exhibits heavy atmospheric soil deposition, water damage, and biological growth (Figure 16). Surface losses and cracks in the cement plaster occur at isolated locations. At one location on the south end of the soffit, a network of cracks occurs adjacent to a hole in the cement plaster (Figure 17). At one location, a flat panel in one soffit was removed to accommodate the installation of electrical equipment (Figure 18).

Figure 16. Heavy atmospheric soil deposition, water damage, and biological growth on cement plaster surfaces at the bridge soffit.

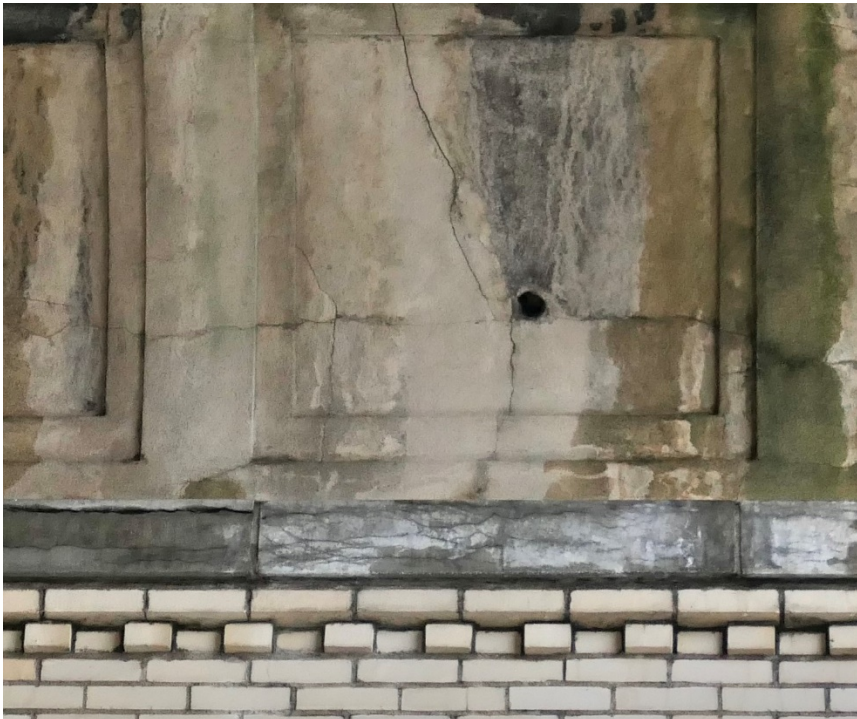
Figure 17. Surfaces losses and cracks at isolated locations in the cement plaster soffit.

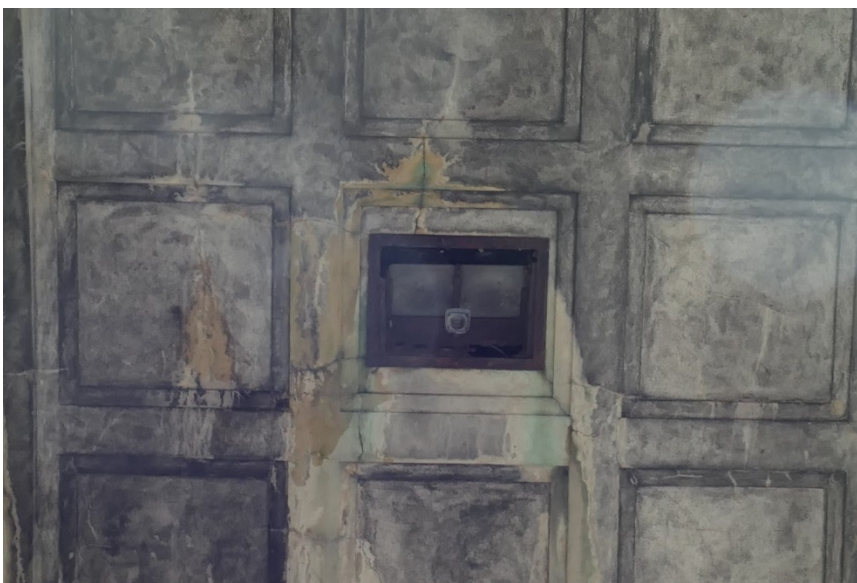
Figure 18. A flat panel in one soffit was removed to accommodate the installation of electrical equipment.

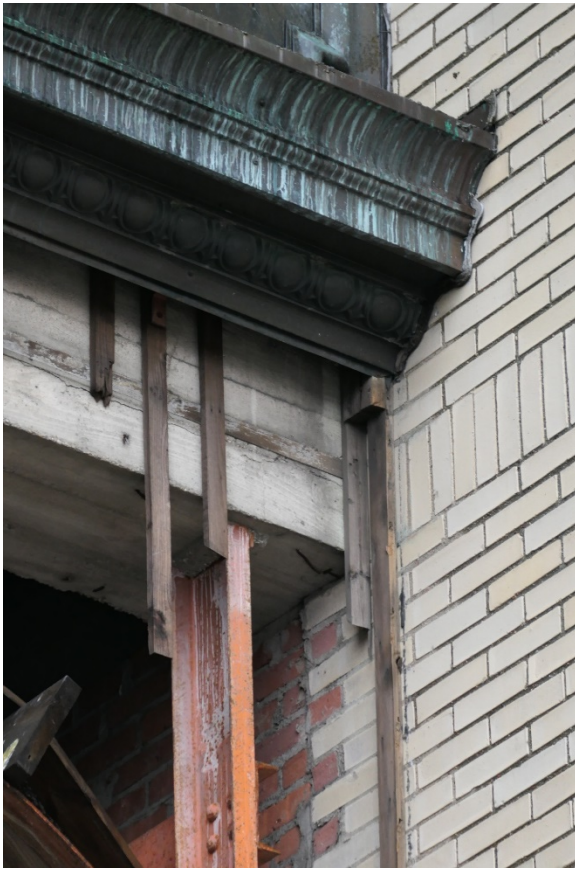
Where exposed to environmental conditions at locations where the sheet-metal cladding is loose or missing, wood elements of the exterior cladding system exhibit water damage and displacement (Figure 19).

Figure 19. Water-damaged and displaced wood elements at the cladding armature.

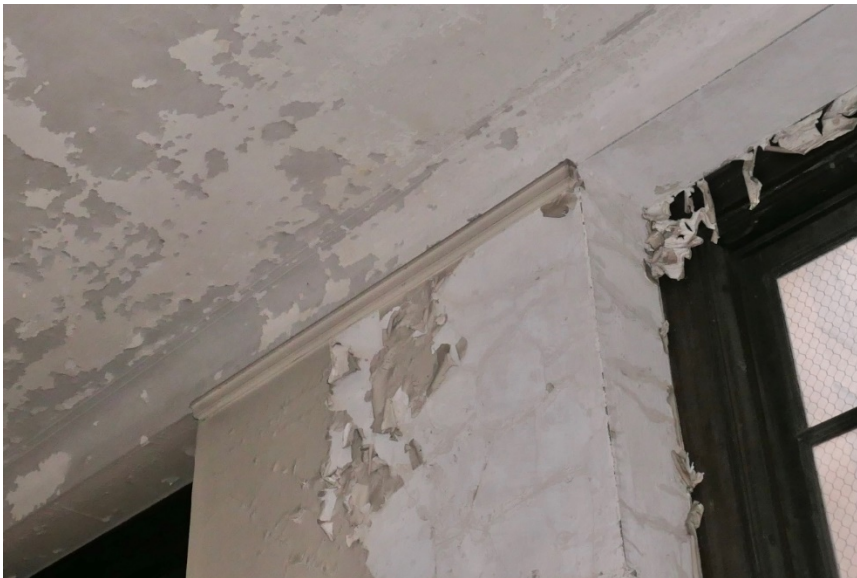
The painted wood picture moldings at the bridge interior on both levels exhibit general atmospheric soil deposition and overall finish failure (Figure 20).

Figure 20. General atmospheric soil deposition and finish failure at the painted wood picture molding at the first level.

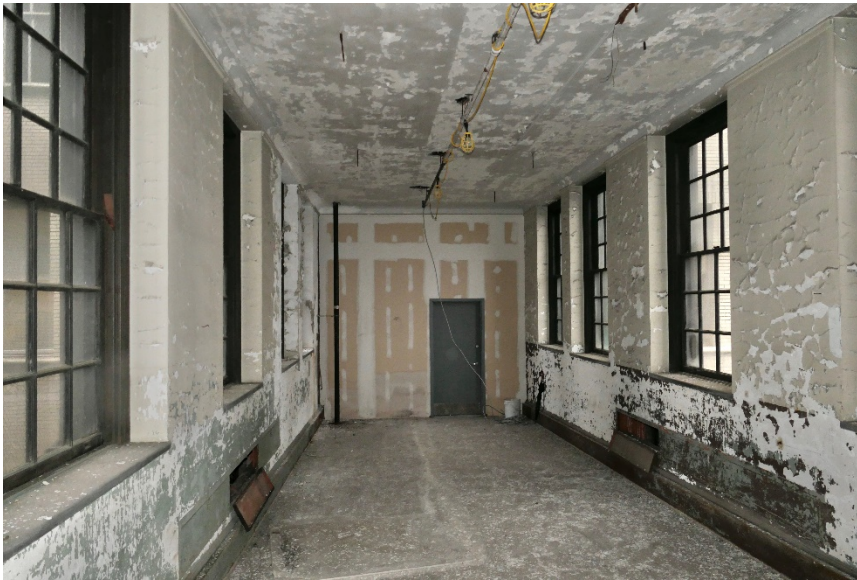
The painted plaster walls and ceilings at the interior of the bridge on both levels exhibit extensive finish failure on all surfaces (Figures 21 and 22). At isolated locations, plaster surfaces exhibit losses and disaggregation where penetrations were made to accommodate non-historic mechanical equipment and other interventions (Figure 23).

Figure 21. Extensive finish failure at painted plaster walls and ceiling at the first level.

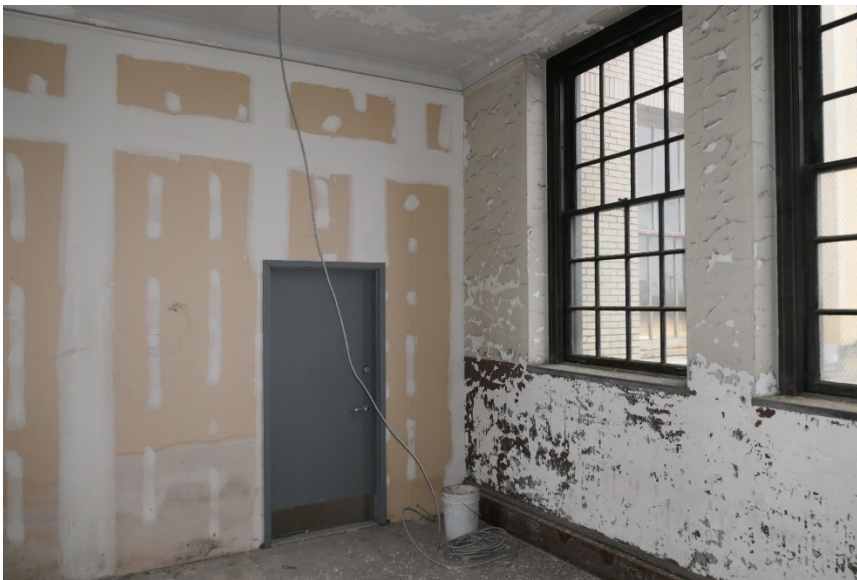
Figure 22. Failing finishes on plaster surfaces on the first level visible at right. Non-historic partition and door at connection to adjacent building visible at left.

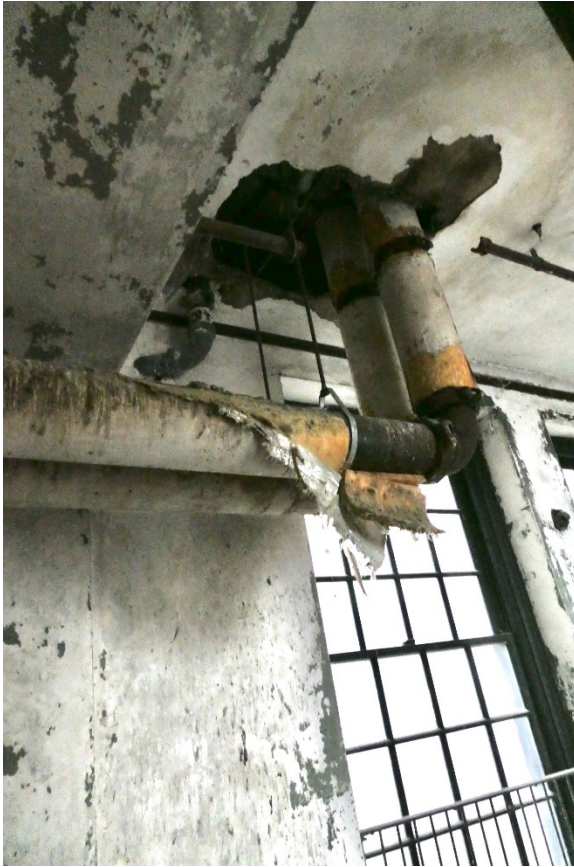
Figure 23. Surfaces losses and disaggregation at plaster surfaces where penetrations were made to accommodate non-historic mechanical equipment on the first level.

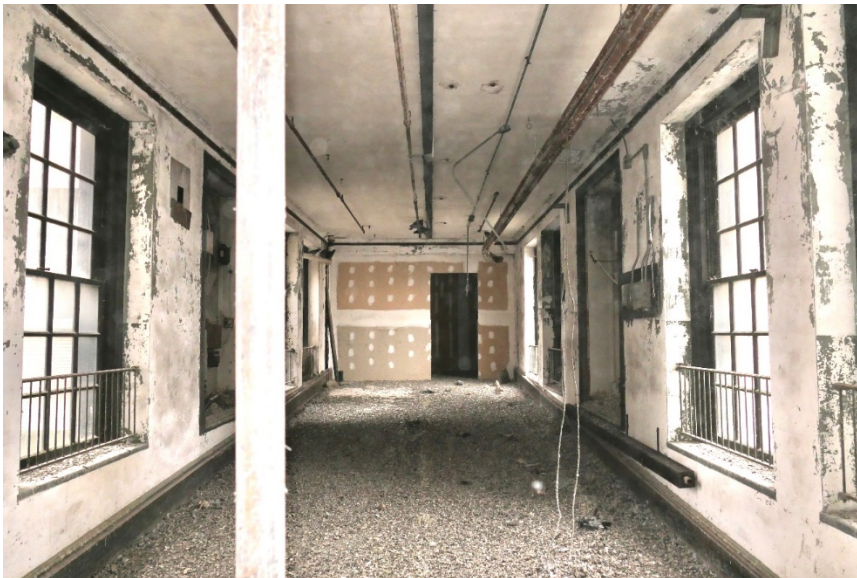
The terrazzo floors at both levels of the bridge are obscured by debris from failing paint finishes and subsequent construction activity (Figure 24). Further investigation is required to determine the condition of the terrazzo.

Figure 24. The terrazzo floors at both levels of the bridge are obscured by pigeon guano and debris from failing paint finishes and subsequent construction activity.
