City of Hartford
Department of Development Services
Planning Division

Return Form to the Planning Desk at the
Licenses & Inspections Division Counter
860-757-9239
260 Constitution Plaza
Hartford, Connecticut 06103-1822

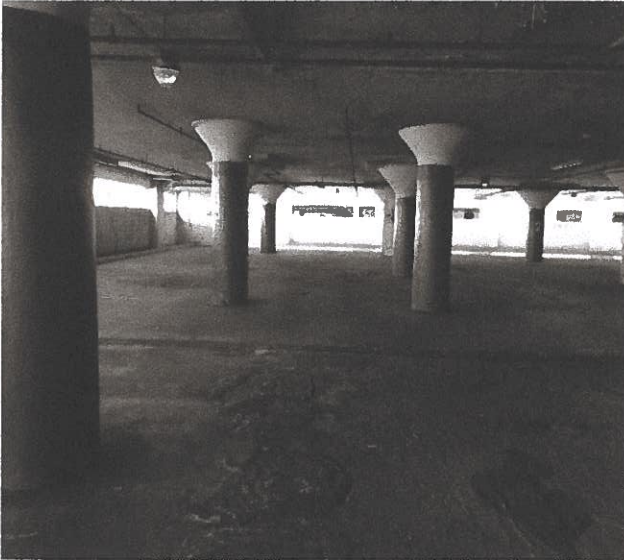
Photo 2 – Ponding on topside slab due to the lack of adequate drainage system.

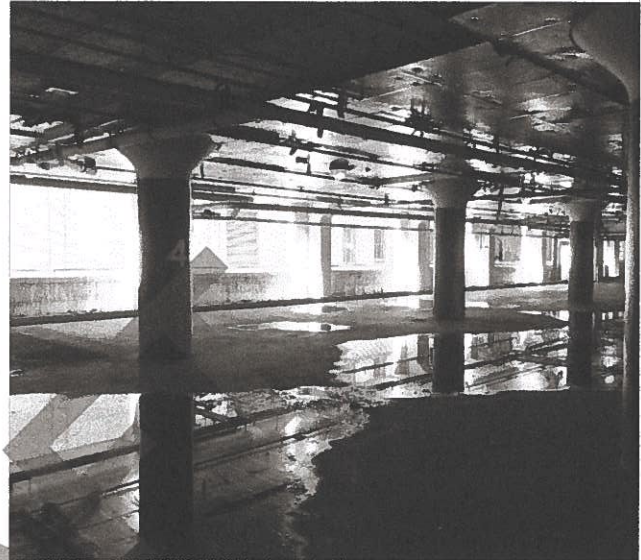
Photo 3 – Topside concrete slab spalls and delamination.

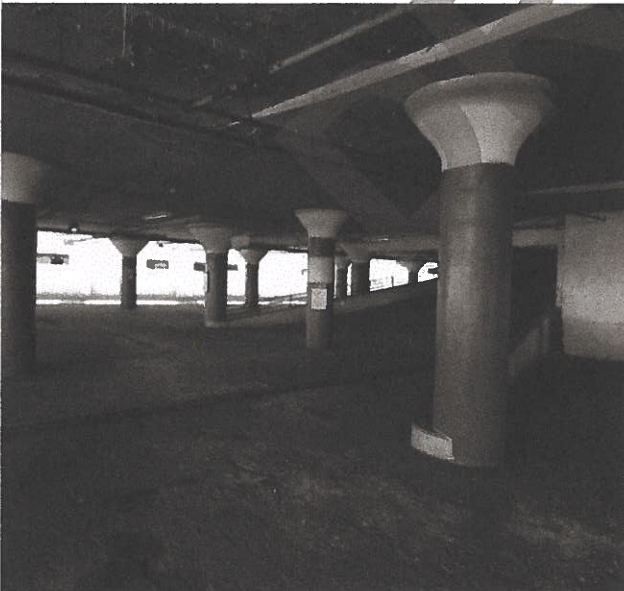
Photo 4 – Topside patches at garage entrance.

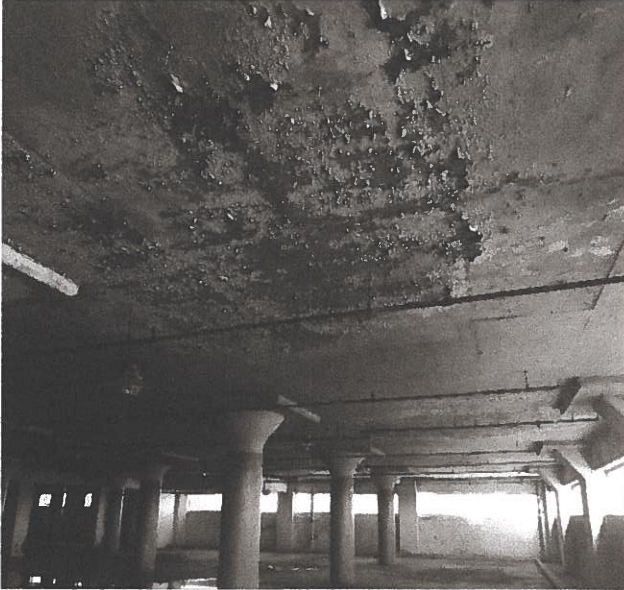
Photo 6 – Deteriorated underside floor slab.

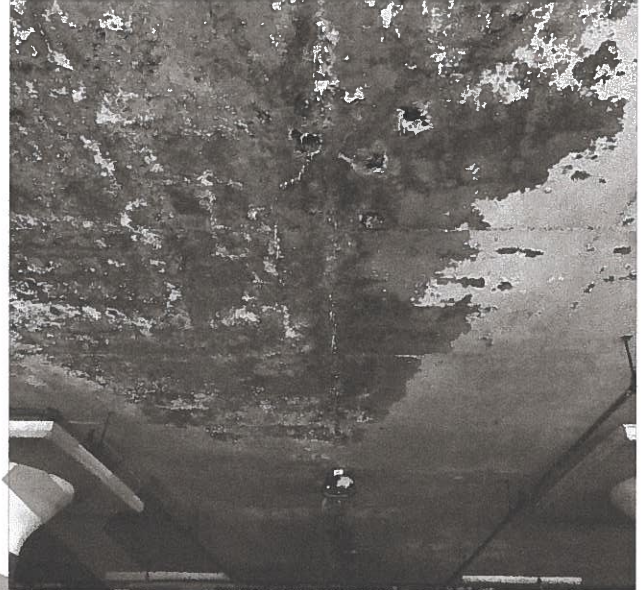
Photo 7 – Random underside beam spall with exposed reinforcing.

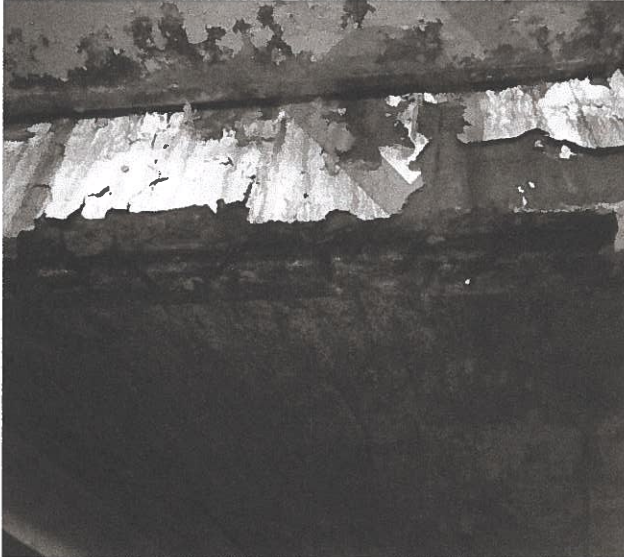
Photo 8 – Large underside spall with exposed steel reinforcement.

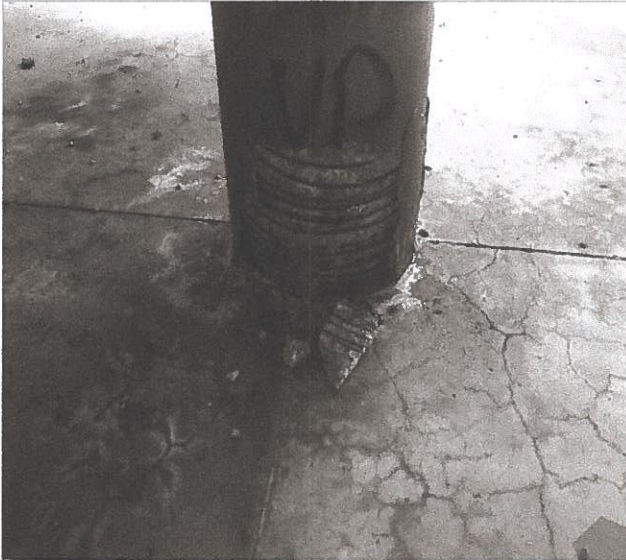
Photo 10 – Column base spalling.

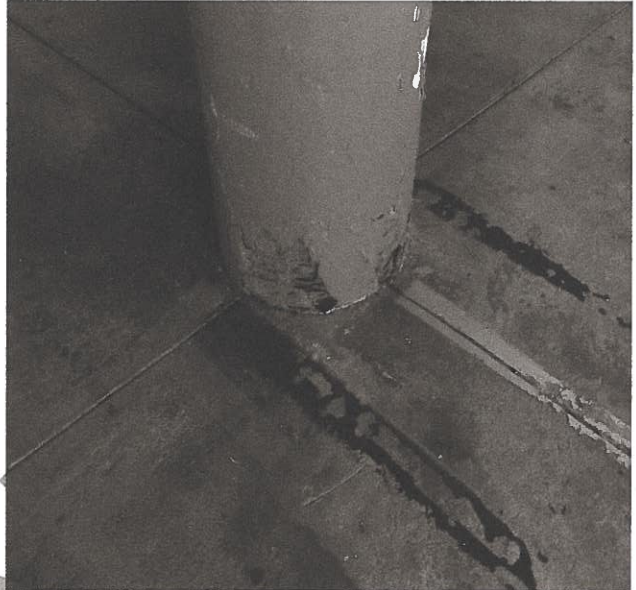
Photo 11 – Column spall with exposed steel reinforcement.

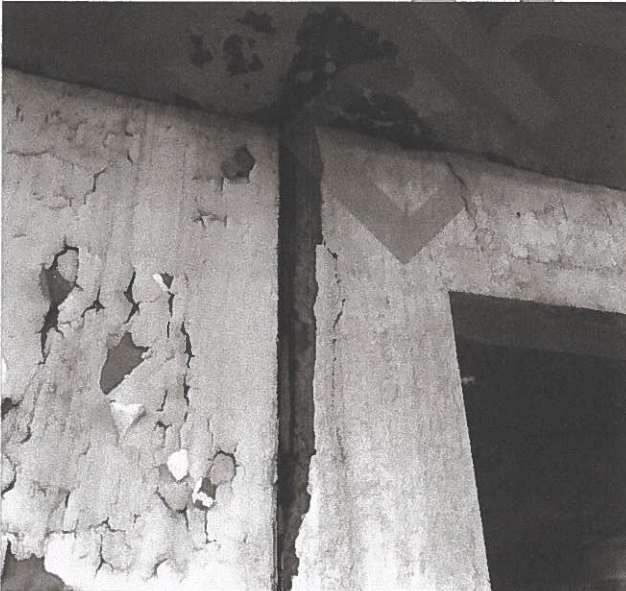
Photo 12 – Column & wall spalling and delamination.

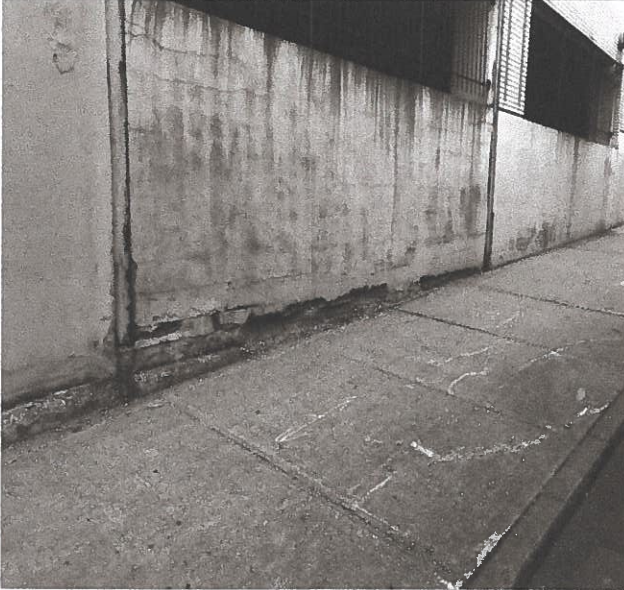
Photo 14 – Staining on exterior brick façade.

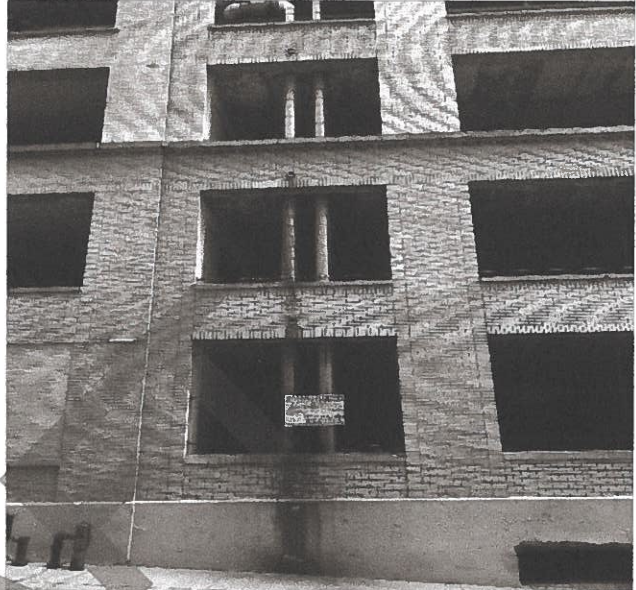
Photo 15 – Cracking at exterior brick wall.

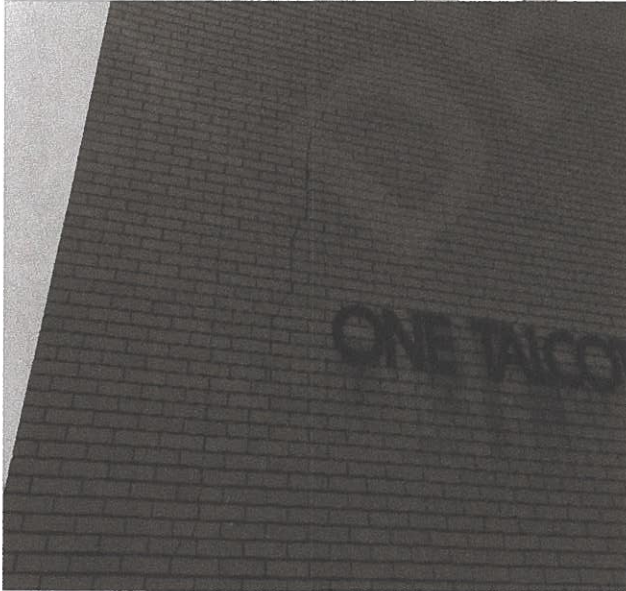
Photo 16 – Cracking and spalling at building base.

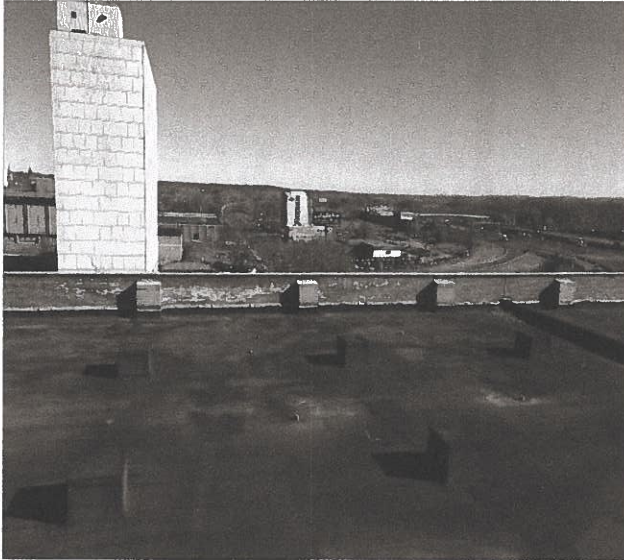
Photo 18 – Minor ponding on garage roofing system. Note the lack of drainage on the Northwest side of roof.

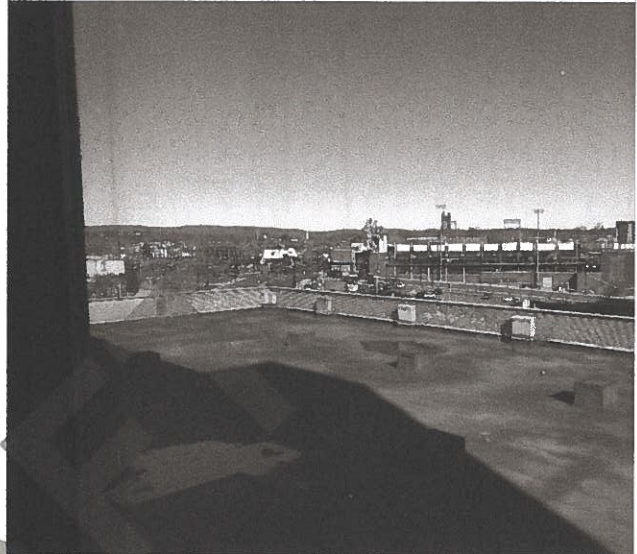
Photo 19 – Minor spalls on Plaza stairs.

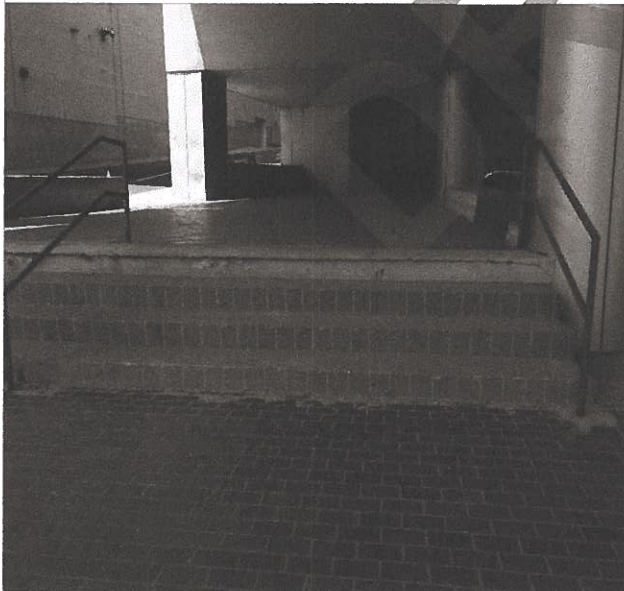
Photo 20 – Plaza surface deterioration.

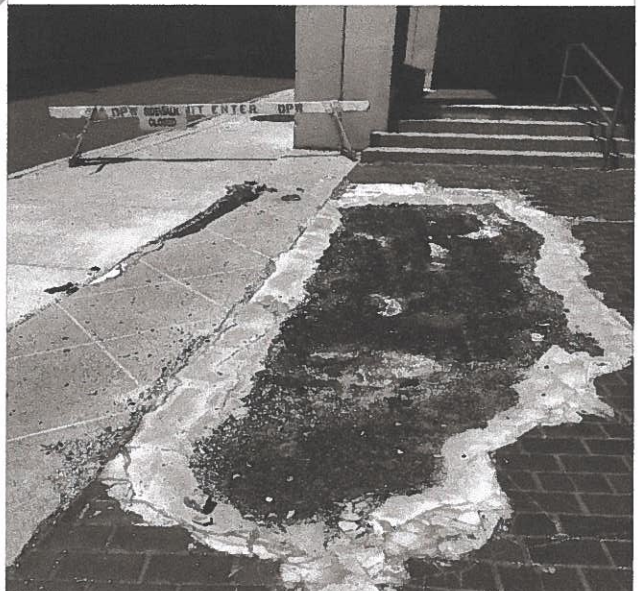
Photo 15 –Existing conditions of walkway between building and Morgan Street surface lot.

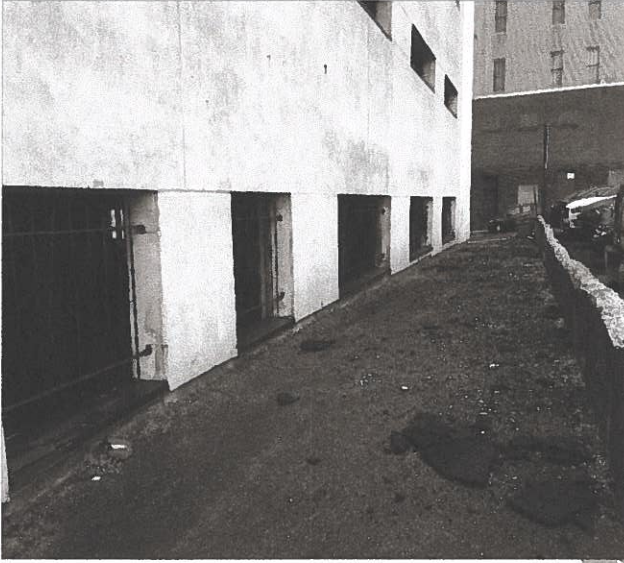
Photo 16 –Morgan Street surface lot walkway weathered asphalt and concrete wall.

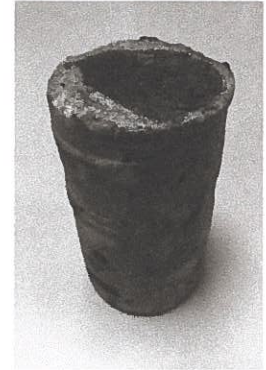
CONSOLIDATION: Good
SEGREGATION: None
GRADATION: Good
ENTRAPPED AIR: Moderate
CRACKING (EXTENT/DEPTH, ETC.): None
DEPTH OF STEEL: NA
SIZE OF STEEL: NA
CONDITION OF STEEL: NA
PRESENCE OF PATCH MATERIAL: NA

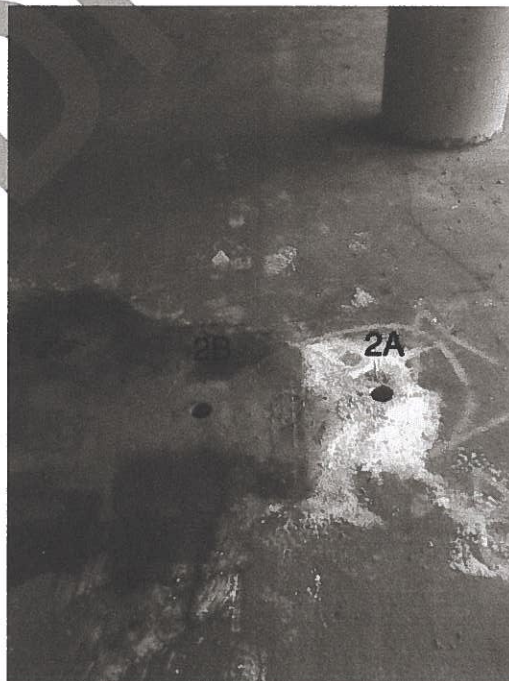
GENERAL COMMENTS: This core was extracted from a good area of concrete within 5 feet of a floor drain. There is accumulated rust on the portion where the core was cut due to the presence of steel 4" below the surface.

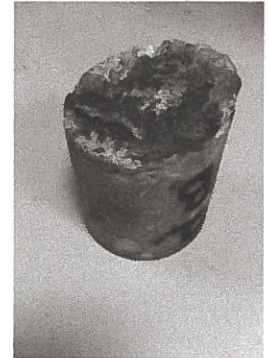
CONSOLIDATION: Good
SEGREGATION: None
GRADATION: Good
ENTRAPPED AIR: Moderate
CRACKING (EXTENT/DEPTH, ETC.): Shallow crack 3" long @ 1/4" down
DEPTH OF STEEL: NA
SIZE OF STEEL: NA
CONDITION OF STEEL: NA
PRESENCE OF PATCH MATERIAL: NA
GENERAL COMMENTS: This core was extracted from a good area of concrete within 5 feet of a floor drain. The core was extracted approximately 18 inches away from core 2A.

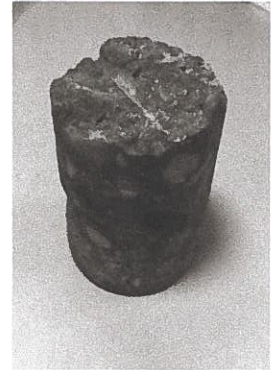
CONSOLIDATION: Good
 SEGREGATION: None
 GRADATION: Good
 ENTRAPPED AIR: Moderate
 CRACKING (EXTENT/DEPTH, ETC.): None
 DEPTH OF STEEL: NA
 SIZE OF STEEL: NA
 CONDITION OF STEEL: NA
 PRESENCE OF PATCH MATERIAL: NA
 GENERAL COMMENTS: This core was extracted from a delaminated area of concrete in a low point where there was water ponding located on level L of the garage. The core was cut at 3" due to the presence of steel below the surface

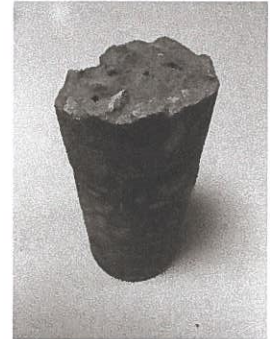
CONSOLIDATION: Good
SEGREGATION: None
GRADATION: Good
ENTRAPPED AIR: Moderate
CRACKING (EXTENT/DEPTH, ETC.): None
DEPTH OF STEEL: NA
SIZE OF STEEL: NA
CONDITION OF STEEL: NA
PRESENCE OF PATCH MATERIAL: NA
GENERAL COMMENTS: This core was extracted from a good area of concrete located on level 1 of the parking garage.

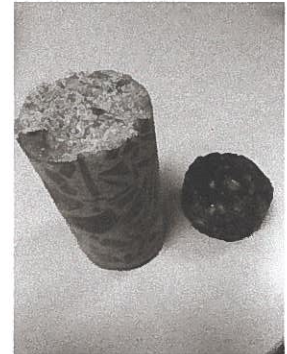
CONSOLIDATION: Good
SEGREGATION: None
GRADATION: Good
ENTRAPPED AIR: Moderate
CRACKING (EXTENT/DEPTH, ETC.): None
DEPTH OF STEEL: NA
SIZE OF STEEL: NA
CONDITION OF STEEL: NA
PRESENCE OF PATCH MATERIAL: NA

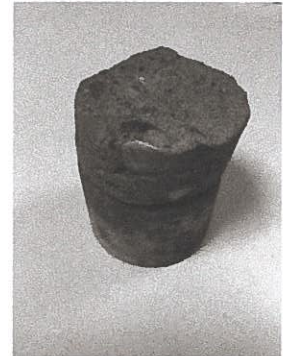
CONSOLIDATION: Good
 SEGREGATION: None
 GRADATION: Good
 ENTRAPPED AIR: Moderate
 CRACKING (EXTENT/DEPTH, ETC.): Clean break @ 1/4" down + Overlay
 DEPTH OF STEEL: NA
 SIZE OF STEEL: NA
 CONDITION OF STEEL: NA
 PRESENCE OF PATCH MATERIAL: NA
 GENERAL COMMENTS: This core was extracted from a good area of concrete located on level 1 of the parking garage. A 2" concrete overlay exists in the region.

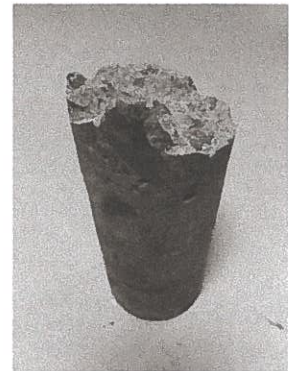
CONSOLIDATION: Good
 SEGREGATION: None
 GRADATION: Good
 ENTRAPPED AIR: Moderate
 CRACKING (EXTENT/DEPTH, ETC.): None
 DEPTH OF STEEL: NA
 SIZE OF STEEL: NA
 CONDITION OF STEEL: NA
 PRESENCE OF PATCH MATERIAL: NA
 GENERAL COMMENTS: This core was extracted from a good area of concrete located on level 2 of the parking garage.

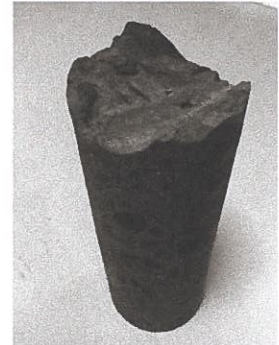
CONSOLIDATION: Good
SEGREGATION: None
GRADATION: Good
ENTRAPPED AIR: Moderate
CRACKING (EXTENT/DEPTH, ETC.): None
DEPTH OF STEEL: NA
SIZE OF STEEL: NA
CONDITION OF STEEL: NA
PRESENCE OF PATCH MATERIAL: NA
GENERAL COMMENTS: This core was extracted from a good area of concrete in a low-point where there were signs of water ponding.

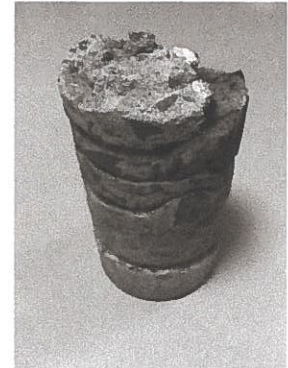
CONSOLIDATION: Good
SEGREGATION: None
GRADATION: Good
ENTRAPPED AIR: Moderate
CRACKING (EXTENT/DEPTH, ETC.): 4 clean breaks at varying depths
DEPTH OF STEEL: NA
SIZE OF STEEL: NA
CONDITION OF STEEL: NA
PRESENCE OF PATCH MATERIAL: NA
GENERAL COMMENTS: This core was extracted from a delaminated area of concrete in a flat region on level 2 of the parking garage. A 1" concrete overlay exists in this region. The core broke into 5 distinguished pieces during extraction.

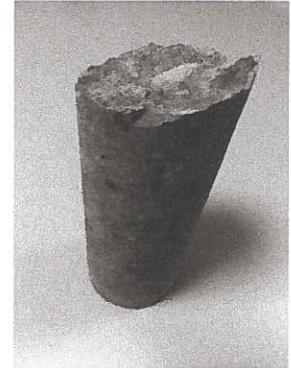
CONSOLIDATION: Good
SEGREGATION: None
GRADATION: Good
ENTRAPPED AIR: Moderate
CRACKING (EXTENT/DEPTH, ETC.): None
DEPTH OF STEEL: NA
SIZE OF STEEL: NA
CONDITION OF STEEL: NA
PRESENCE OF PATCH MATERIAL: NA
GENERAL COMMENTS: This core was extracted from a delaminated area of concrete in a flat region.

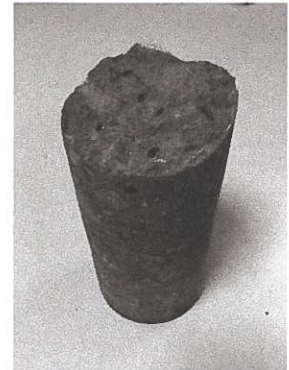
CONSOLIDATION: Good
SEGREGATION: None
GRADATION: Good
ENTRAPPED AIR: Moderate-High
CRACKING (EXTENT/DEPTH, ETC.): None
DEPTH OF STEEL: NA
SIZE OF STEEL: NA
CONDITION OF STEEL: NA
PRESENCE OF PATCH MATERIAL: NA
GENERAL COMMENTS: This core was extracted from a delaminated area of concrete in a flat region on level 3 of the parking garage.

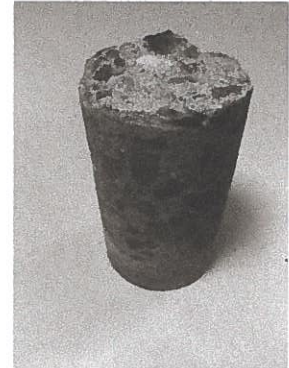
CONSOLIDATION: Good
SEGREGATION: None
GRADATION: Good
ENTRAPPED AIR: Moderate
CRACKING (EXTENT/DEPTH, ETC.): None
DEPTH OF STEEL: NA
SIZE OF STEEL: NA
CONDITION OF STEEL: NA
PRESENCE OF PATCH MATERIAL: NA
GENERAL COMMENTS: This core was extracted from a good area of concrete in a flat region on level 3 of the parking garage.

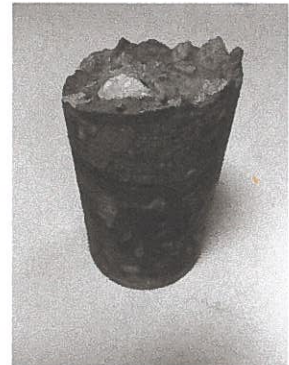
CONSOLIDATION: Good
 SEGREGATION: None
 GRADATION: Good
 ENTRAPPED AIR: Moderate-High
 CRACKING (EXTENT/DEPTH, ETC.): None
 DEPTH OF STEEL: NA
 SIZE OF STEEL: NA
 CONDITION OF STEEL: NA
 PRESENCE OF PATCH MATERIAL: NA
 GENERAL COMMENTS: This core was extracted from a good area of concrete in a flat region located on level 4 of the parking garage.

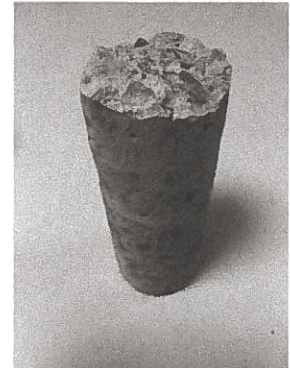
CONSOLIDATION: Good
SEGREGATION: None
GRADATION: Good
ENTRAPPED AIR: Moderate-High
CRACKING (EXTENT/DEPTH, ETC.): None
DEPTH OF STEEL: NA
SIZE OF STEEL: NA
CONDITION OF STEEL: NA
PRESENCE OF PATCH MATERIAL: NA
GENERAL COMMENTS: This core was extracted from a delaminated area of concrete in a flat region located on level 4 of the parking garage.

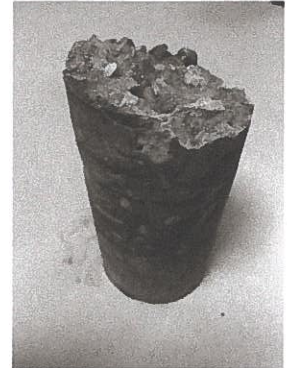
CONSOLIDATION: Good
SEGREGATION: None
GRADATION: Good
ENTRAPPED AIR: Moderate
CRACKING (EXTENT/DEPTH, ETC.): None
DEPTH OF STEEL: NA
SIZE OF STEEL: NA
CONDITION OF STEEL: NA
PRESENCE OF PATCH MATERIAL: NA
GENERAL COMMENTS: This core was extracted from a good area of concrete located on level 4 of the parking garage. The core was within 5 feet of a floor drain.

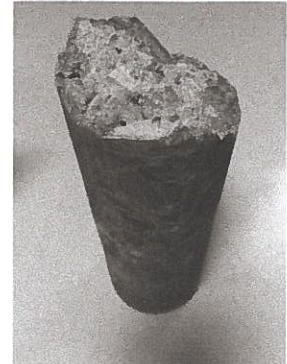
CONSOLIDATION: Good
SEGREGATION: None
GRADATION: Good
ENTRAPPED AIR: Moderate
CRACKING (EXTENT/DEPTH, ETC.): None
DEPTH OF STEEL: NA
SIZE OF STEEL: NA
CONDITION OF STEEL: NA
PRESENCE OF PATCH MATERIAL: NA
GENERAL COMMENTS: This core was extracted from a good area of concrete in a low point located on level 4 of the parking garage.

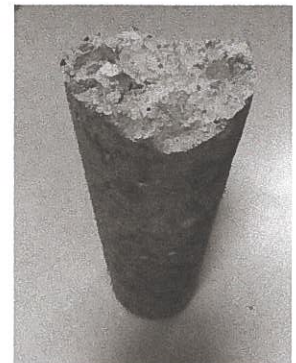
CONSOLIDATION: Good
 SEGREGATION: None
 GRADATION: Good
 ENTRAPPED AIR: Moderate
 CRACKING (EXTENT/DEPTH, ETC.): None
 DEPTH OF STEEL: NA
 SIZE OF STEEL: NA
 CONDITION OF STEEL: NA
 PRESENCE OF PATCH MATERIAL: NA
 GENERAL COMMENTS: This core was extracted from delaminated area of concrete in a flat region located on level 3 of the parking garage.

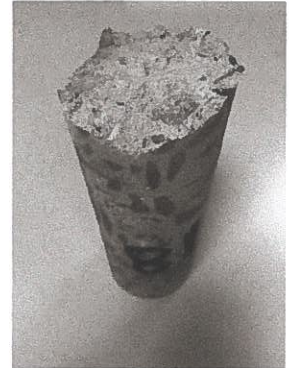
CONSOLIDATION: Good
SEGREGATION: None
GRADATION: Good
ENTRAPPED AIR: Moderate
CRACKING (EXTENT/DEPTH, ETC.): None
DEPTH OF STEEL: NA
SIZE OF STEEL: NA
CONDITION OF STEEL: NA
PRESENCE OF PATCH MATERIAL: NA
GENERAL COMMENTS: This core was extracted from a delaminated area of concrete located on level 2 of the parking garage.

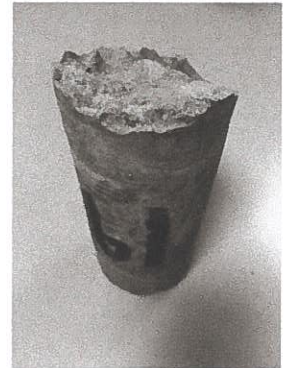
CONSOLIDATION: Good
 SEGREGATION: None
 GRADATION: Good
 ENTRAPPED AIR: Moderate
 CRACKING (EXTENT/DEPTH, ETC.): None
 DEPTH OF STEEL: NA
 SIZE OF STEEL: NA
 CONDITION OF STEEL: NA
 PRESENCE OF PATCH MATERIAL: NA
 GENERAL COMMENTS:

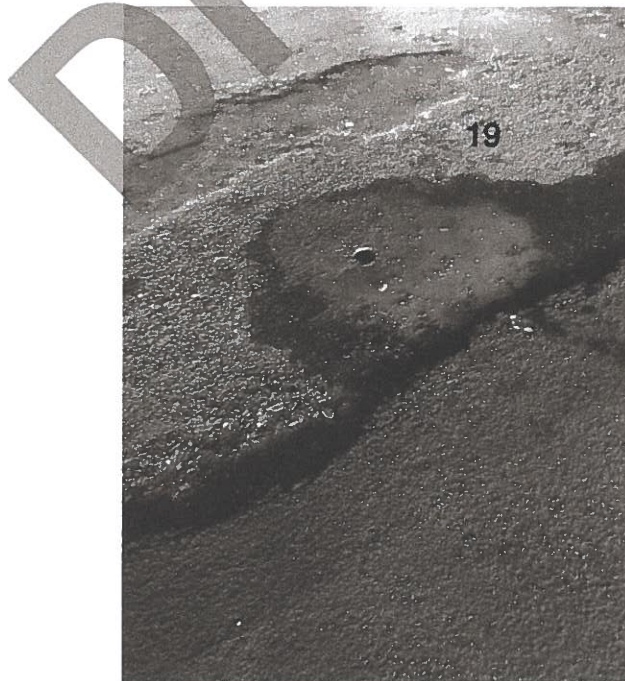
This core was extracted from delaminated area of concrete in a flat region located on level 1 of the parking garage. The core was taken near an asphalt covered area.

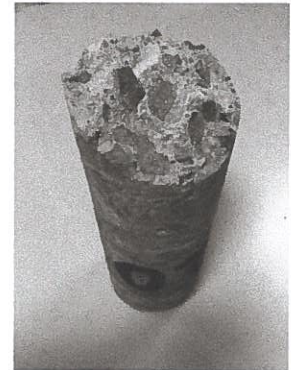
CONSOLIDATION: Good
 SEGREGATION: None
 GRADATION: Good
 ENTRAPPED AIR: Moderate
 CRACKING (EXTENT/DEPTH, ETC.): None
 DEPTH OF STEEL: NA
 SIZE OF STEEL: NA
 CONDITION OF STEEL: NA
 PRESENCE OF PATCH MATERIAL: NA
 GENERAL COMMENTS: This core was extracted from a good area of concrete in a flat region located on level L of the parking garage.

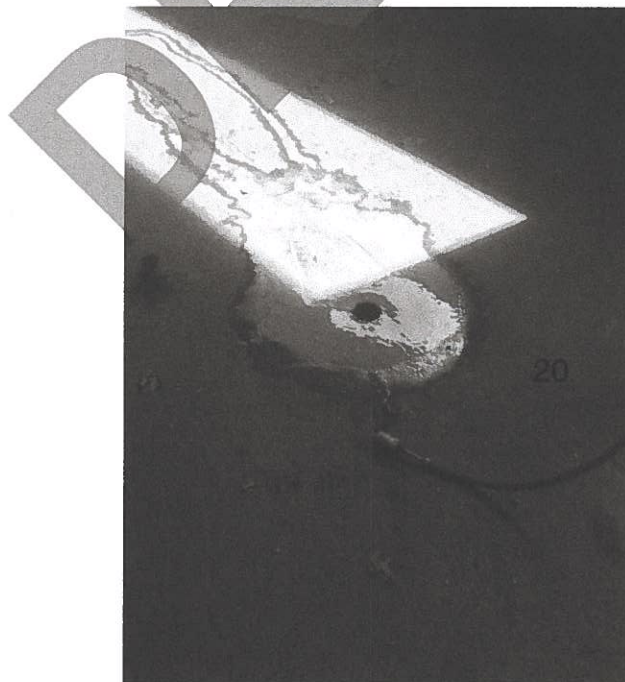
ONE TALCOTT PLAZA PARKING GARAGE
APPENDIX C – CONCRETE TESTING
