## BUILDING SECTIONS 100 CEDAR STREET HARTFORD, CT

Re: #100 Cedar Street, Hartford

At your request I inspected the cornice on 100 Cedar Street to determine the material used in its construction and to determine the condition that it is in.

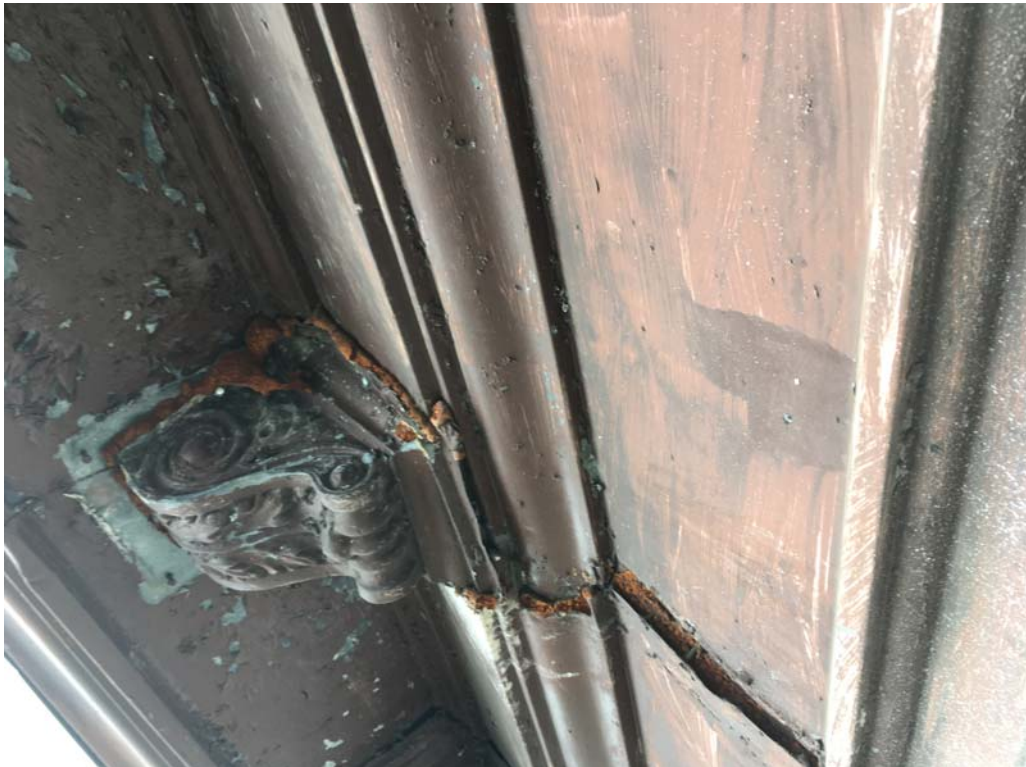
Corbel appears to have fallen off and been refastened. Gaps created by movement have been filled with expanding foam insulation. Soft wood behind the metal was observed in this area

While much of the galvanized sheet metal components of the cornice appear to be in decent condition the general alignment of the cornice along the face of the building is a concern. I feel the alignment issues and evidence of excessive movement are caused by deterioration of the structural components under the metal covering. For this reason, I suggest you monitor the cornice for any additional movement and remove it if any becomes evident.

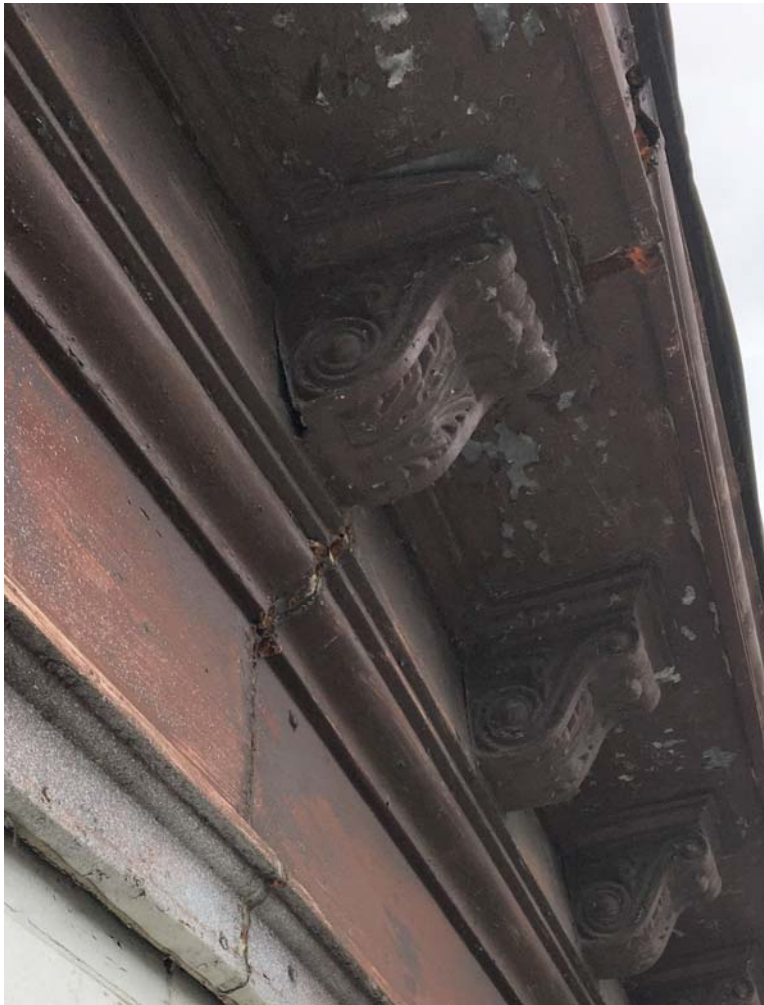
Another joint with excessive movement where the gap has been filled with expanding foam insulation. Note the gaps at the corbel and between the wall and the cornice.
