PZ-HIST-23-000053

Address: 224 WASHINGTON ST, HARTFORD, CT 06106

RE: Structural Condition Assessment
224 Washington Street, Hartford, CT
Fuss & O'Neill Reference No. 20221213.A10

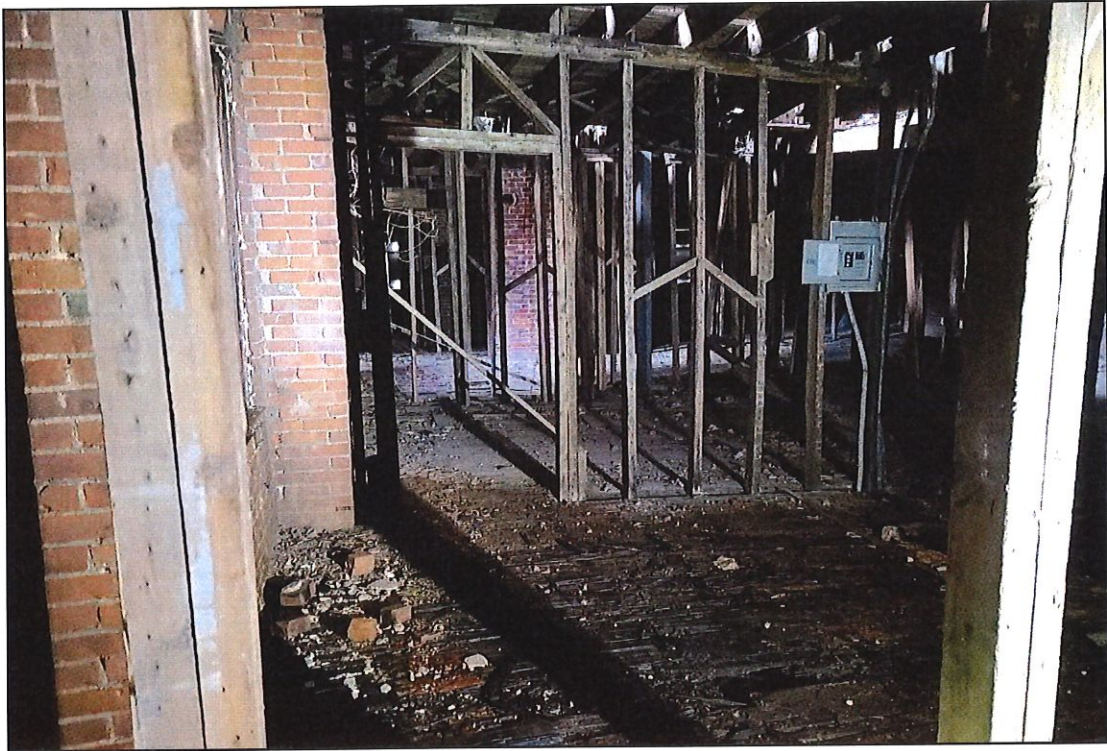
As is typical for most structures that are left unoccupied and unprotected after a significant fire event, much of the damage and deterioration can be attributed to prolonged and continued exposure to water infiltration from a previously failed roof and missing and/or broken windows, doors, and sections of exterior walls. There was also evidence of localized fire damage to much of the timber framing members on the upper levels.

Photo 1: Typical Condition of Interior Framing

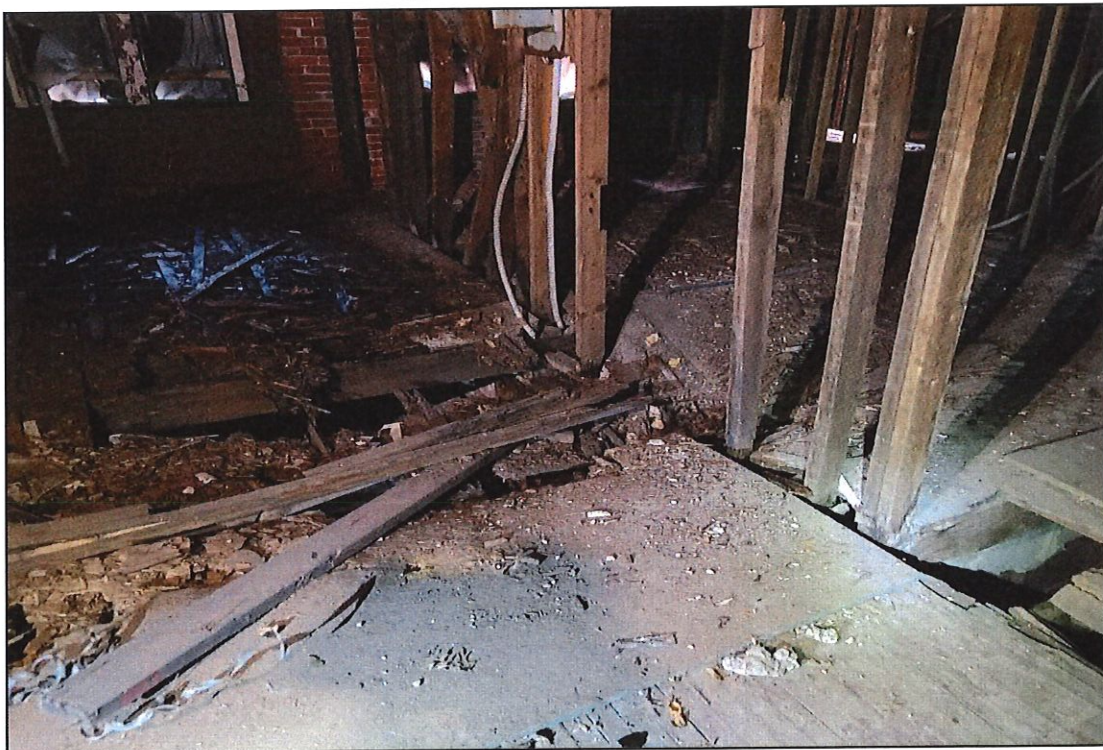
- Portions of the 1st and 2nd floor framing suffered partial collapse and are inaccessible due to the damage and deterioration.
- The interior timber framed stairway is in poor condition as it approaches the 3rd level of the structure and could not be used to access the upper levels of the building. The damage is due to both fire and water infiltration.

Photo 2: Partially Collapsed Floor Framing

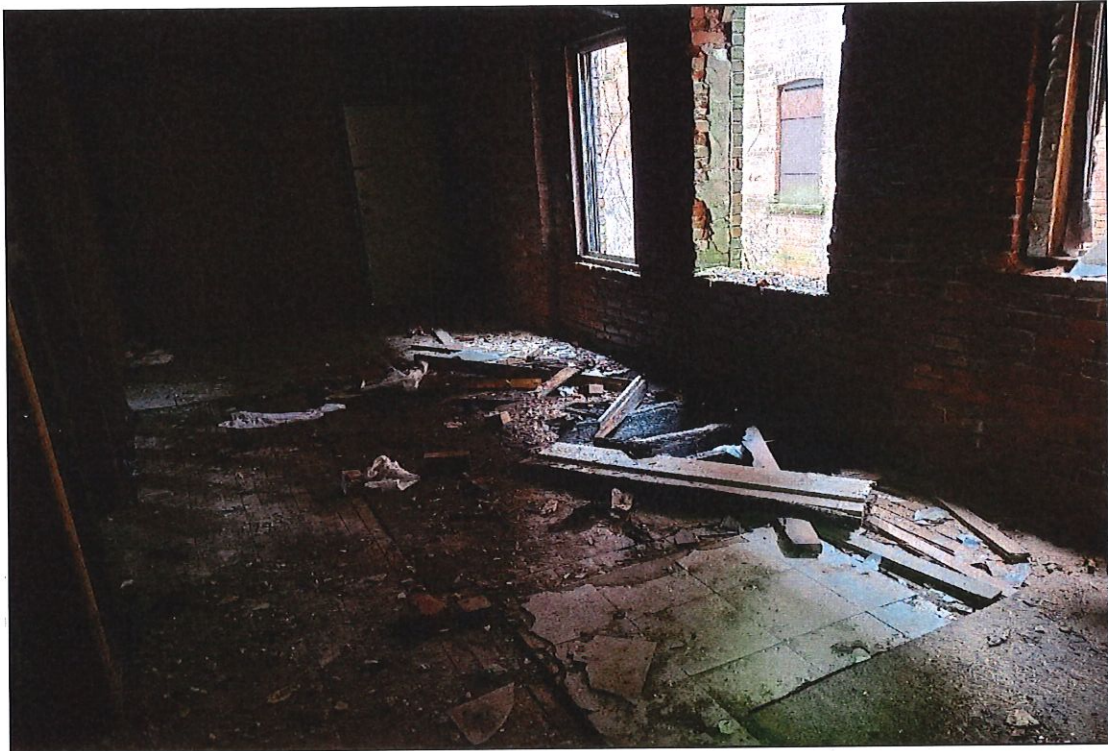
Photo 3: Severe Damage due to Prolonged Water Infiltration

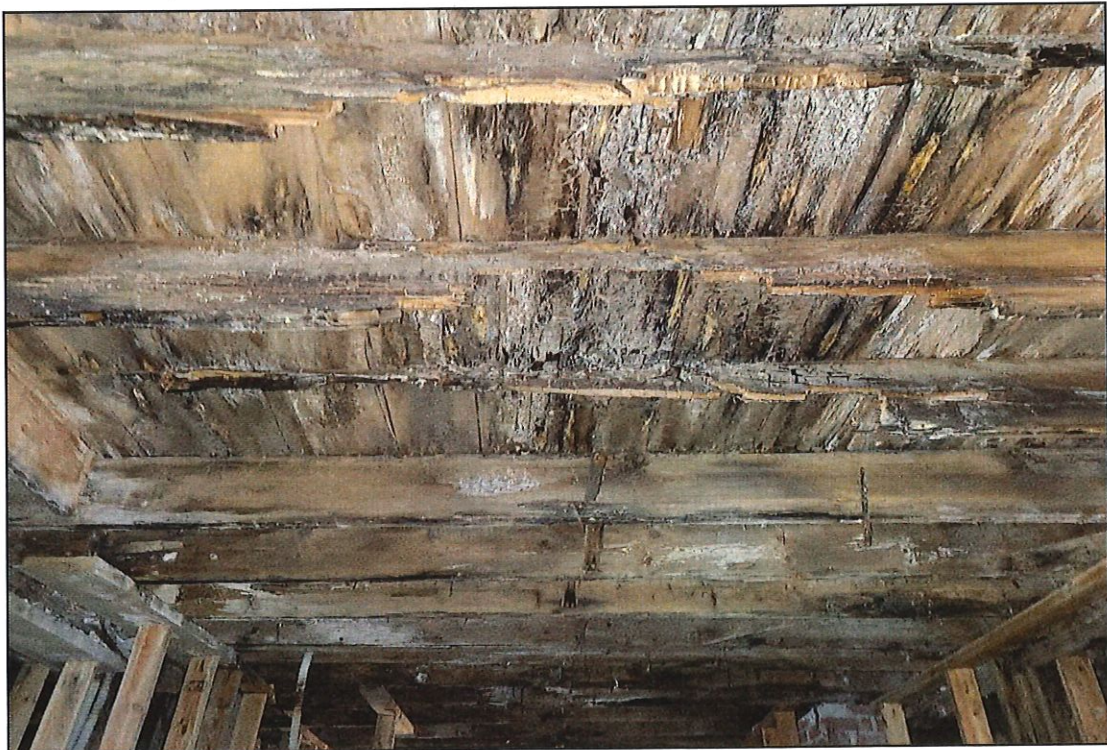
- Many of the building's windows are either missing or broken, providing additional pathways for water to infiltrate and damage the structure.
- Based on our limited observations we estimate that over 50% of the floor framing members for the building have experienced significant deterioration and are not safe to walk on. The remaining framing members are in fair condition; however, their prolonged exposure to water infiltration will cause them to continue to deteriorate at an accelerated pace.

Photo 4: Significantly Compromised Floor Framing

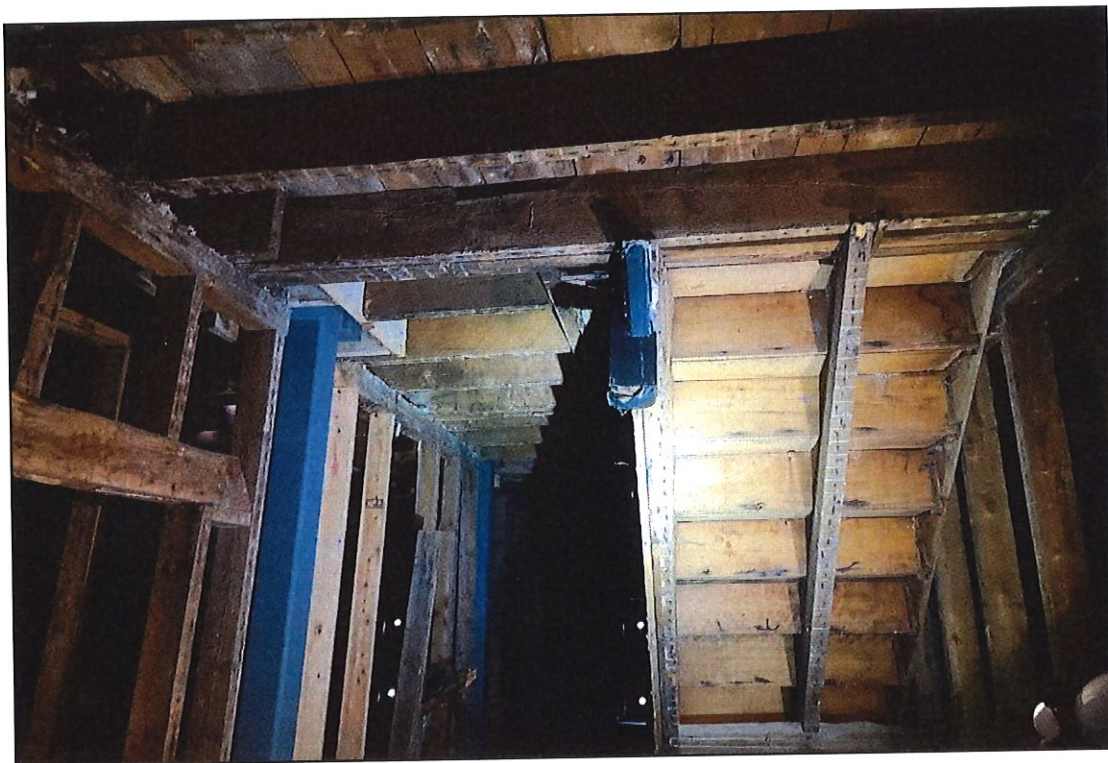
not be directly observed because of heavy damage and deterioration to the structure. There was evidence of previous stabilization with the presence of steel columns; however, it is believed that the steel columns are founded on a masonry pier that's condition is unknown with severely compromised framing surrounding the pier.

Photo 5: Steel Shoring Post Near Interior Stairs

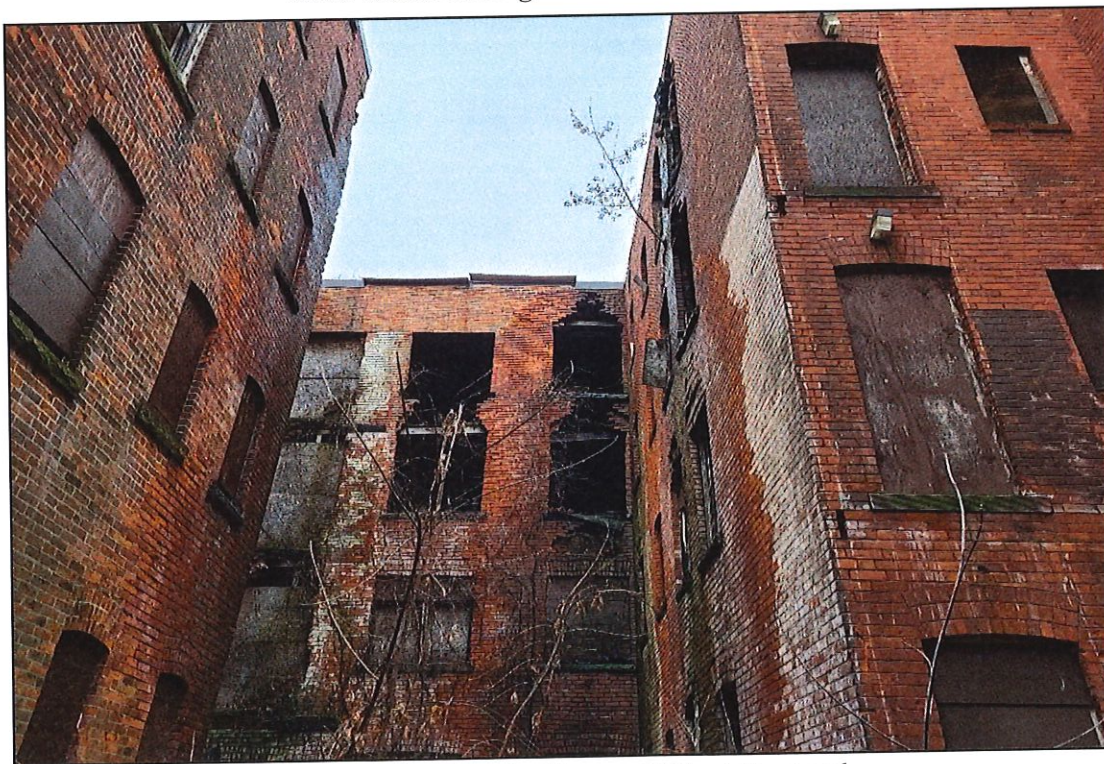
- The exterior brick masonry bearing walls have multiple locations of significant deterioration, especially around window and door openings at the upper portions of the courtyard for the structure. The walls are unstable due to their deterioration and their condition is exacerbated by the deterioration of the timber framing that is no longer adequately bracing the walls at each floor level.

Photo 6: Failing Exterior Masonry Walls at Courtyard

Repairing and/or stabilizing the building would include the complete replacement of all interior timber framing members for all 4 stories of the building and reconstruction of approximately 50% of its exterior masonry load-bearing walls. A restoration effort of this magnitude would pose significant logistical and safety challenges and be cost prohibitive when compared to demolishing the structure. Based on our observations and experience with other similarly deteriorated structures, we recommend that 224 Washington Street be demolished within the next 6 months to minimize risk to abutting properties and nearby pedestrians.

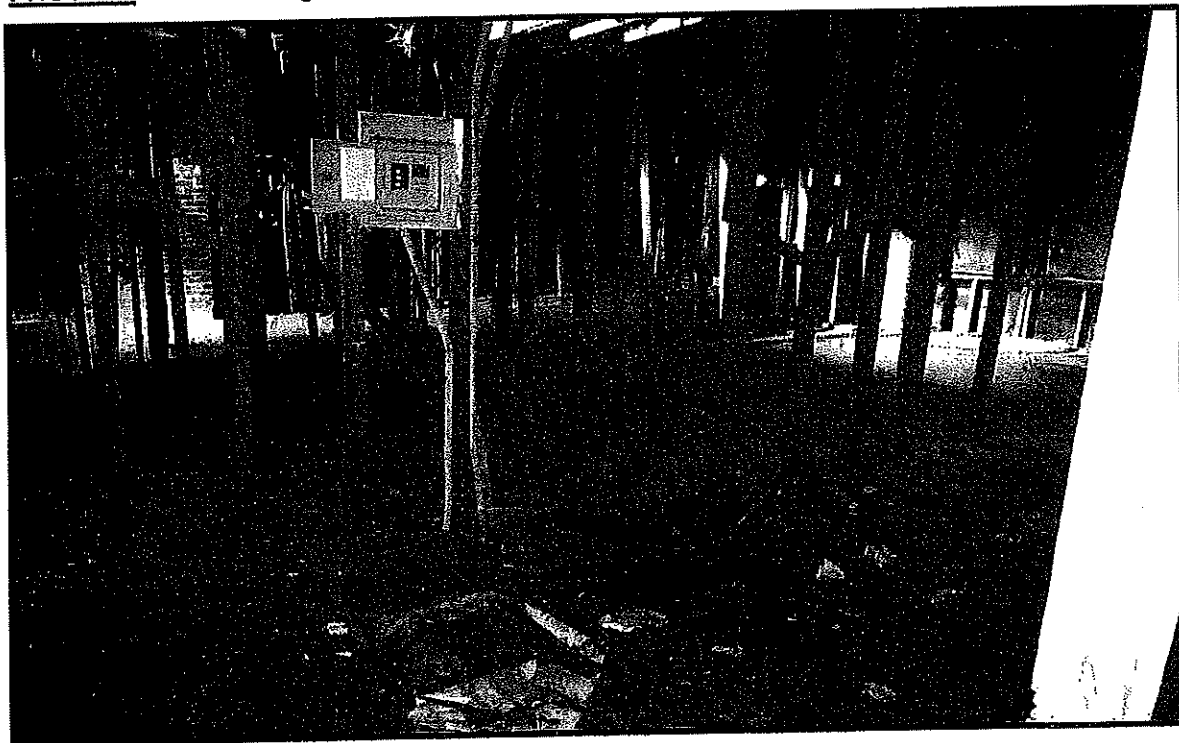
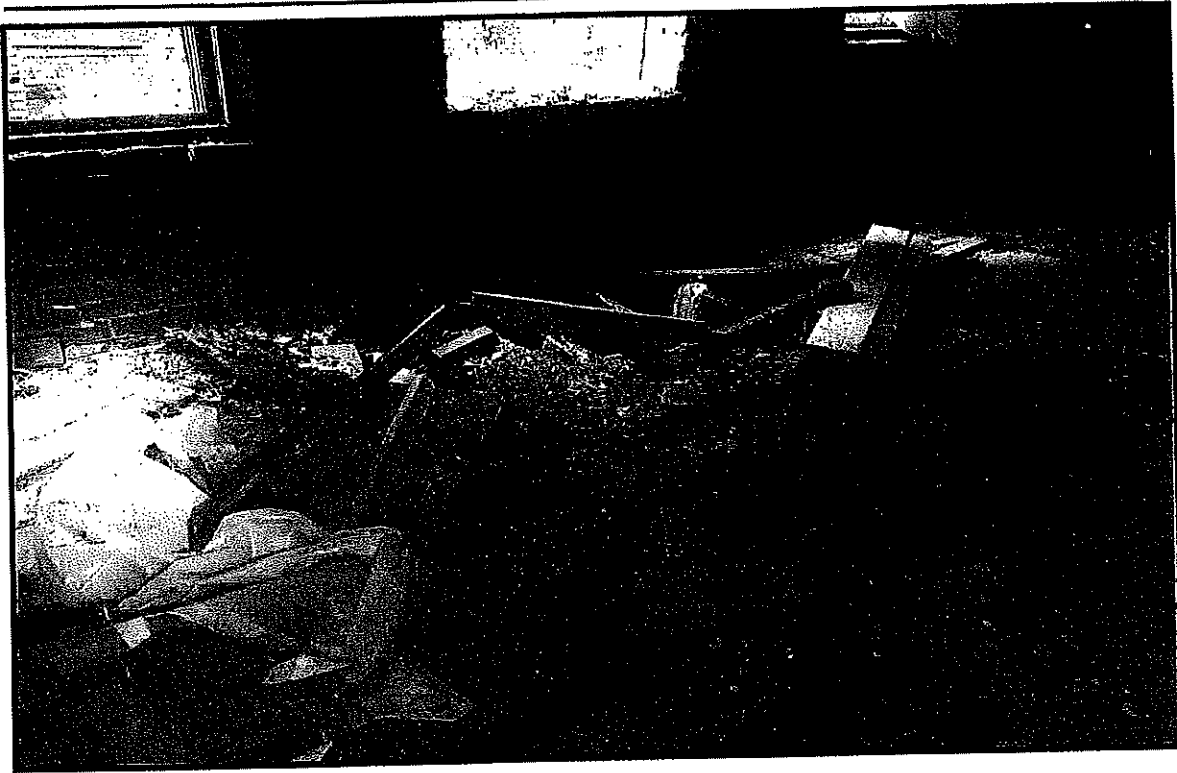
1. Significant deterioration and partially collapsed floor framing due to long term moisture infiltration and failure of exterior masonry bearing walls. See Photos 4 thru 8.

PHOTO 4: - 224 Washington Street Deteriorated and Partially Collapsed Floor Framing.

PHOTO 5: - 224 Washington Street Deteriorated and Partially Collapsed Floor Framing.

PHOTO 6: - 224 Washington Street Deteriorated and Partially Collapsed Floor Framing.

PHOTO 7: - 224 Washington Street Deteriorated and Partially Collapsed Floor Framing.

PHOTO 8: - 224 Washington Street Deteriorated and Partially Collapsed Floor Framing.

Our inspection of the interior of the building was limited due the current condition of the floor framing and corresponding life safety concerns. However, based on the extent of the observed damage, it is our professional opinion that the building cannot be not be safely occupied at this time unless temporary measures are undertaken to stabilize the structure. Making the building safe to occupy will require the installation of extensive and expensive temporary shoring along portions of the interior and exterior of the building. Although the complete extent of required permanent repairs is unknown at this time, the remedial work required will be extensive and costly. Therefore, it is our opinion that consideration should be given to razing the building in its entirety.

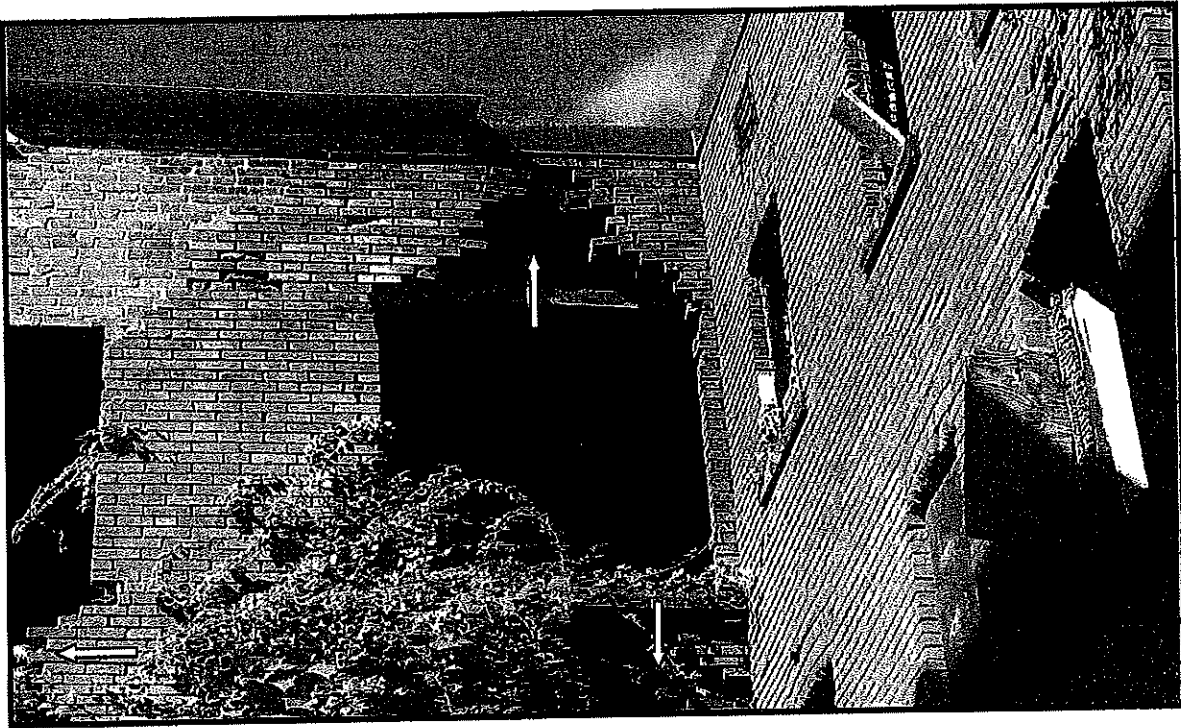
2. Failed brick and partially collapsed masonry walls along the northern and eastern exteriors. See Photos 9 thru 12.
3. Loose bricks and/or partial collapse at window header courses. Bricks were found along the ground at the north side of the building from a failed 4th floor window. See Photo 13.
4. Isolated visible fire damage. See Photo 14.

PHOTO 9: - 224 Washington Street East Wall Masonry Failure at Window Head and Sill.

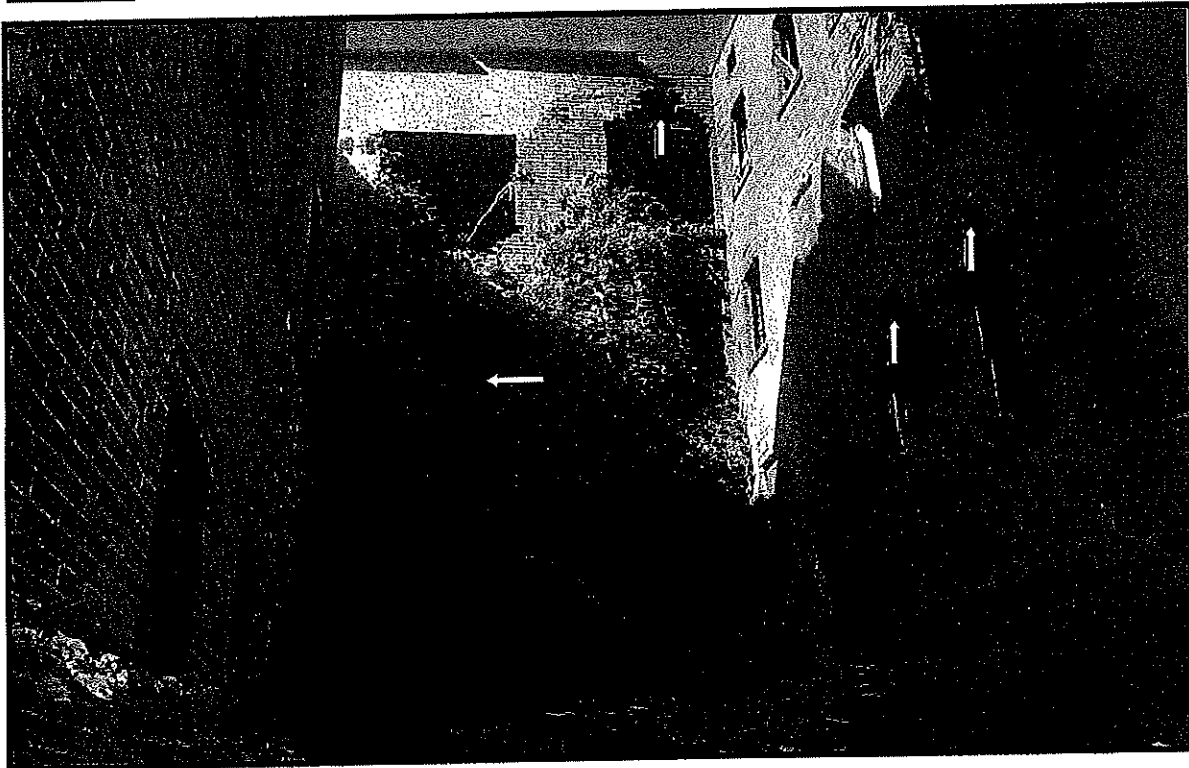
PHOTO 10: - 224 Washington Street East Elevation Masonry Wall Partial Collapse.

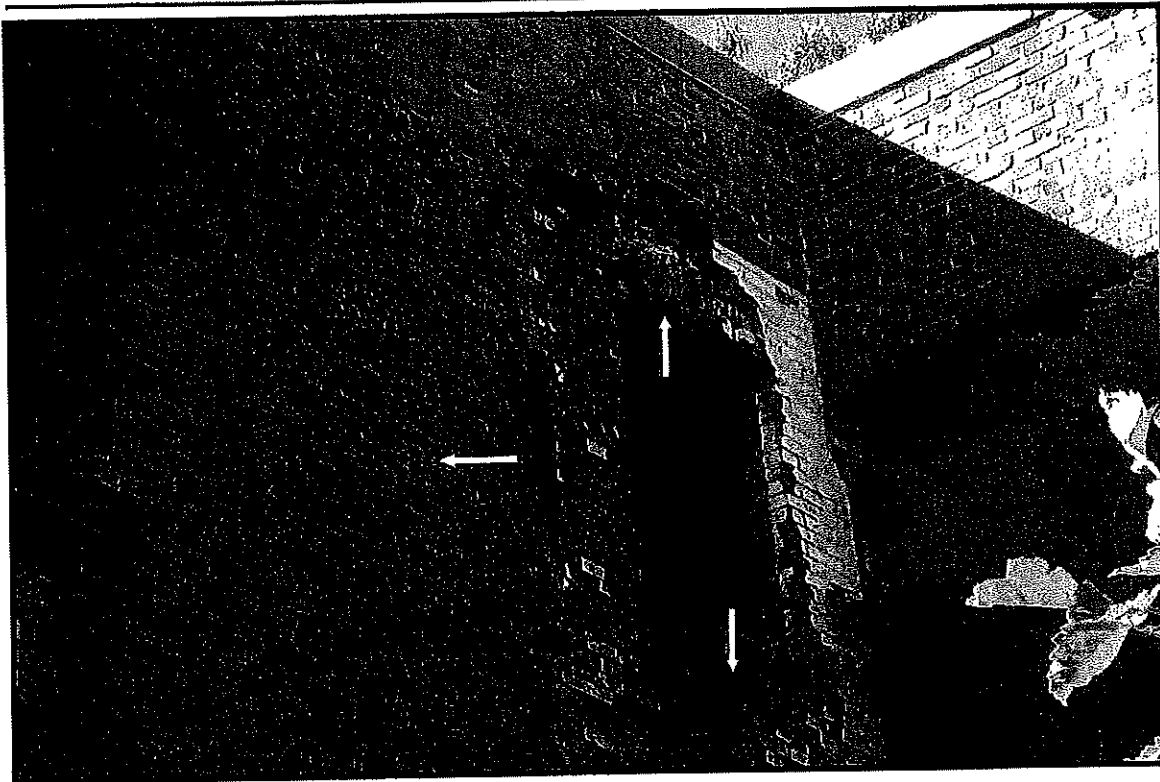
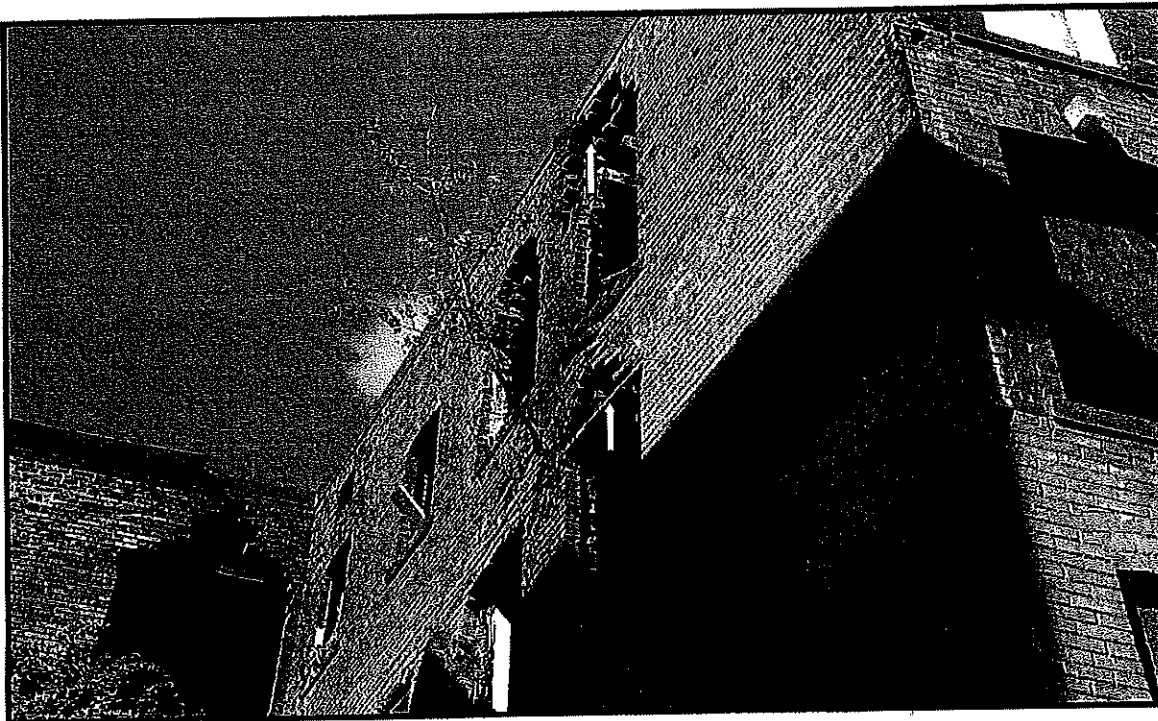
PHOTO 11: - 224 Washington Street East Wall Masonry Deterioration and Wall Failures.

PHOTO 12: - 224 Washington Street East Wall Masonry Deterioration and Wall Failures.

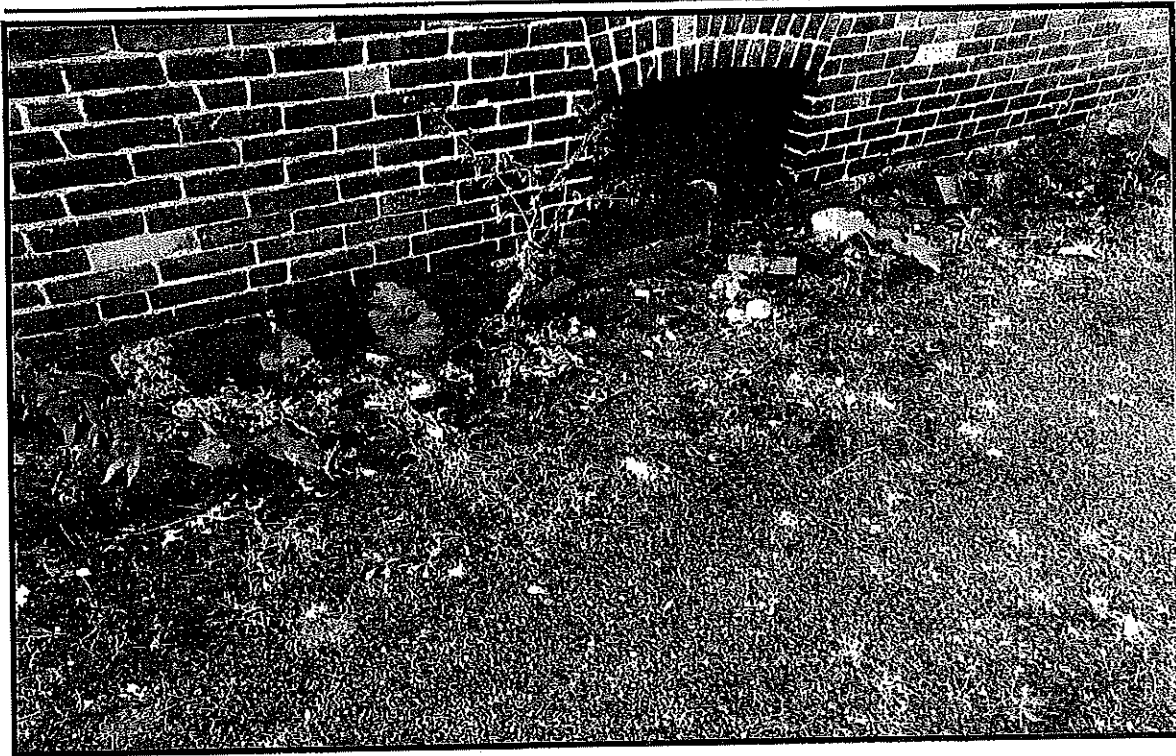
PHOTO 13: - 224 Washington Street North Wall Bricks From Failed Window Head Above.

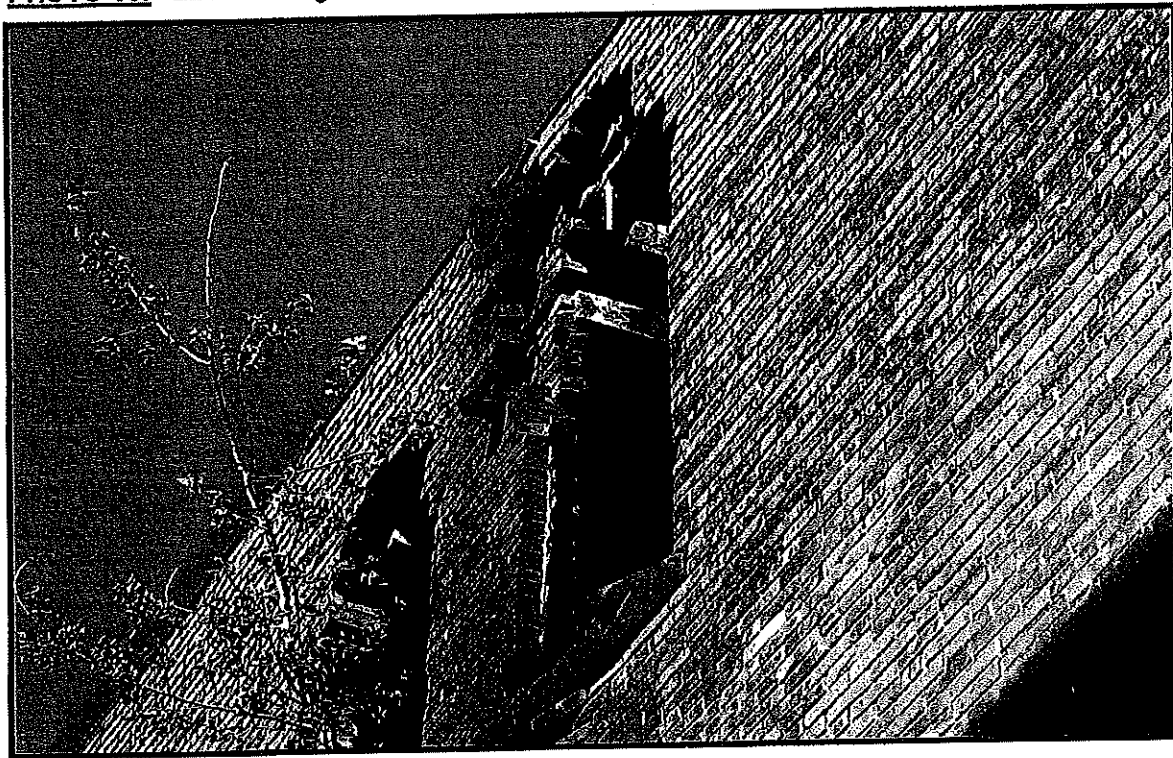
PHOTO 14: - 224 Washington Street East Wall Fire Damage. Note Unsupported Roof Framing.

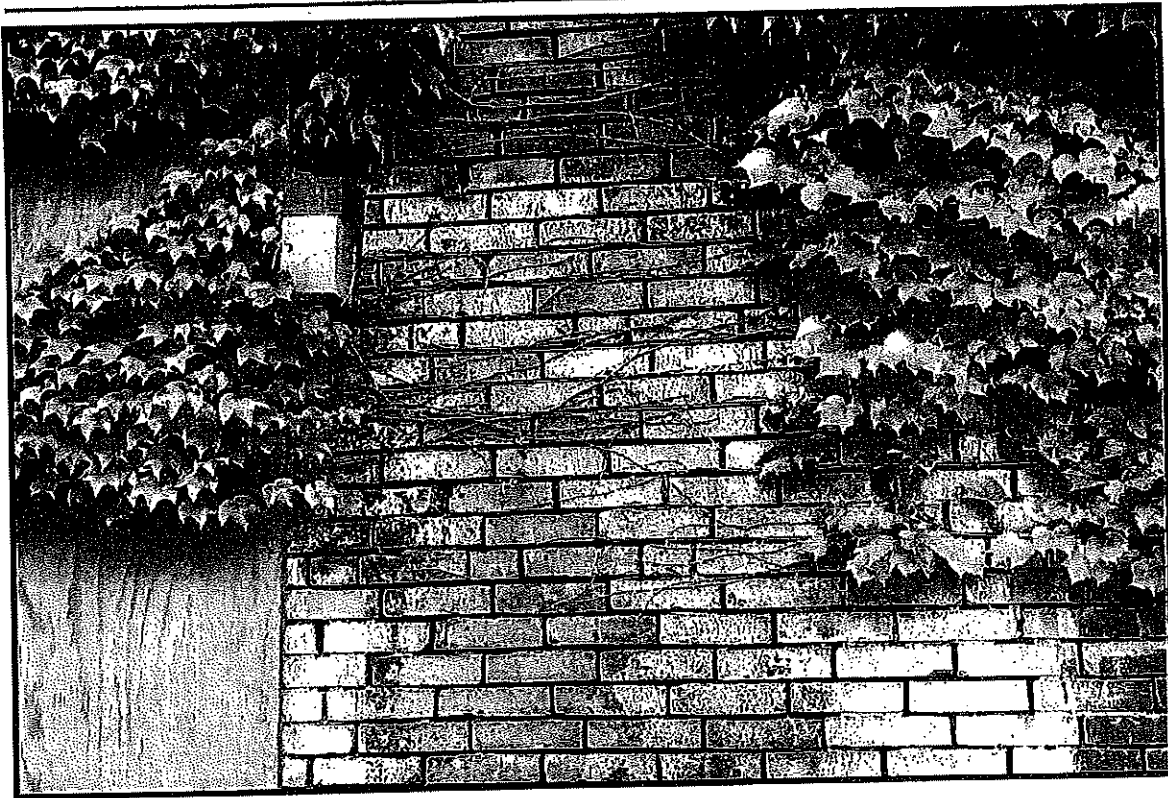
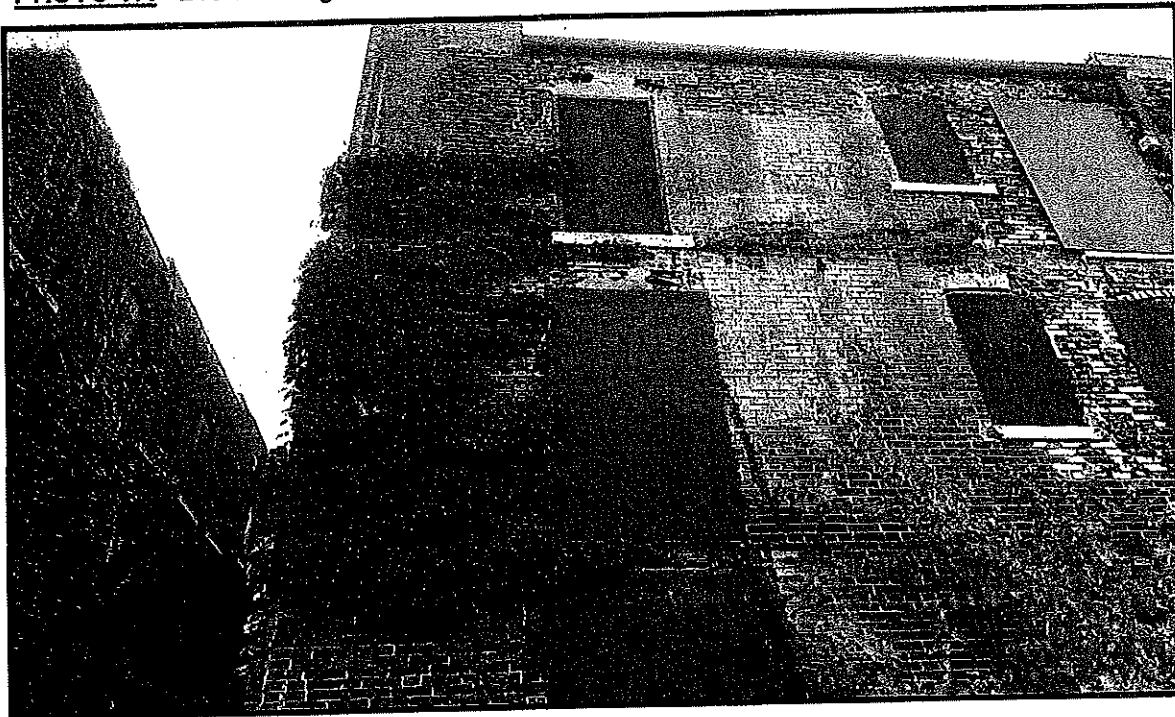
PHOTO 17: - 216 Washington Street East Elevation Deteriorated Mortar Joints.

PHOTO 18: - 216 Washington Street East Elevation Deteriorated Mortar Joints.

PHOTO 19: - 216 Washington Street East Elevation Deteriorated Mortar Joints.

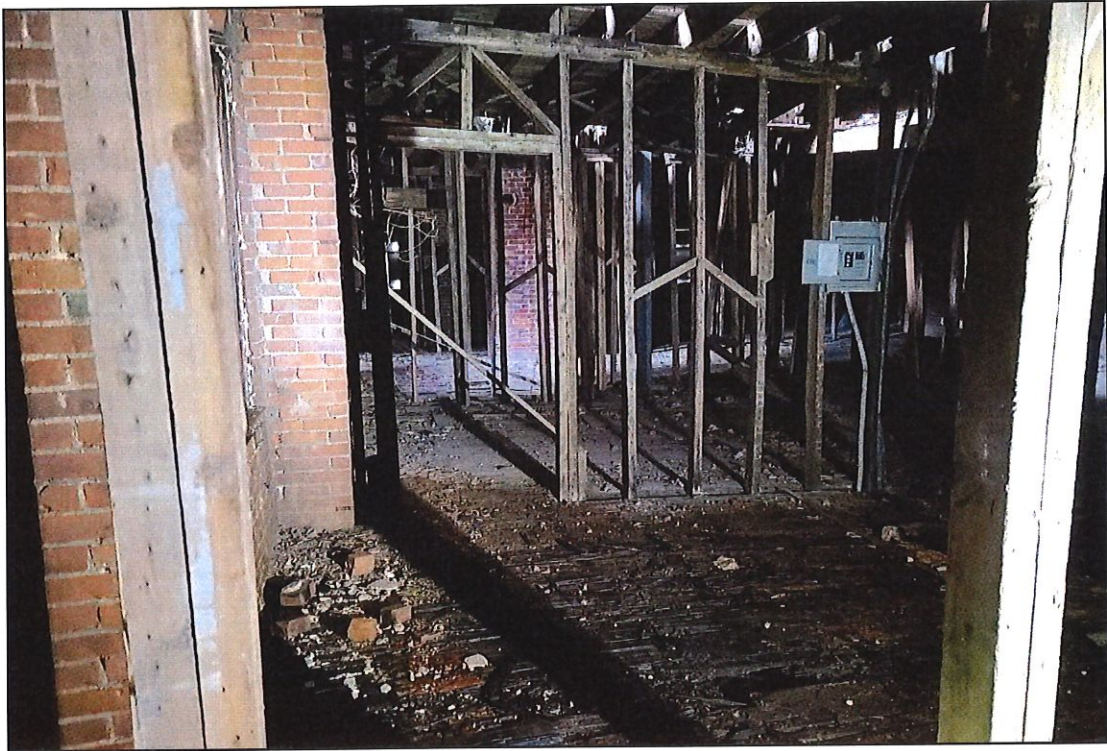
Photo 1: Typical Condition of Interior Framing

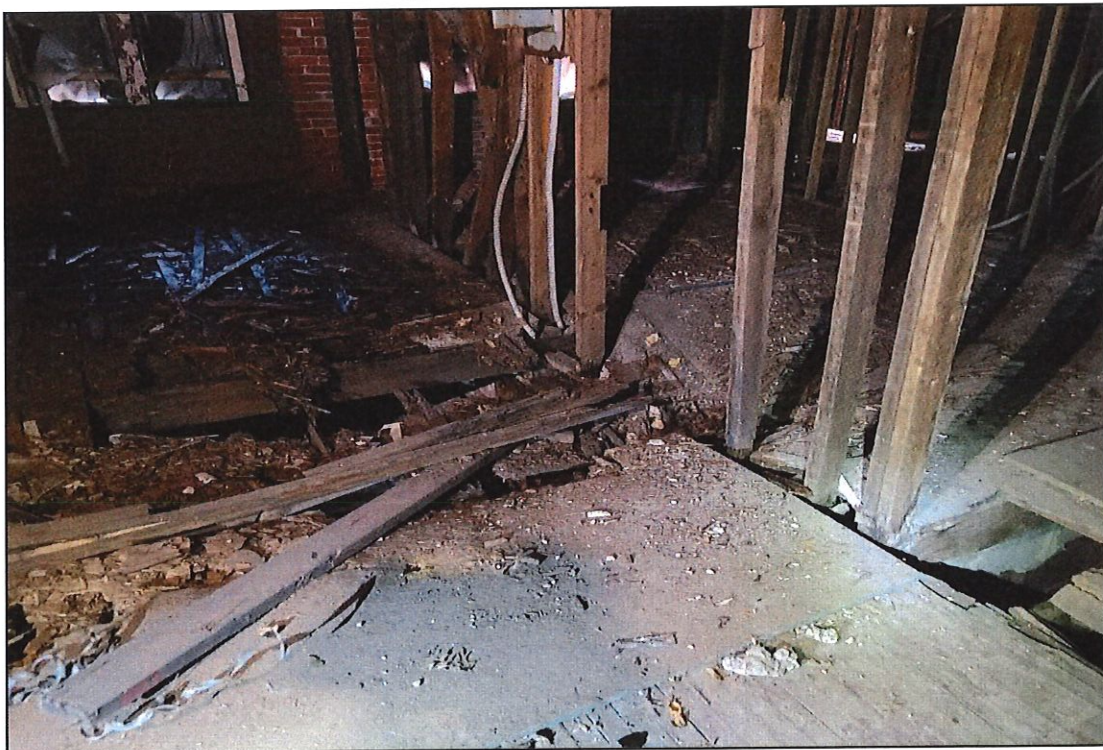
- Portions of the 1st and 2nd floor framing suffered partial collapse and are inaccessible due to the damage and deterioration.
- The interior timber framed stairway is in poor condition as it approaches the 3rd level of the structure and could not be used to access the upper levels of the building. The damage is due to both fire and water infiltration.

Photo 2: Partially Collapsed Floor Framing

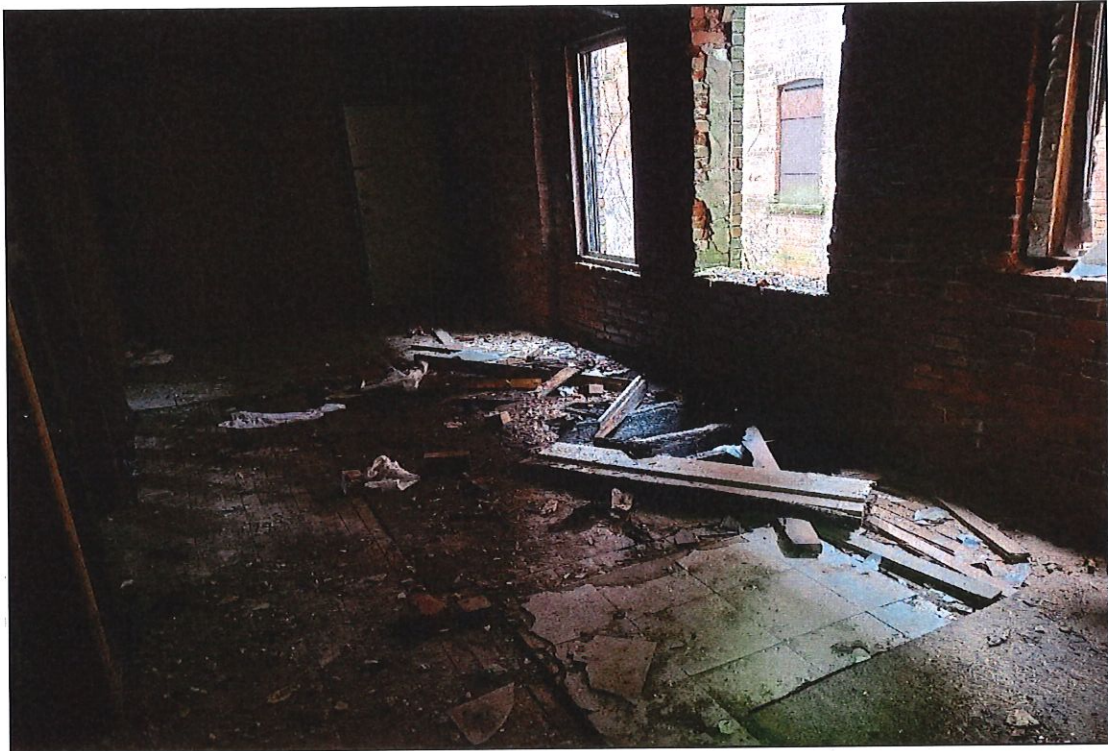
Photo 3: Severe Damage due to Prolonged Water Infiltration

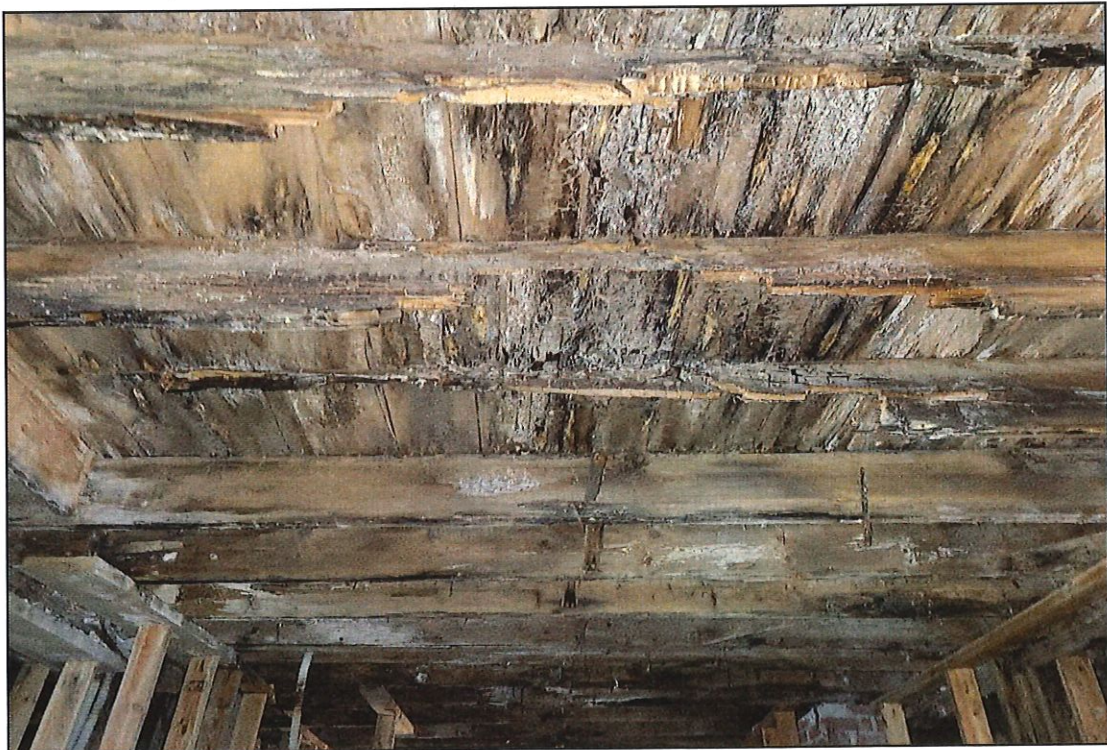
- Many of the building's windows are either missing or broken, providing additional pathways for water to infiltrate and damage the structure.
- Based on our limited observations we estimate that over 50% of the floor framing members for the building have experienced significant deterioration and are not safe to walk on. The remaining framing members are in fair condition; however, their prolonged exposure to water infiltration will cause them to continue to deteriorate at an accelerated pace.

Photo 4: Significantly Compromised Floor Framing

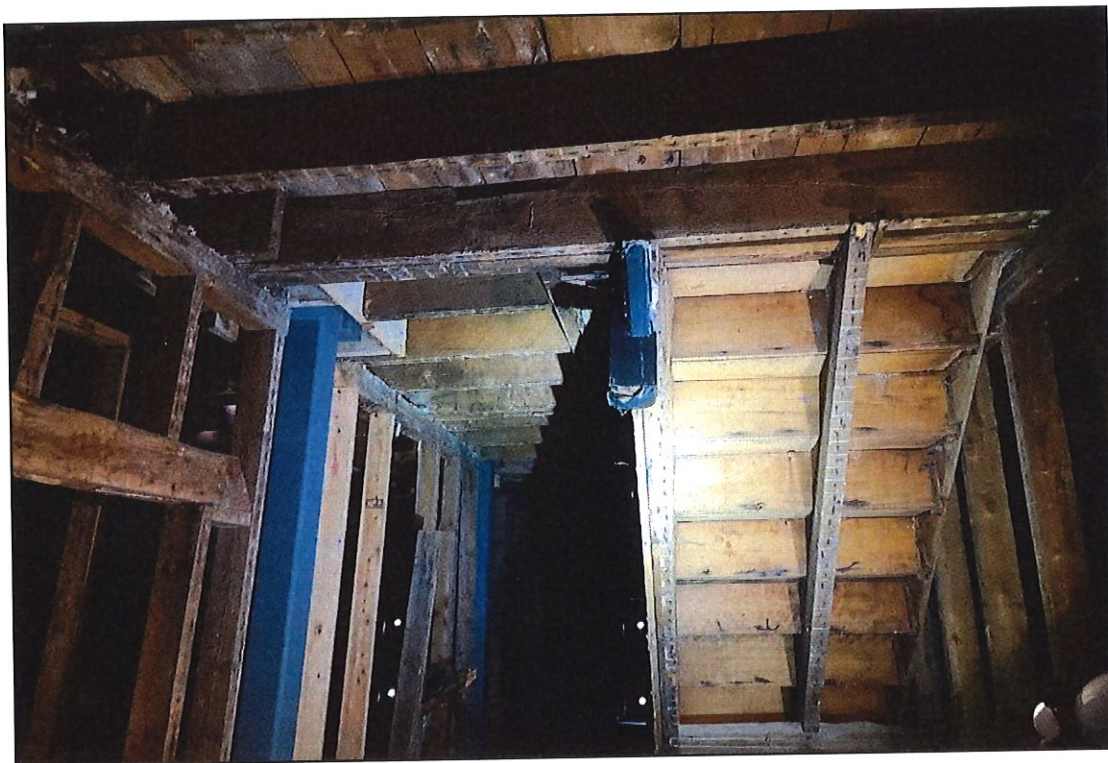
not be directly observed because of heavy damage and deterioration to the structure. There was evidence of previous stabilization with the presence of steel columns; however, it is believed that the steel columns are founded on a masonry pier that's condition is unknown with severely compromised framing surrounding the pier.

Photo 5: Steel Shoring Post Near Interior Stairs

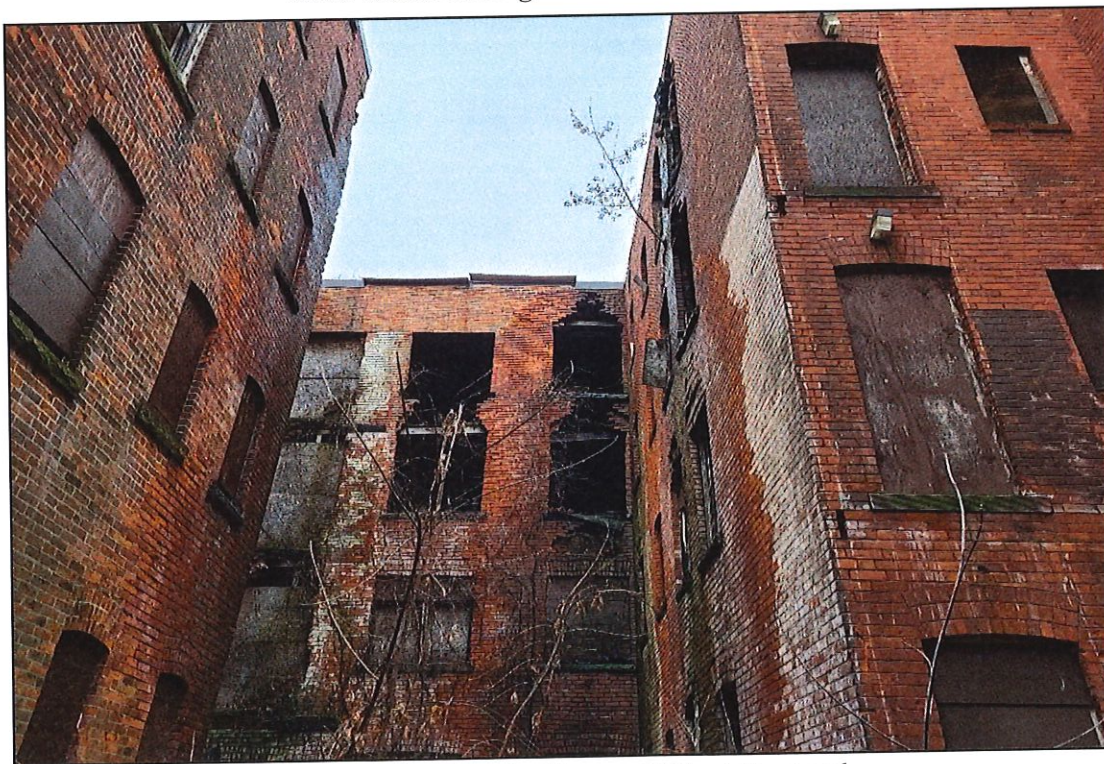
- The exterior brick masonry bearing walls have multiple locations of significant deterioration, especially around window and door openings at the upper portions of the courtyard for the structure. The walls are unstable due to their deterioration and their condition is exacerbated by the deterioration of the timber framing that is no longer adequately bracing the walls at each floor level.

Photo 6: Failing Exterior Masonry Walls at Courtyard

Repairing and/or stabilizing the building would include the complete replacement of all interior timber framing members for all 4 stories of the building and reconstruction of approximately 50% of its exterior masonry load-bearing walls. A restoration effort of this magnitude would pose significant logistical and safety challenges and be cost prohibitive when compared to demolishing the structure. Based on our observations and experience with other similarly deteriorated structures, we recommend that 224 Washington Street be demolished within the next 6 months to minimize risk to abutting properties and nearby pedestrians.

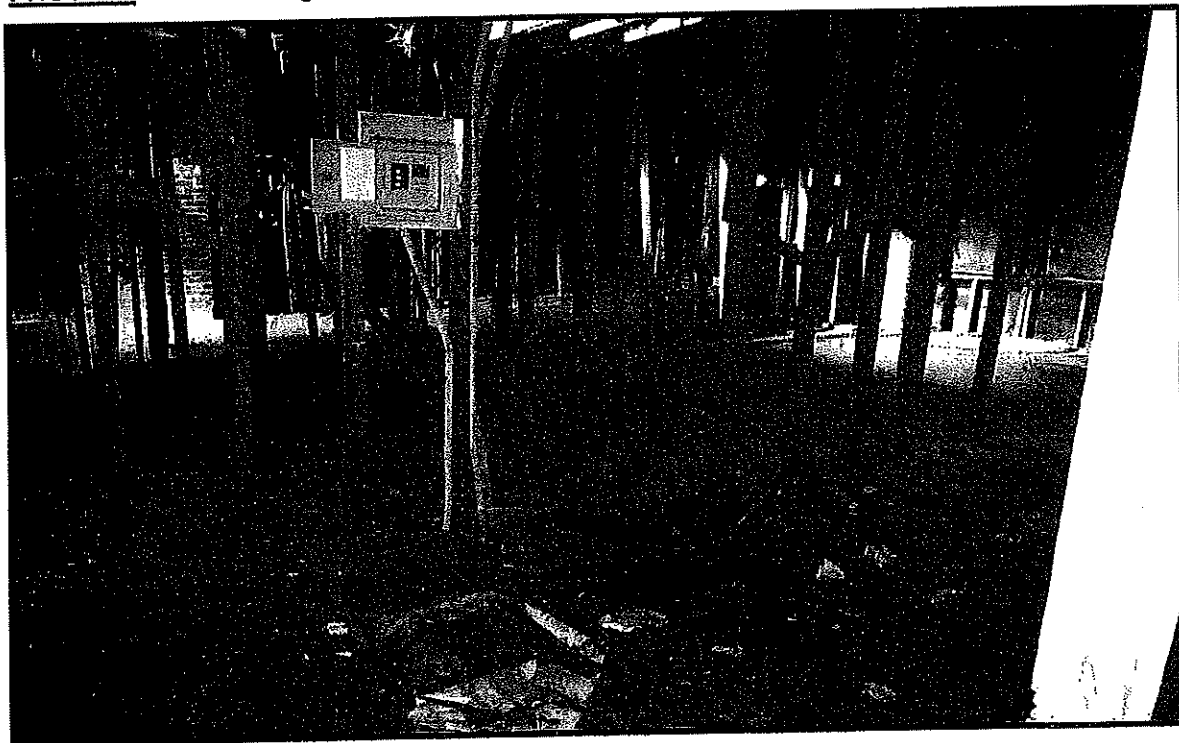
1. Significant deterioration and partially collapsed floor framing due to long term moisture infiltration and failure of exterior masonry bearing walls. See Photos 4 thru 8.

PHOTO 4: - 224 Washington Street Deteriorated and Partially Collapsed Floor Framing.

PHOTO 5: - 224 Washington Street Deteriorated and Partially Collapsed Floor Framing.

PHOTO 6: - 224 Washington Street Deteriorated and Partially Collapsed Floor Framing.

PHOTO 7: - 224 Washington Street Deteriorated and Partially Collapsed Floor Framing.

PHOTO 8: - 224 Washington Street Deteriorated and Partially Collapsed Floor Framing.

Our inspection of the interior of the building was limited due the current condition of the floor framing and corresponding life safety concerns. However, based on the extent of the observed damage, it is our professional opinion that the building cannot be not be safely occupied at this time unless temporary measures are undertaken to stabilize the structure. Making the building safe to occupy will require the installation of extensive and expensive temporary shoring along portions of the interior and exterior of the building. Although the complete extent of required permanent repairs is unknown at this time, the remedial work required will be extensive and costly. Therefore, it is our opinion that consideration should be given to razing the building in its entirety.
