PZ-HIST-23-000053

Address: 224 WASHINGTON ST, HARTFORD, CT 06106

RE: Structural Condition Assessment
224 Washington Street, Hartford, CT
Fuss & O'Neill Reference No. 20221213.A10

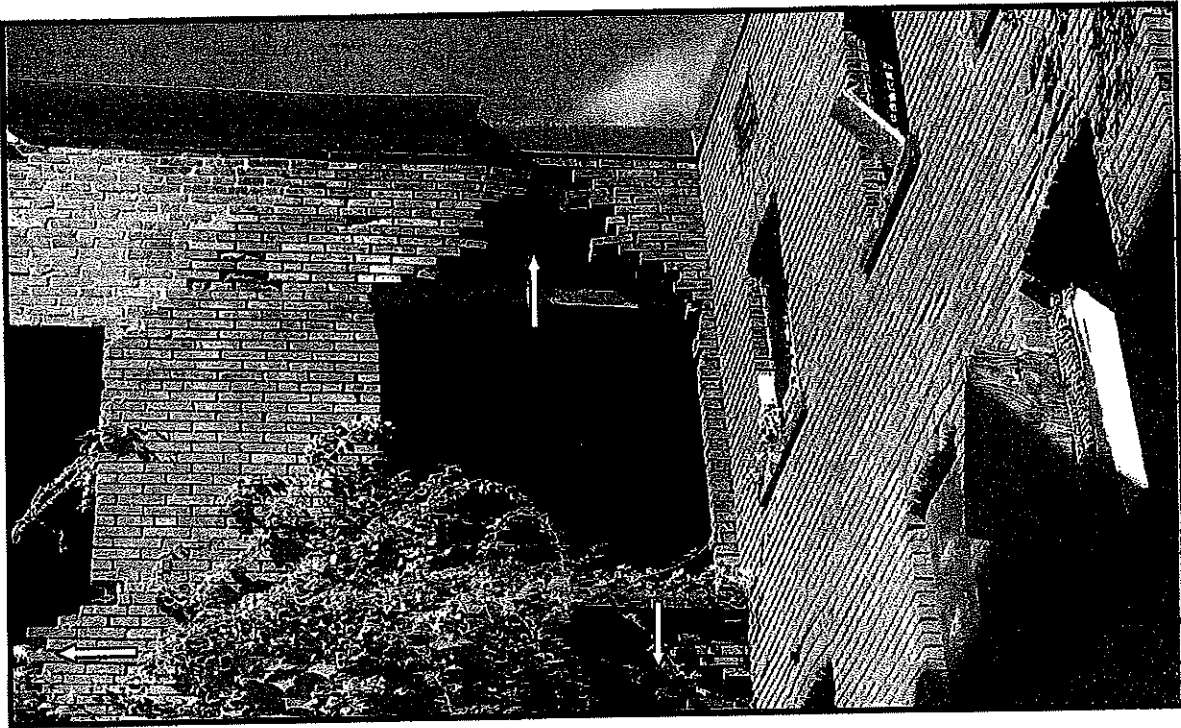
2. Failed brick and partially collapsed masonry walls along the northern and eastern exteriors. See Photos 9 thru 12.
3. Loose bricks and/or partial collapse at window header courses. Bricks were found along the ground at the north side of the building from a failed 4th floor window. See Photo 13.
4. Isolated visible fire damage. See Photo 14.

PHOTO 9: - 224 Washington Street East Wall Masonry Failure at Window Head and Sill.

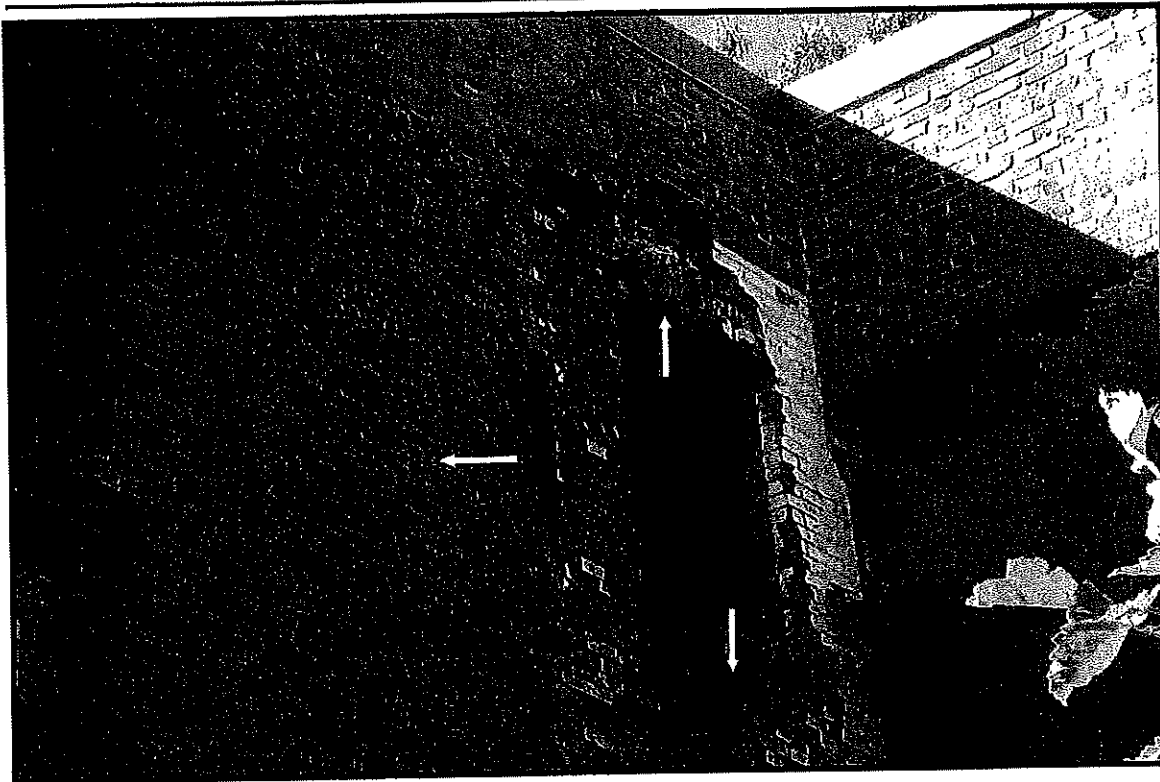
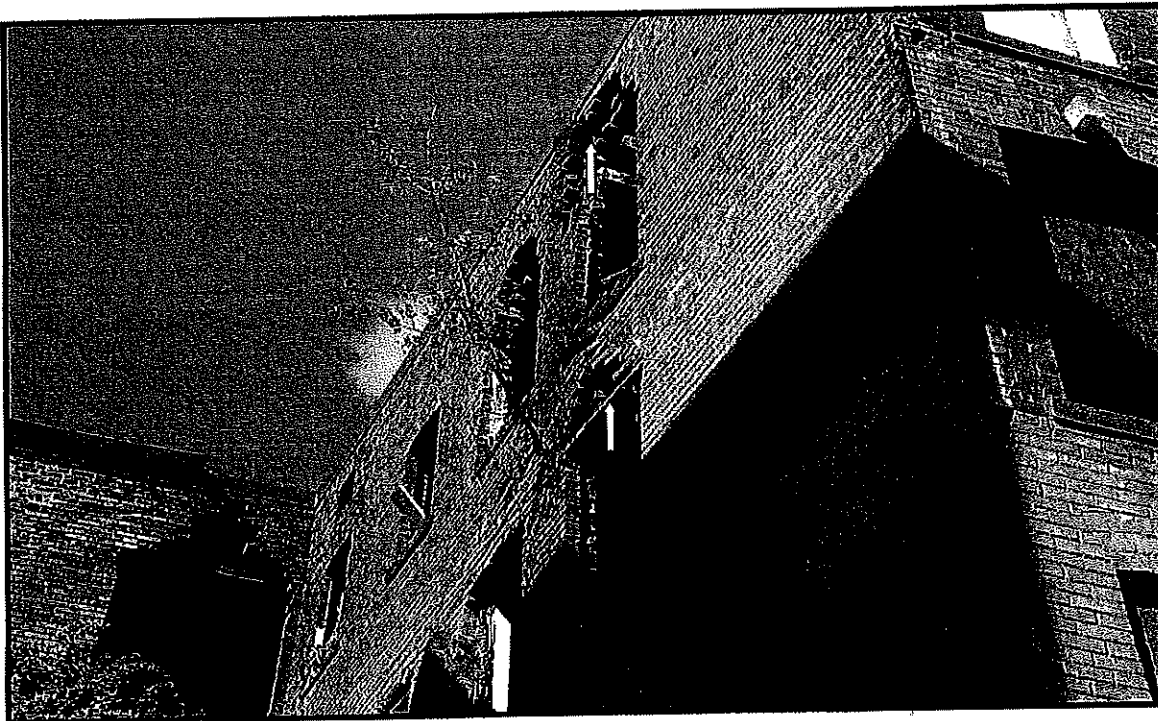
PHOTO 11: - 224 Washington Street East Wall Masonry Deterioration and Wall Failures.

PHOTO 12: - 224 Washington Street East Wall Masonry Deterioration and Wall Failures.

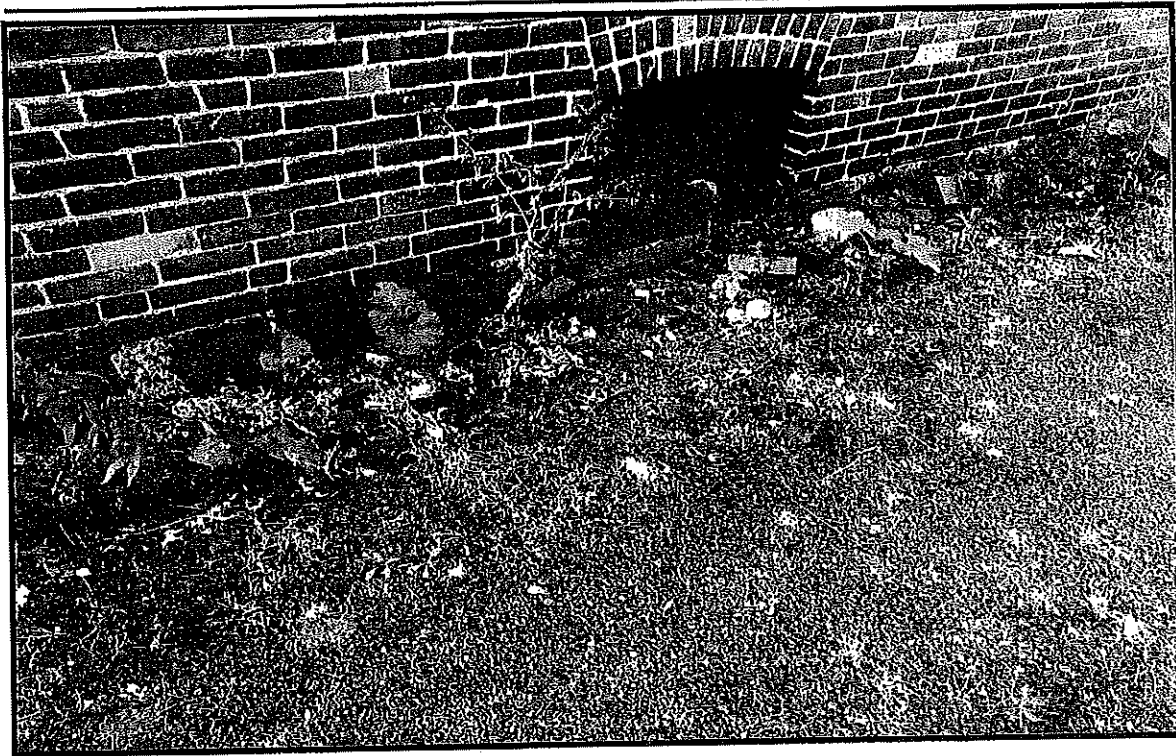
PHOTO 13: - 224 Washington Street North Wall Bricks From Failed Window Head Above.

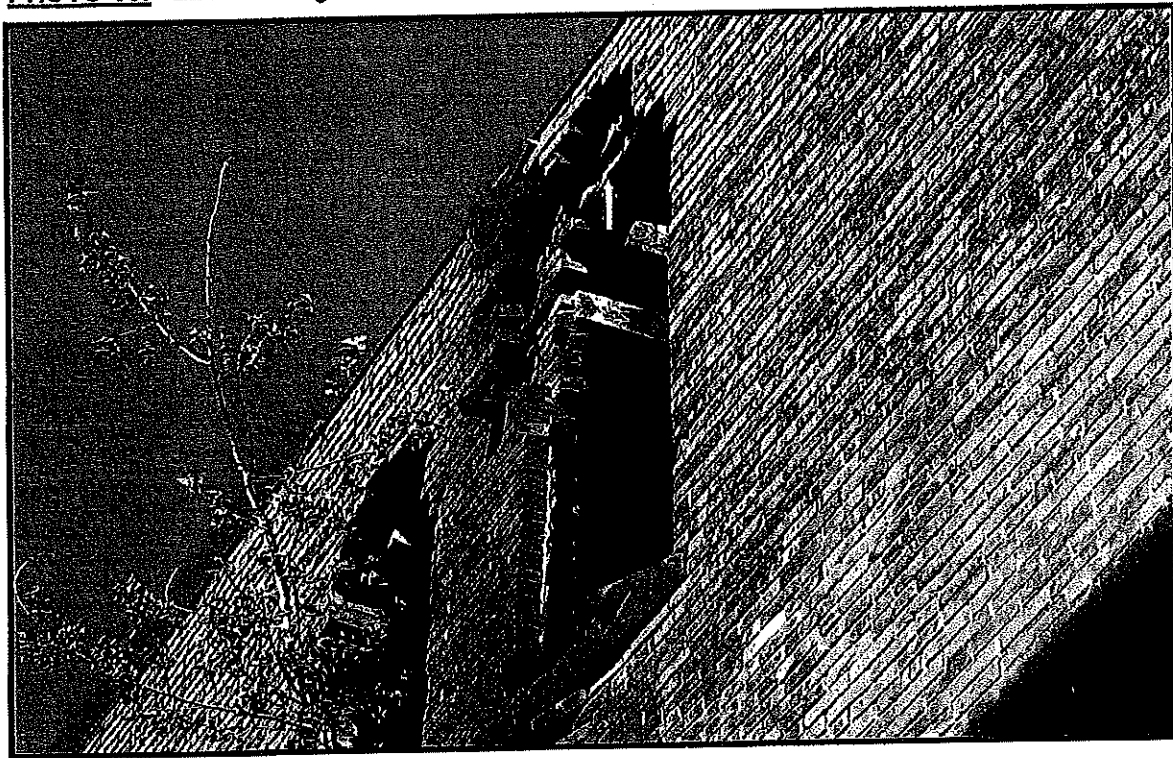
PHOTO 14: - 224 Washington Street East Wall Fire Damage. Note Unsupported Roof Framing.

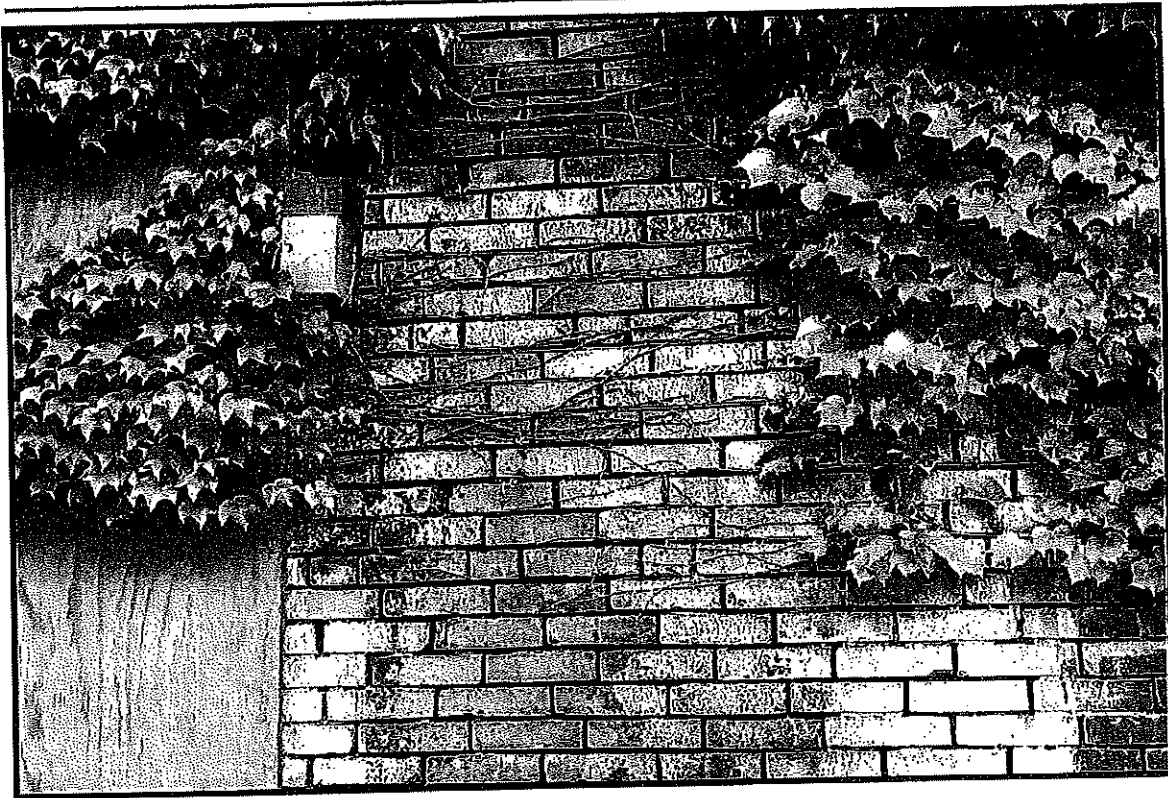
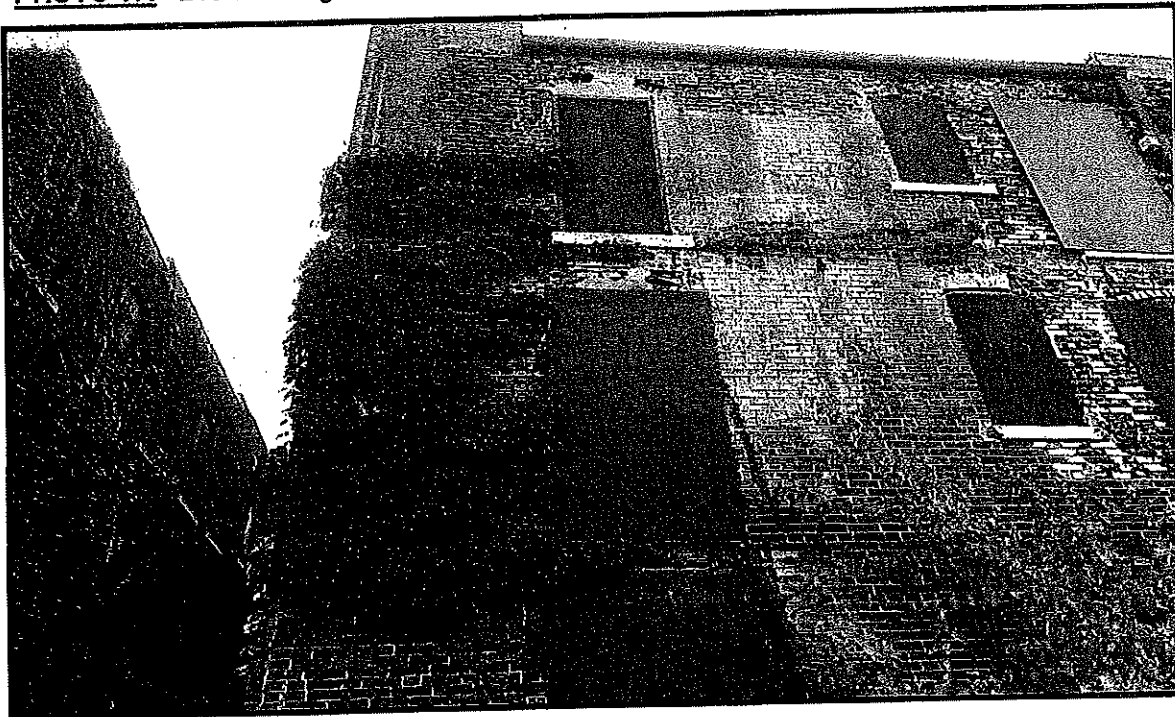
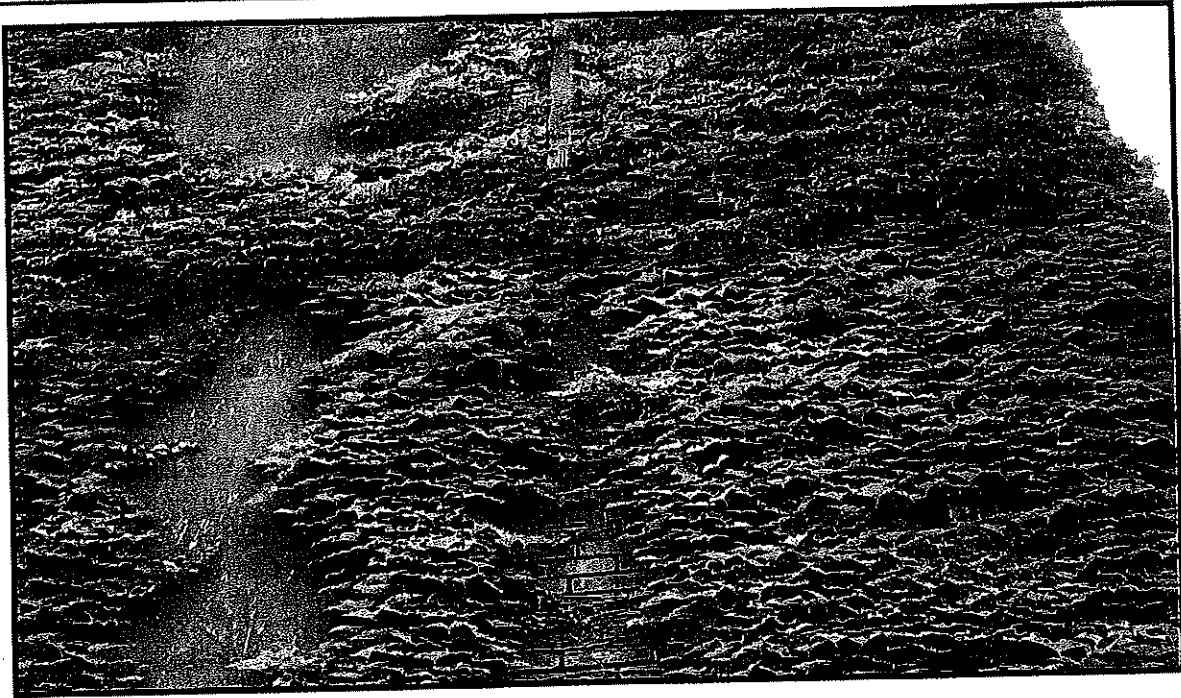
PHOTO 17: - 216 Washington Street East Elevation Deteriorated Mortar Joints.

PHOTO 18: - 216 Washington Street East Elevation Deteriorated Mortar Joints.

PHOTO 19: - 216 Washington Street East Elevation Deteriorated Mortar Joints.
