DEPARTMENT OF DEVELOPMENT SERVICES – PLANNING DIVISION

REPORT: 100 Cedar Street, Hartford, CT 06106

STAFF REPORT

PROJECT: 100 Cedar Street
PARCEL ID: 247-447-003

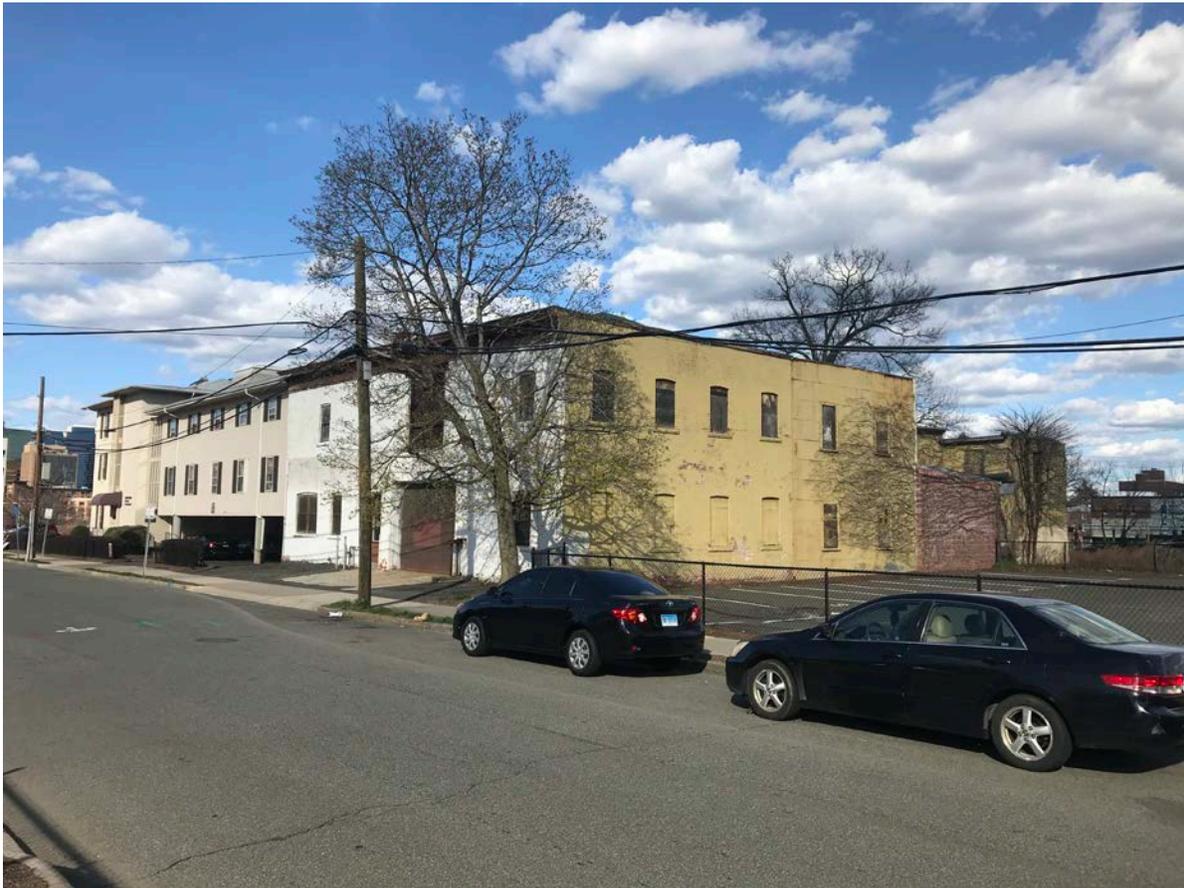
Current Conditions: The exterior of the building at 100 Cedar is in fair condition, though the paint on the brick and trim work is failing. Many of the windows are boarded. The cast iron cornice mentioned in the district nomination is still present on the front façade and portions of the rear. Many additions made over the years may have resulted in more of the cast iron cornice being removed or enclosed. The majority of the building is brick, though the rear additions have horizontal clapboard siding. The pictures provided by the applicant paint a different picture of the interior of the structure. The interior reveals that the building as a whole has been cobbled together by a variety of additions.

100 Cedar Street Front and Side (south) façade taken on April 13, 2021

Staff recommends denial of this application.
