DEPARTMENT OF DEVELOPMENT SERVICES – PLANNING DIVISION
REPORT: 1000 Albany Avenue, Hartford, CT 06112
For consideration: October 21, 2020

STAFF REPORT

PROJECT: 1000 Albany Avenue
PARCEL ID: 198-201-008

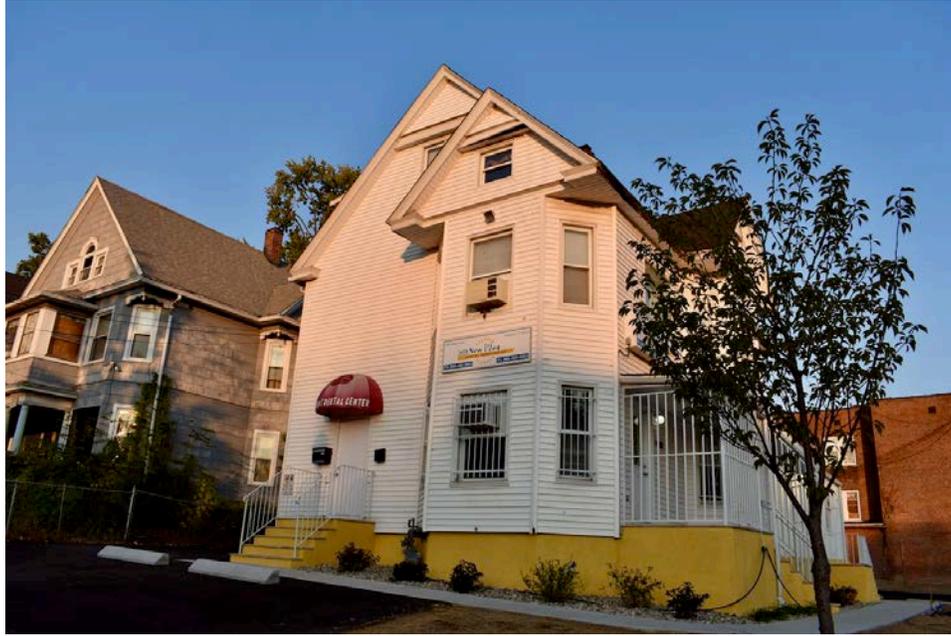
Figure 1. Image taken by Staff October 9, 2020. View of the subject property from the corner of Deerfield and Albany Ave showing the two sides which already have 4" vinyl siding. The entrance pictured is on Deerfield Street.

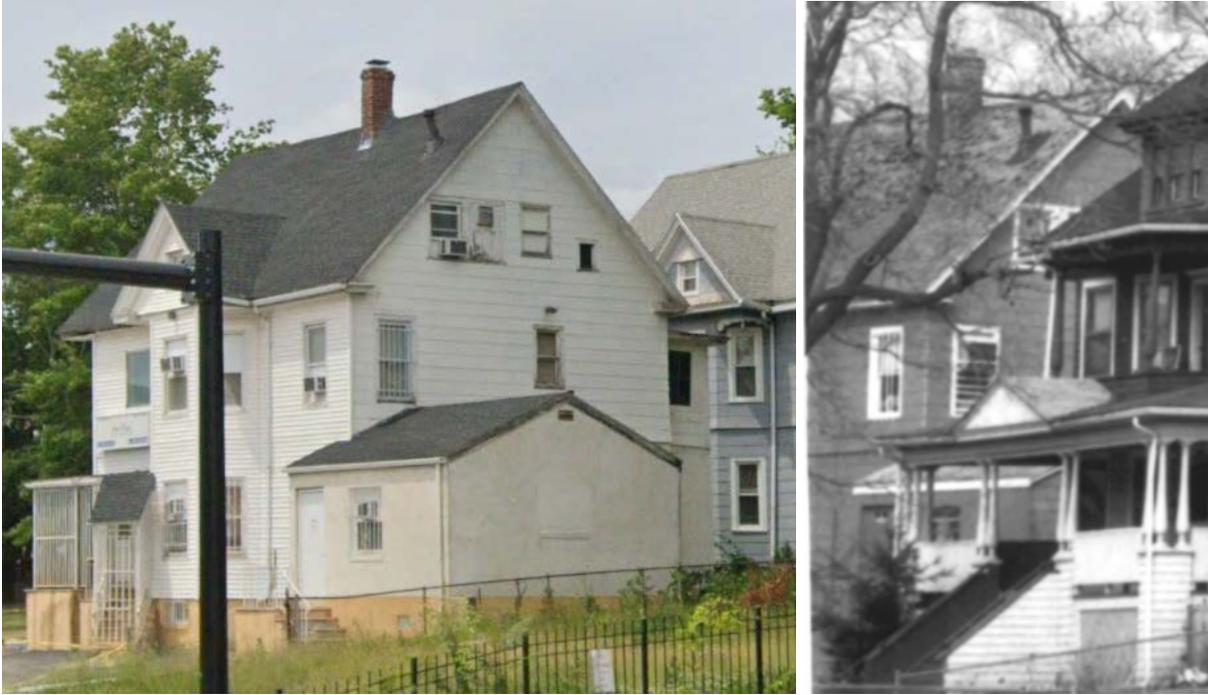
Figures 6&7. Left, rear of home from Google Streetview June 2019. Right, enlargement of image 3 from the 1986 historic nomination, the house in the background is the subject property shown with the original 12” clapboard and windows hoods, casings, and sills.

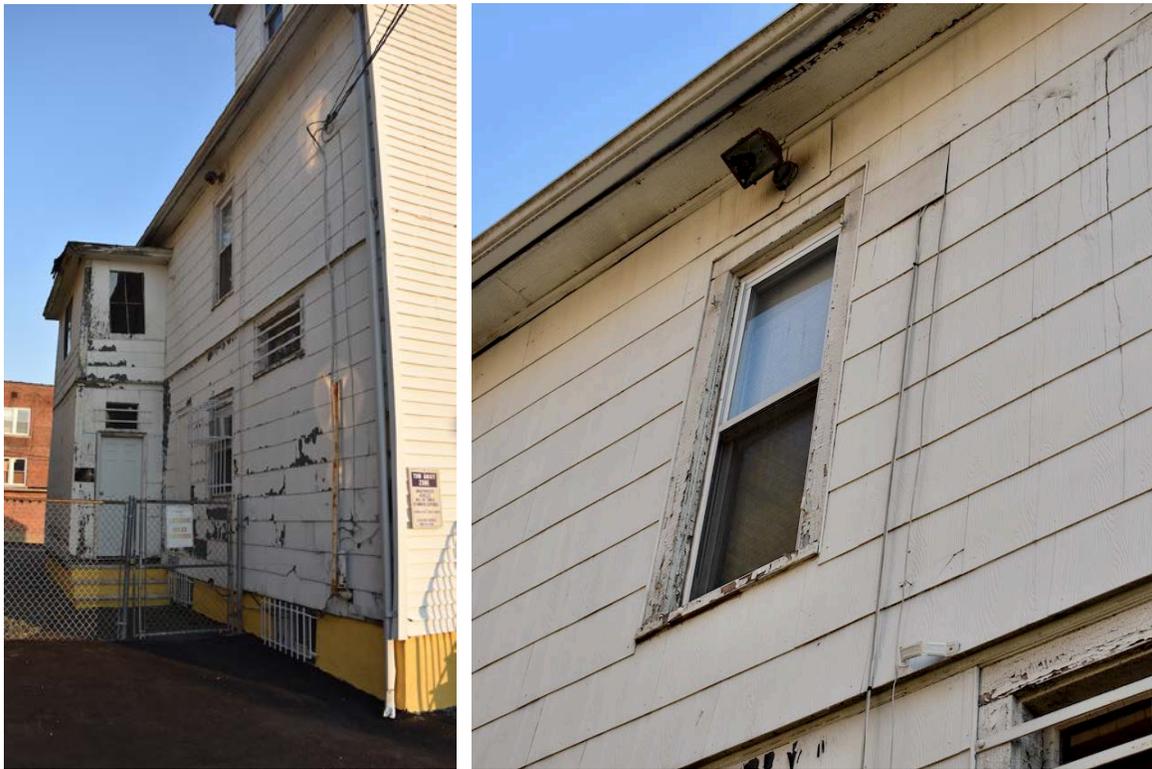
Figure 8&9. Images taken by Staff October 9, 2020. The interior side of property has older 12” siding, reminiscent of the original wood siding. It is unlikely that this is the original siding, however, as evidenced by locations where the siding is flush with the original wood window sill and casing.

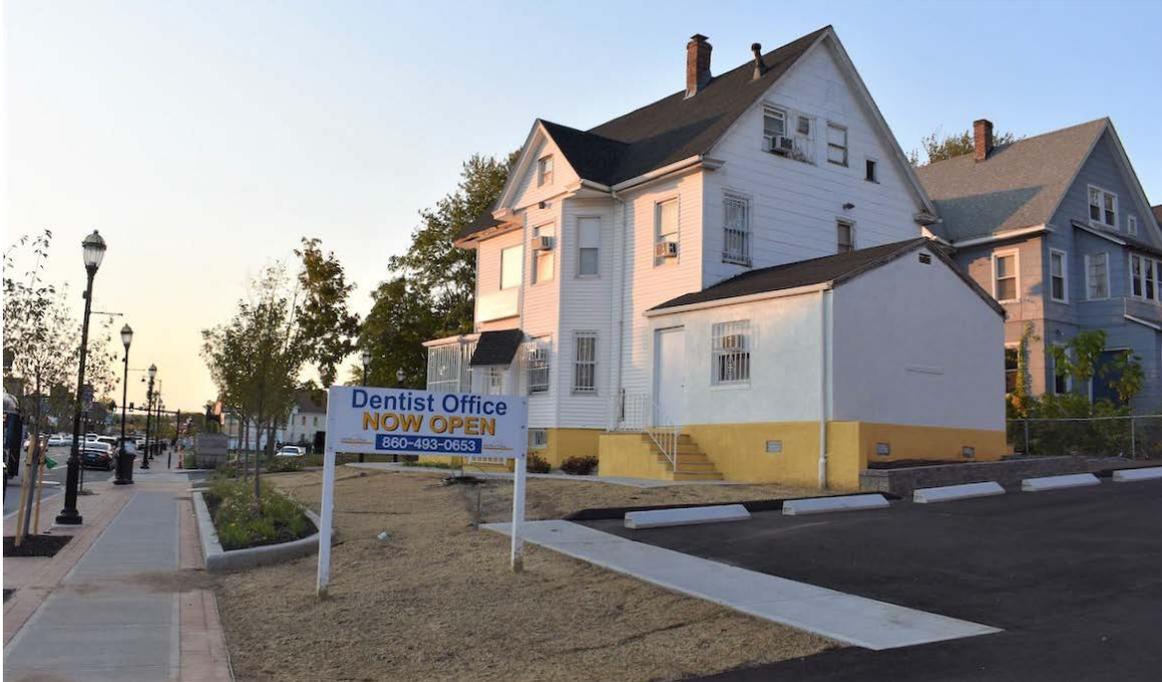
Figure 10. Image taken by Staff October 9, 2020. Rear/side of the structure perpendicular to Albany Ave has the older painted siding and the side facing Albany Ave (left) is vinyl.

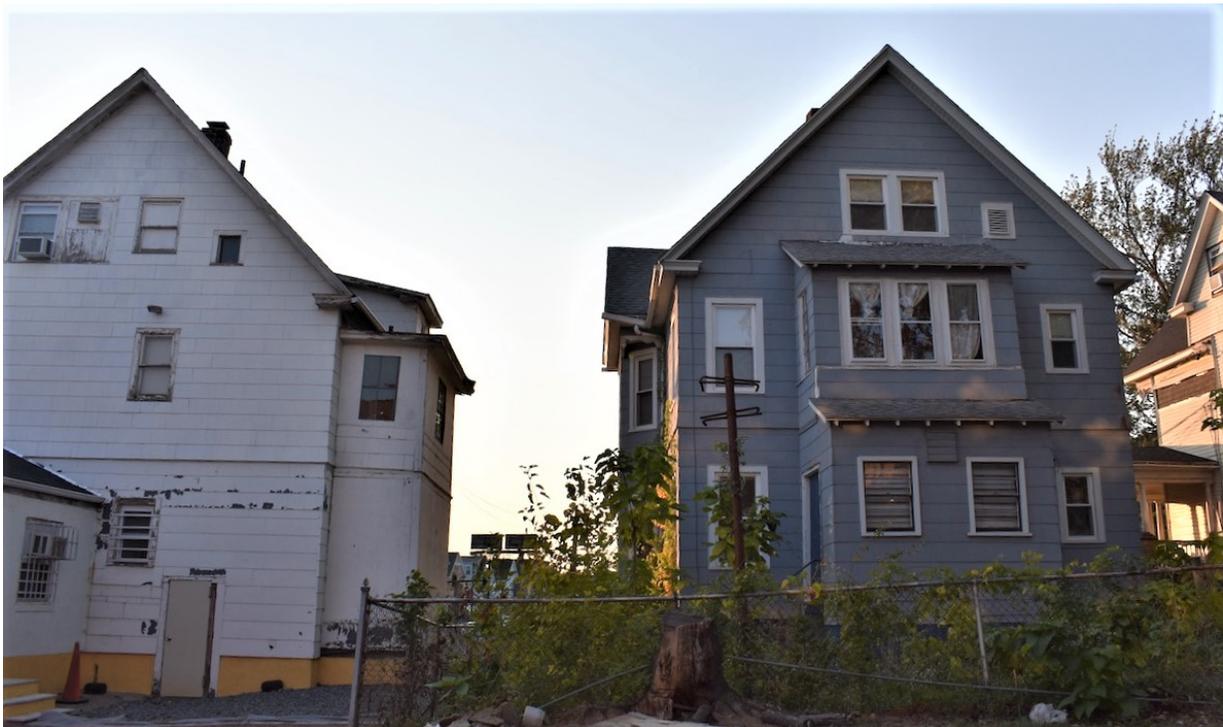
Figure 11. Image taken by Staff October 9, 2020. Showing the rear of the subject property on the left with synthetic shingles the same scale as the wood clapboard on the structure on the right, 4 Deerfield Street.

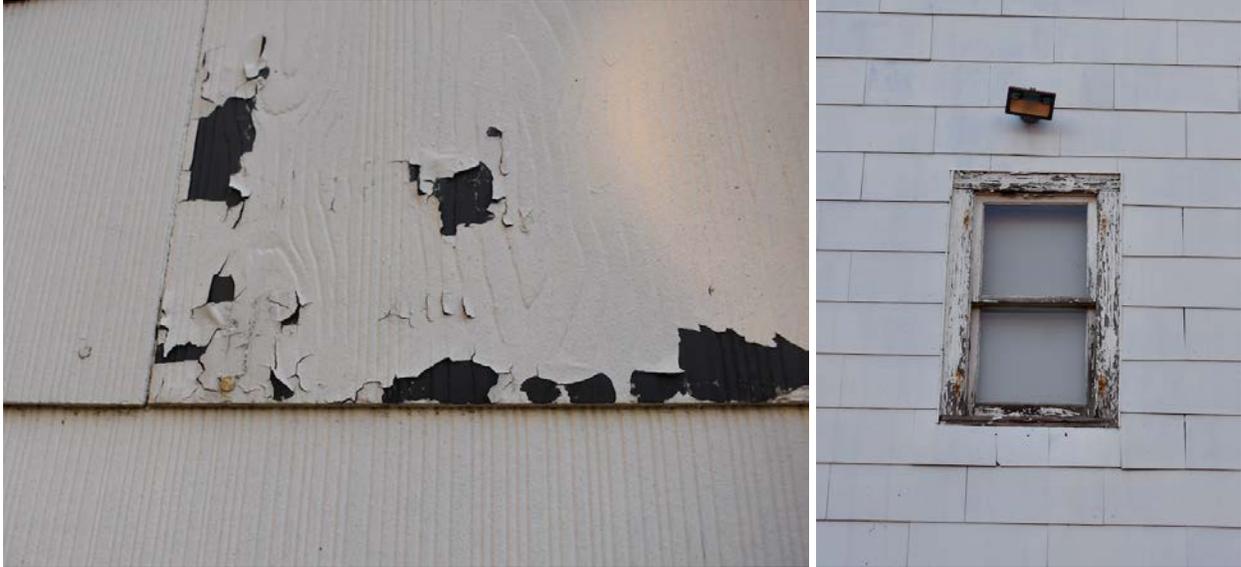
Figure 12&13. Images taken by Staff October 9, 2020. Up close look at the 12” synthetic, painted clapboard on the side and rear of the structure and an original window visible from Albany Ave. This is not the original wood clapboard but appears to be nailed over the original and later painted.

Per the image from the 1985 National Historic District nomination, the home had simple window hoods, casings, and sills, and butted clapboards rather than corner boards. The original wood clapboards were 12” and better suited the scale of the building than the 4” vinyl siding installed on the front and side of the property. Much the wood detail was lost when the front and corner side of the house was covered in vinyl. The remaining window sills, casings, and hoods visible on the rear and side of the structure are surrounded by the synthetic clapboard that appears to have been nailed onto the original wood clapboard.

1. Additional details on the existing siding material on the side and rear of the subject structure and it’s intended treatment.

More information is needed to understand if the proposed additional layer of vinyl siding and insulation are to be added on top of this synthetic layer already in place and what effects that would have on the wood structure below. It is also unclear if the painted synthetic clapboard could be safely removed to reveal the original wood clapboard.

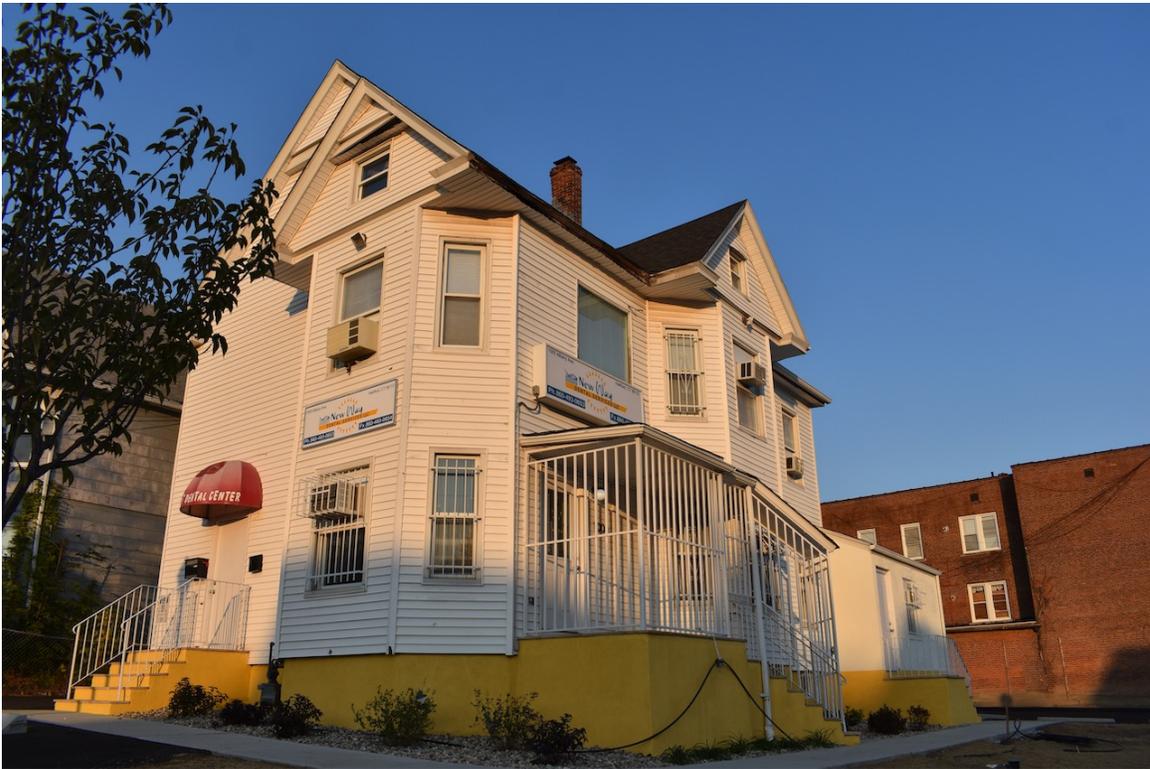
Figure 14. Image taken by Staff October 9, 2020. The building’s gable roof and third floor triangular pediments over the bay windows still remain as a defining feature, despite the lack of original porch, details, and ornamentation. The front and corner side were previously covered with 4” vinyl siding and the wood window sills, casings, and hoods were enclosed with aluminum coil.
