DEPARTMENT OF DEVELOPMENT SERVICES – PLANNING DIVISION

REPORT: 31-33 Capen Street, Hartford, CT 06106

STAFF REPORT

PROJECT: 31-33 Capen Street
PARCEL ID: 133-310-053

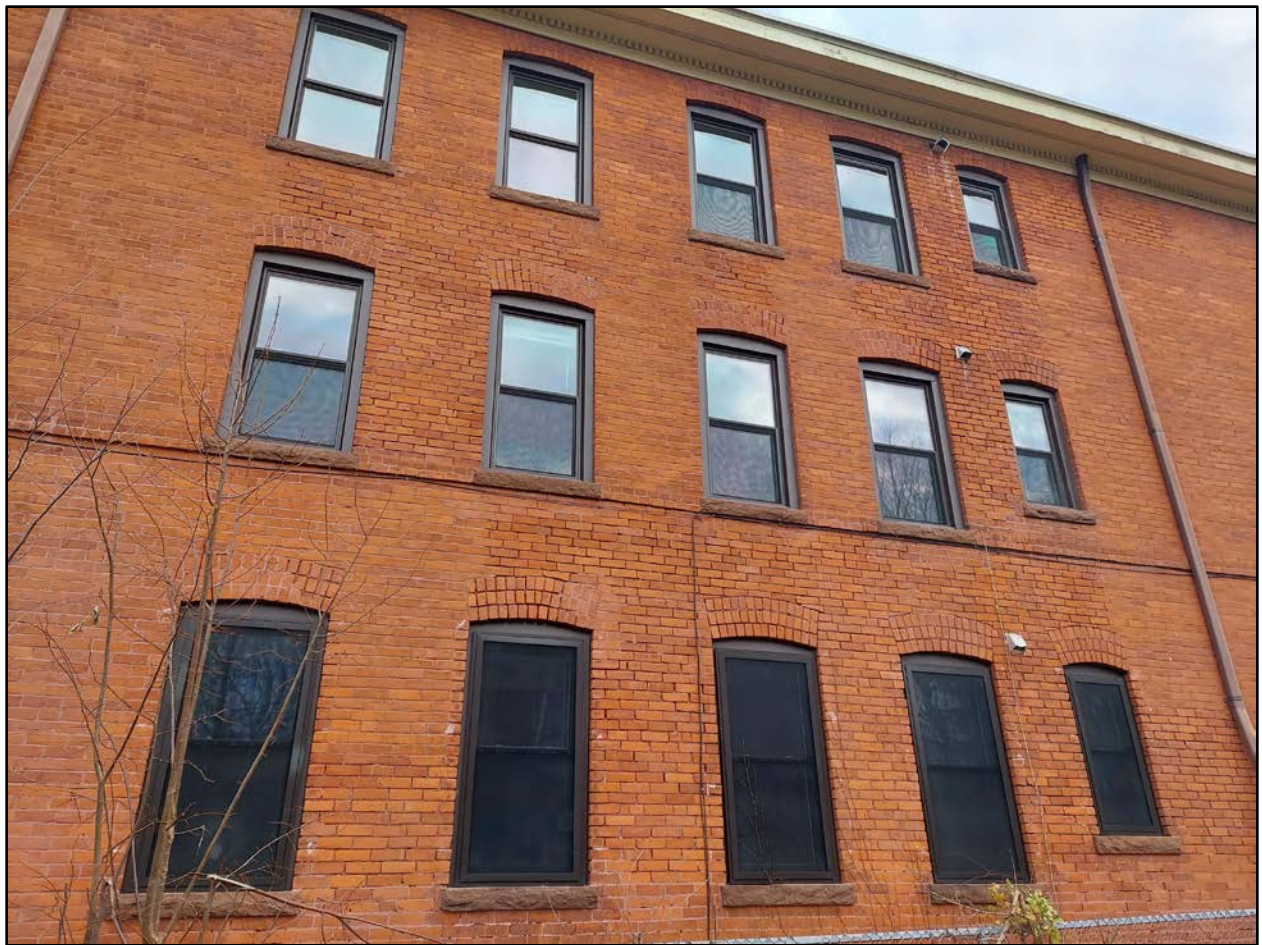
Figure 2: Existing vinyl windows, West Façade. Staff Photo, Nov. 21, 2020

The structure currently has non-historic vinyl windows and metal hollow entrance doors. The Applicant proposes to replace the existing windows with double-hung, four-lite fiberglass windows and frames. No further detail regarding the windows was provided with the application. Staff have attempted to contact the applicant for more information to no avail. The Applicant proposes to replace the existing entrance doors with similar “stamped” metal hollow doors. It should be noted that the doors have been called out by the applicant as in kind replacement. Upon field verification, it appears that the doors are single panel metal hollow core. More information is required to identify what the applicant means by “stamped”. It should further be noted that the existing and proposed drawing set shows an arched lintel over the front door. Field verification confirmed that this feature is not present. The proposed window and doors would likely be historically inappropriate.

- (1) The Applicant should replace the front porch railing with a wood railing with square balusters and should replace the proposed square composite stair treads with wood bullnose treads
- (2) The fiberglass windows which are proposed to be replaced shall be replaced with two over two window lites
- (3) The front entrance door shall be replaced with a more historically appropriate design
- (4) Any scraping of paint should be done by hand.

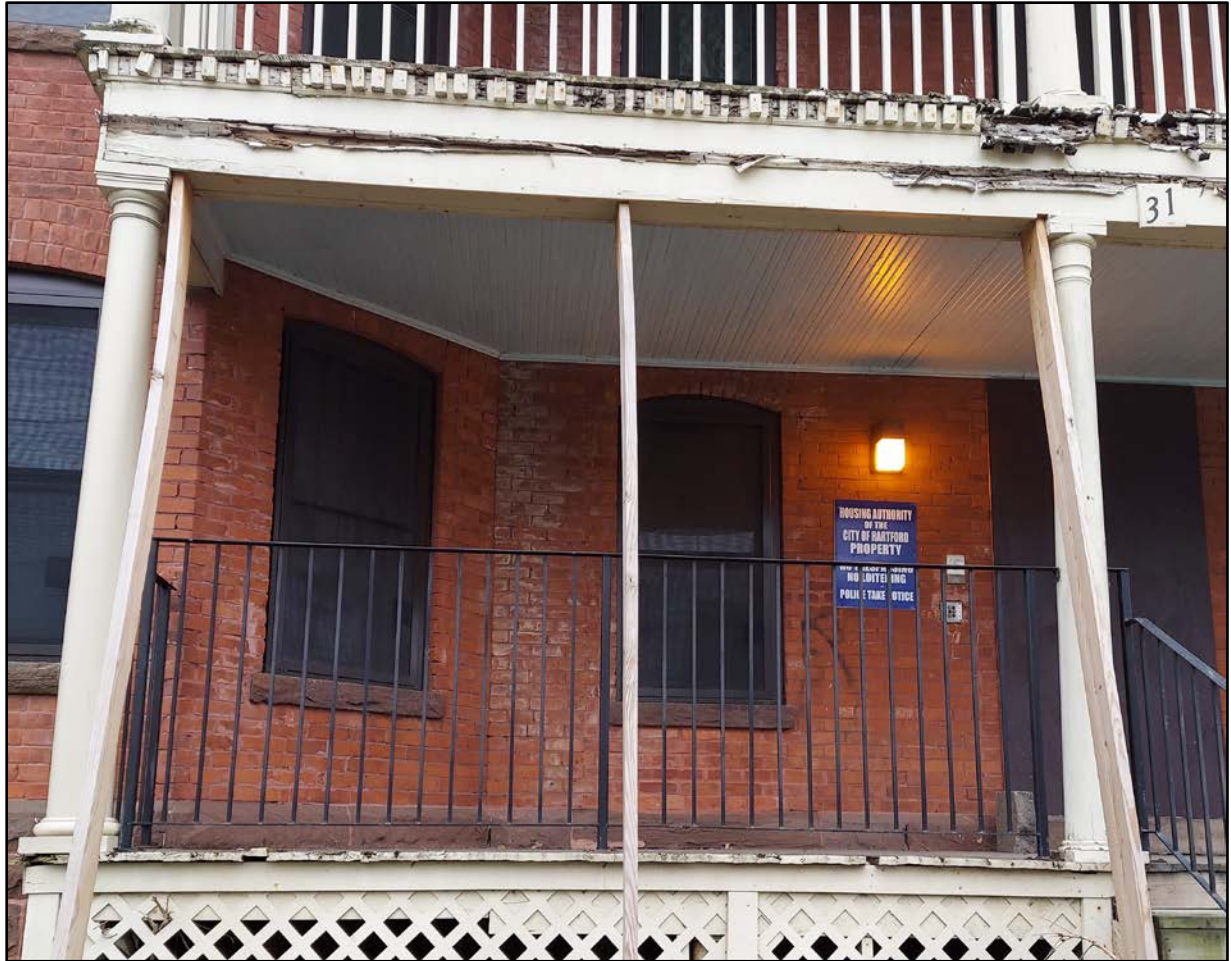
Current Conditions: There have been some notable alterations since it was first constructed. Non-historic metal doors have been installed as have vinyl windows. The first porch railing, front steps, and metal hand railing are also non-historical. The front porch also shows signs of deterioration, most notably, the lattice, columns, and second-story floor and dentils.

Figure 3: Front Entrance and Porch. Staff Photo, November 21, 2020

The front porch of the structure has some signs of deterioration. These include the lattice, columns, second-story floor, dentils, among other elements. The Applicant has indicated that the dentil molding would be restored. The proposal would also replace the deteriorated lattice and columns. According to the application, the flooring, stairs, columns, and lattice would be replaced in kind. According to the application, the porch railings would be replaced with an aluminum railing. The existing first floor porch railing is metal, but it is not clear whether the current second and third floor porch railings are metal as well. The project proposed, though, represents an opportunity to restore any porch elements to their historical condition.

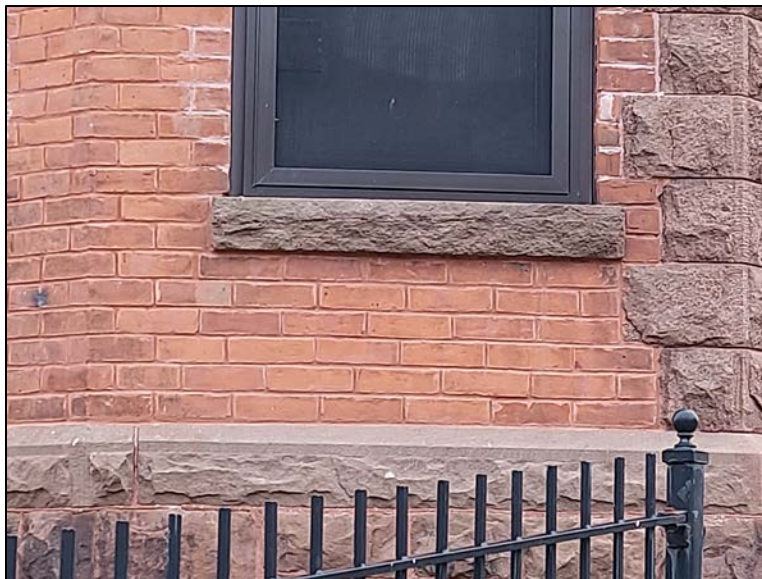
As for the masonry, the Applicant has stated that repointing and replacement of brick would occur as necessary. The Applicant did not provide specific area and location of brick to be repointed or replaced. They merely stated that they would examine the brickwork to determine where such work needed to occur. They did state on the elevations submitted that any damaged bricks would be replaced with matching brick.

Figure 6, Exterior brick masonry. Staff Photo, Nov. 21, 2020
