DEPARTMENT OF DEVELOPMENT SERVICES – PLANNING DIVISION
 REPORT: 36-70 Talcott Street, Hartford, CT 06103
 For consideration: November 18, 2020

STAFF REPORT

PROJECT: 36-70 Talcott Street Demolition
 PARCEL ID: 268-349-022
 ENERGOV ID: COMM-2020-0281

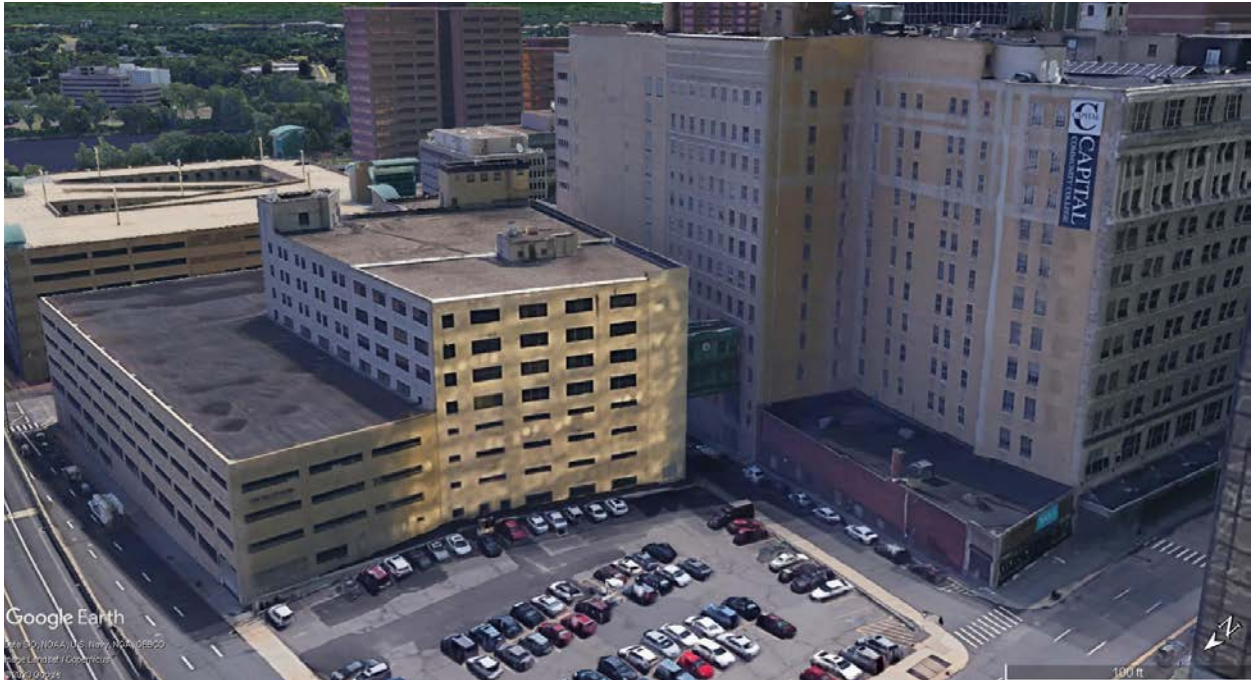
Figure 1. Google Earth, dated 9/18/2019. View of the 36-70 Talcott Street the intersection of Main and Morgan. The original warehouse structure is located along Talcott Street, in the center of the image, and the copper, Neoclassical Revival bridge connects it to the former G. Fox Store on the right, now Capital Community College. The 4-story addition on the left that wraps the north and east sides of the Warehouse Building is not within the district.

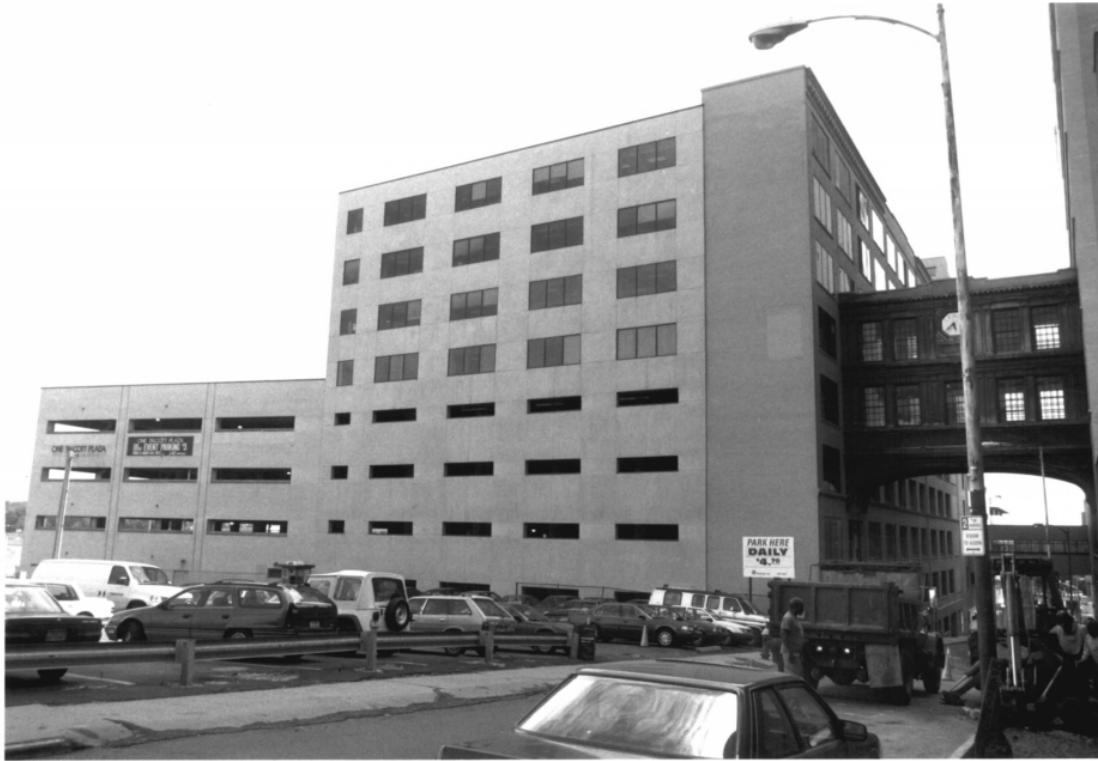
Figure 3. Photograph 10 of 12 from the Department Store Historic District Nomination, dated 1994. The original photo caption: “G. Fox Building warehouse and parking garage at 40 Talcott Street, camera facing northeast.” The building exterior remains essentially the same today but with additional wear.

Warehouse is connected to store by copper-clad 2- story bridge above Talcott Street; Neo-Classical style, 1918. Details include paneled pilasters, clock face on second story, cornice with modillions and stepped parapet, and 12-over-12 windows. Photograph 10 (Figure 3 of this report).”

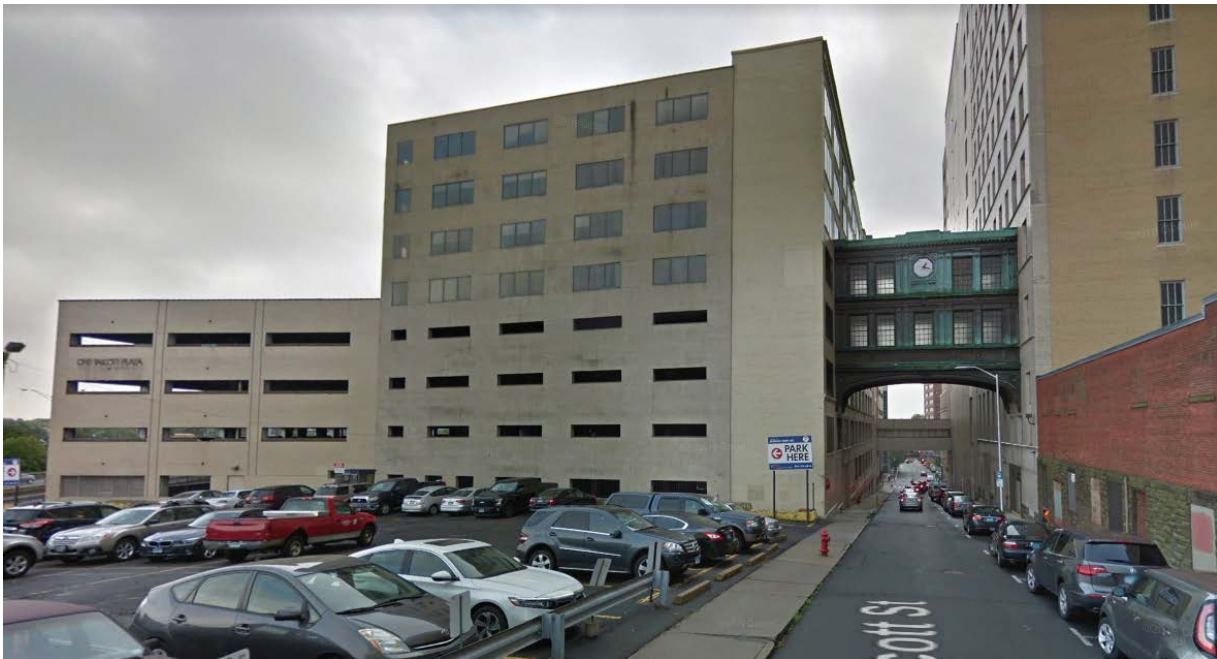
Figure 4. Google Streetview, dated June 2019. View east on Talcott Street from Main Street. The bridge is connected to the 1918, former G. Fox & Co. store building which is also of Neo-Classical Revival Style with Art-Deco marquisse added above first story (1935, Taussig-Flesch Associates) and further addition to the rear and upper stories.

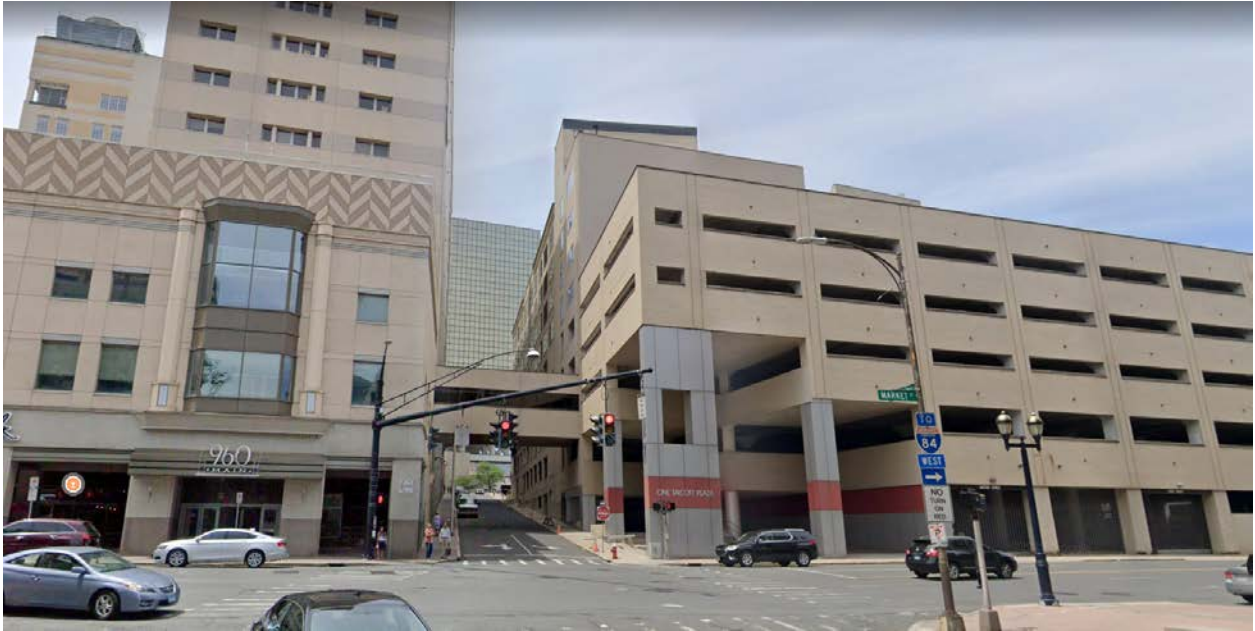
Figure 5. Google Streetview, dated June 2019. View west on Talcott Street from Market Street. The portion of the building on Market Street is a later addition and not part of the district. The pedestrian bridge shown connects the parking garage, right, with the Art-Deco style addition to the G. Fox & Co. store building, left.

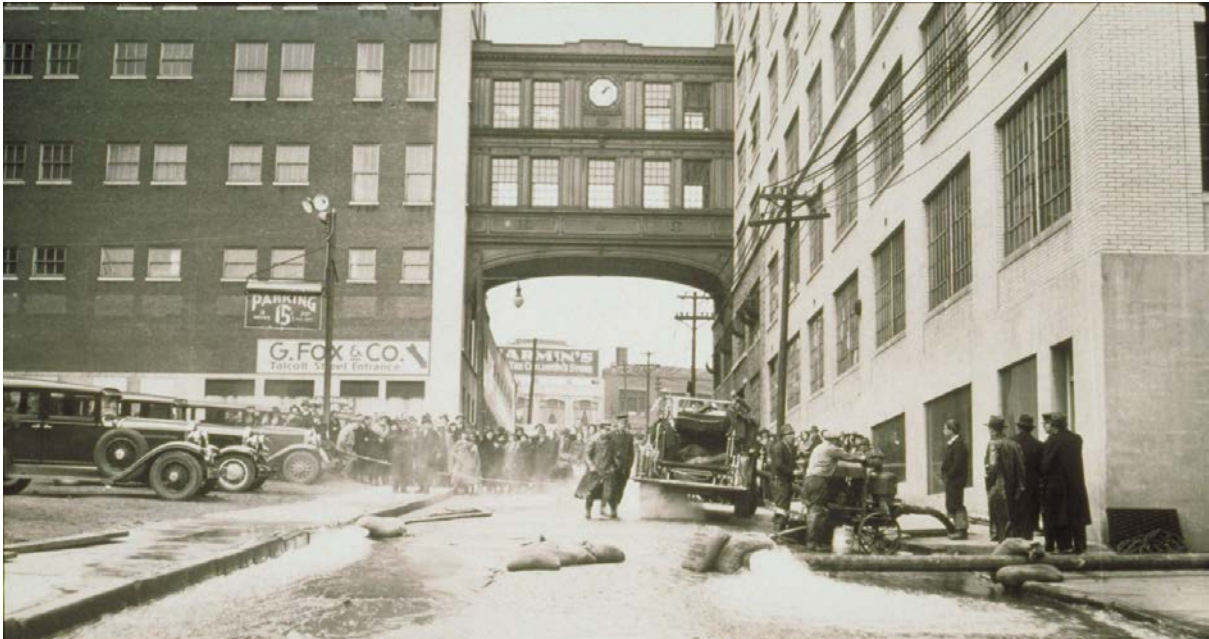
Figure 6. Connecticut Historical Society museum & library, Connecticut Images Collection, “Flood of 1936: pumping water on Talcott Street, Hartford.” View looking west up Talcott St. The Warehouse Building, right side of Talcott, prior to removal of the original windows. This predates the addition to the warehouse building on the north side of the street, constructed a few years later and shown in the following image (Figure 7).

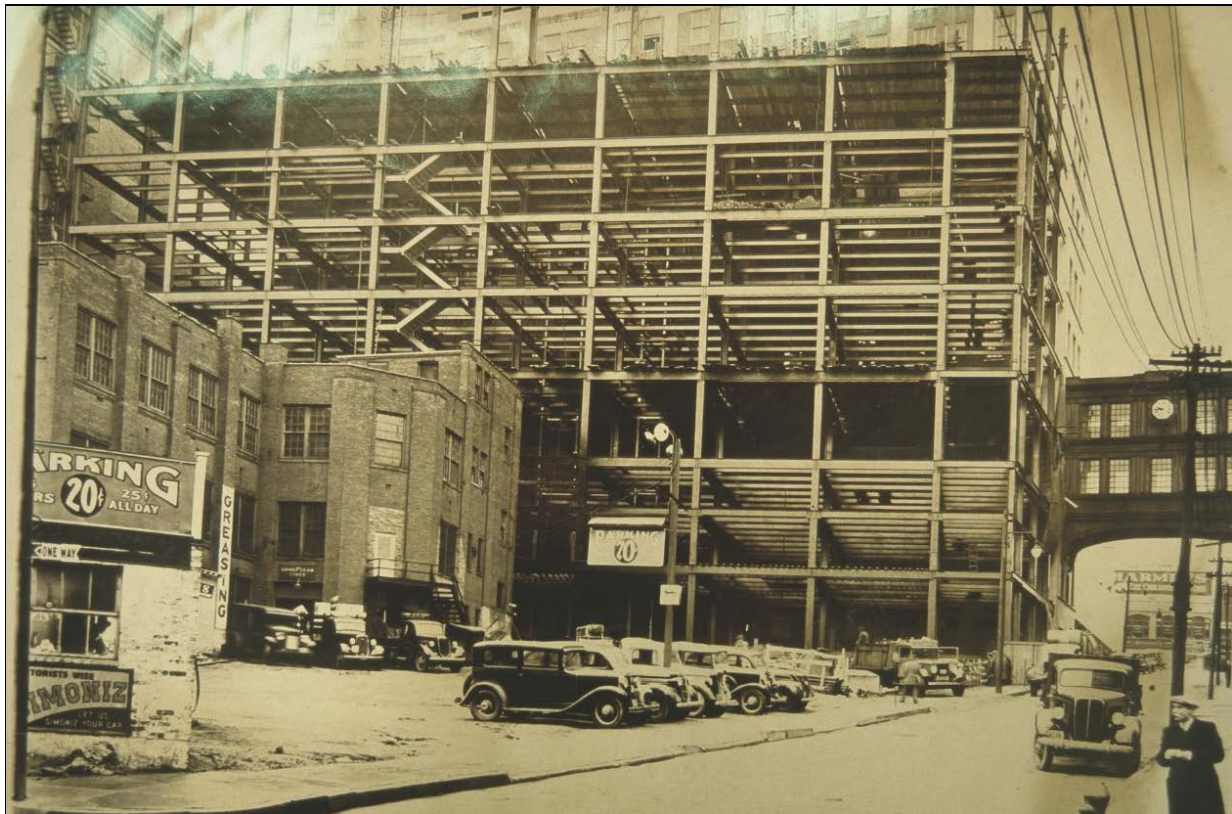
Figure 7. Unknown photographer, "G. Fox Store, Hartford: Exterior view, 1938 addition construction [HSP 2485]." doi:10.2307/community.159454. Trinity College's collection of Hartford images holds this photograph taken during construction of an eastern addition to the G. Fox. Store building and shows a portion of the pedestrian bridge.
