DEPARTMENT OF DEVELOPMENT SERVICES – PLANNING DIVISION
REPORT: 1000 Albany Avenue, Hartford, CT 06112
For consideration: October 21, 2020

STAFF REPORT

PROJECT: 1000 Albany Avenue
PARCEL ID: 198-201-008

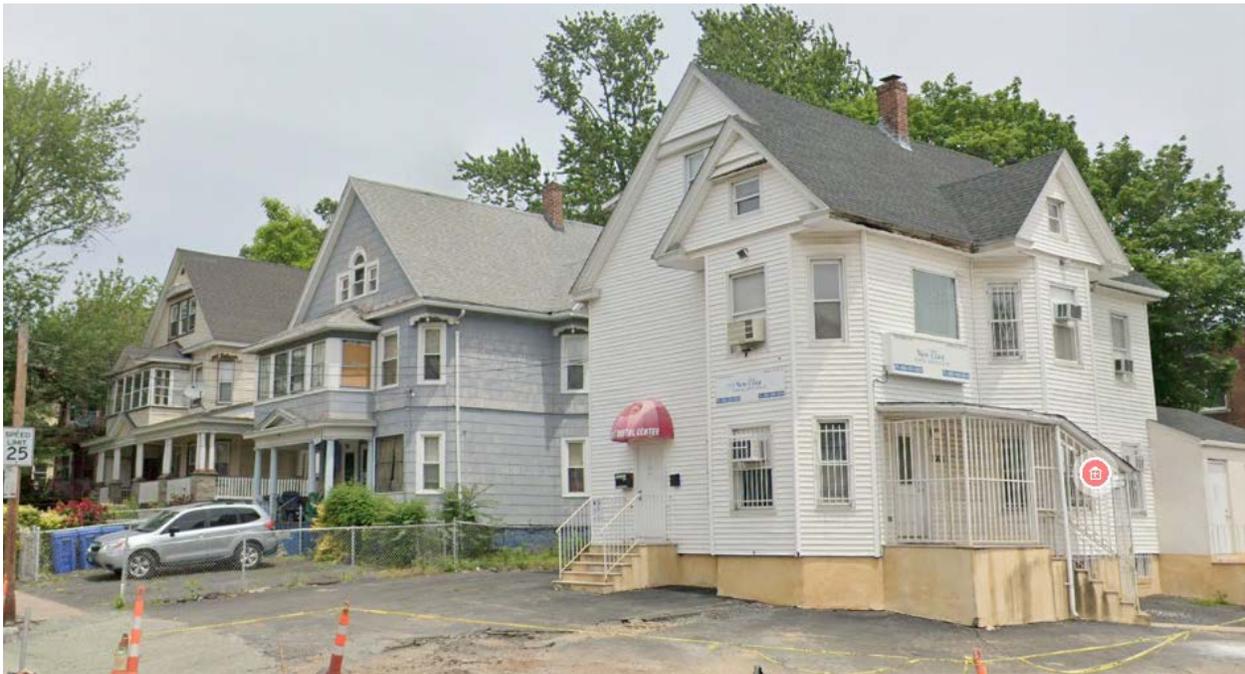
Figure 2. Google Streetview, dated June 2019. View from Subject Property looking northeast on Deerfield Ave; prior to recent site improvements. 4 and 6-8 Deerfield in background were constructed in 1904. As seen in Figure 1, the foundation has since been repainted and foundation platings were added.

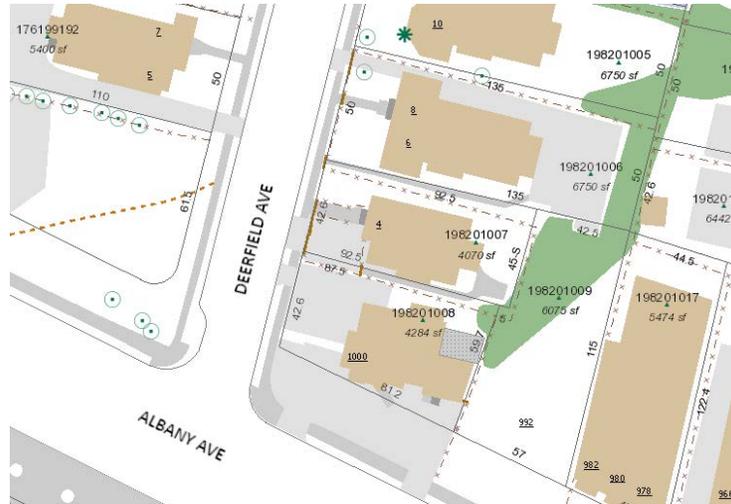
Figure 4. Hartford GIS. 2 Deerfield Ave was likely the original address associated with 1000 Albany Ave.

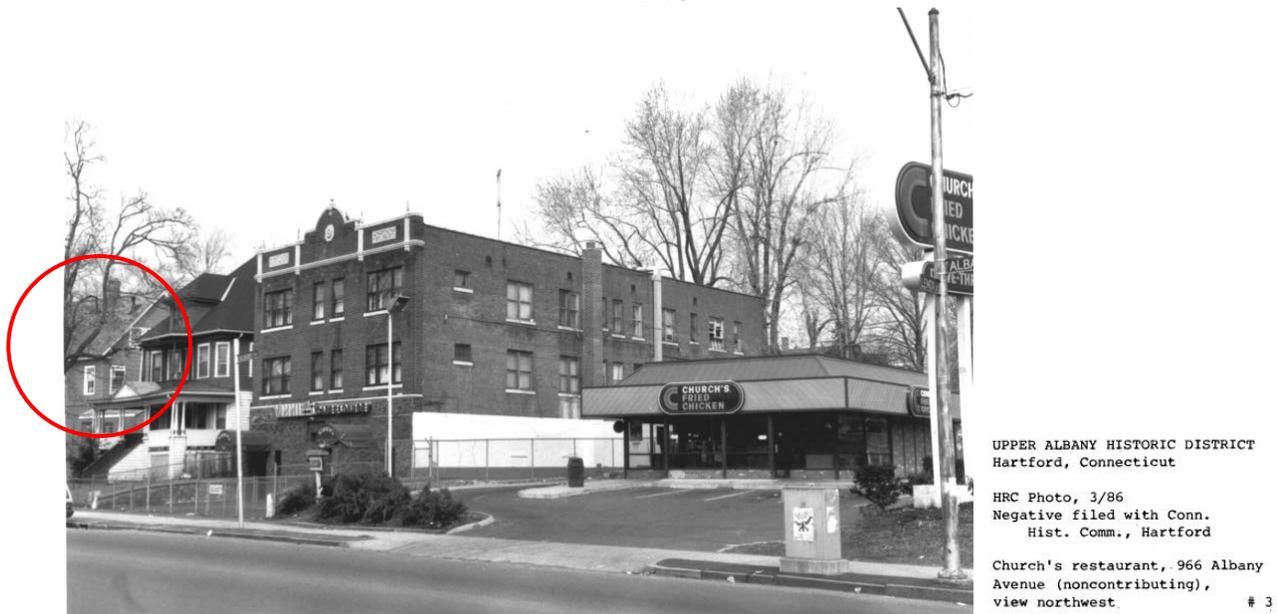
UPPER ALBANY HISTORIC DISTRICT
Hartford, Connecticut
HRC Photo, 3/86
Negative filed with Conn.
Hist. Comm., Hartford
Church's restaurant, 966 Albany
Avenue (noncontributing),
view northwest. # 3

Figure 5. Image 3 from the National Historic District Nomination. The the red circle indicates the the subject building in the background, 992 Albany Ave in front of it no longer remains, the brick apartment building at 978-982 Albany Ave still stands, Church's resturant is now Popeye's.

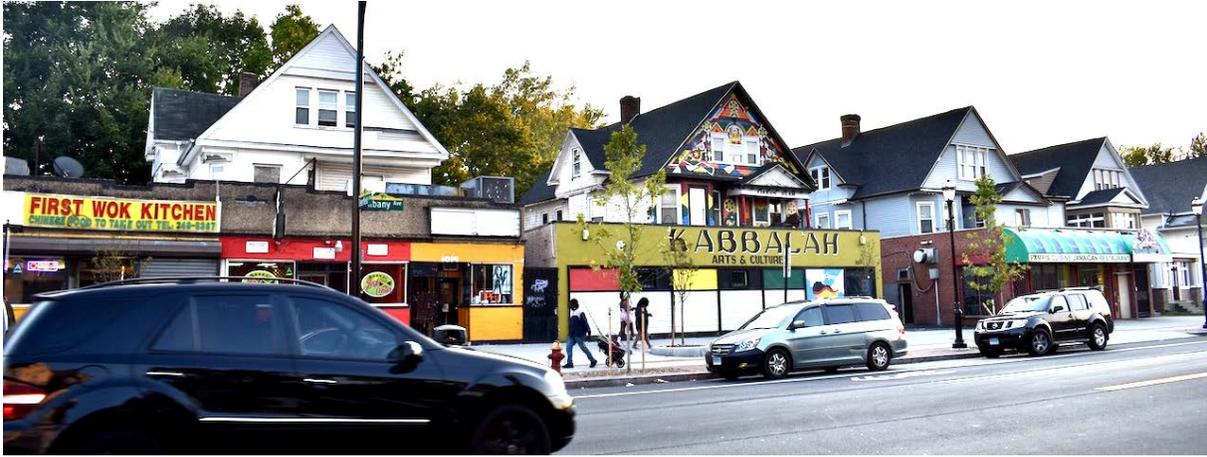
Figure 15. Image taken by Staff October 9, 2020. Non-contributing cottage commercial buildings on the south side of Albany Ave, across the street from the subject parcel. Buildings such as Kamora's Cultural Corner, are aiming to establish a new character and identity for the neighborhood.

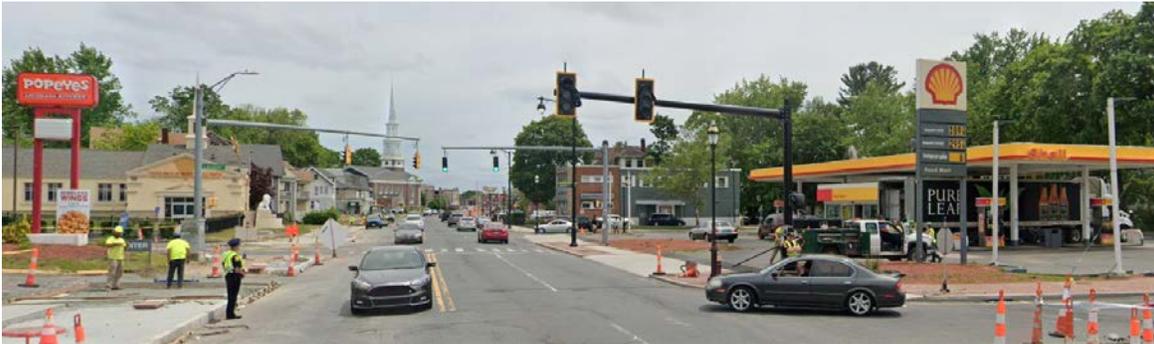
Figure 16. Google Streetview June 2019. Looking east on Albany Ave, the street has lost many of its original buildings and new developments such as Popeyes at 964 Albany Ave and the Shell Gas station at 949 Albany Ave have taken their place.

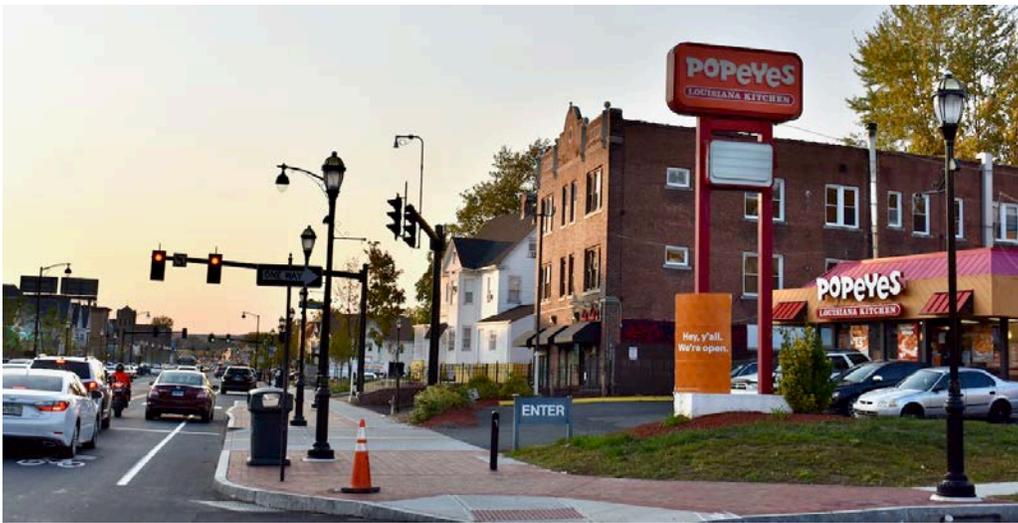
Figure 17. Images taken by Staff October 9, 2020. Looking northwest towards the subject parcel, showing the same structures as Figure 5, from the National Historic District Nomination. 992 Albany Ave is now a parking lot for the subject parcel.
