## BUILDING SECTIONS 100 CEDAR STREET HARTFORD, CT

Re: #100 Cedar Street, Hartford

At your request I inspected the cornice on 100 Cedar Street to determine the material used in its construction and to determine the condition that it is in.

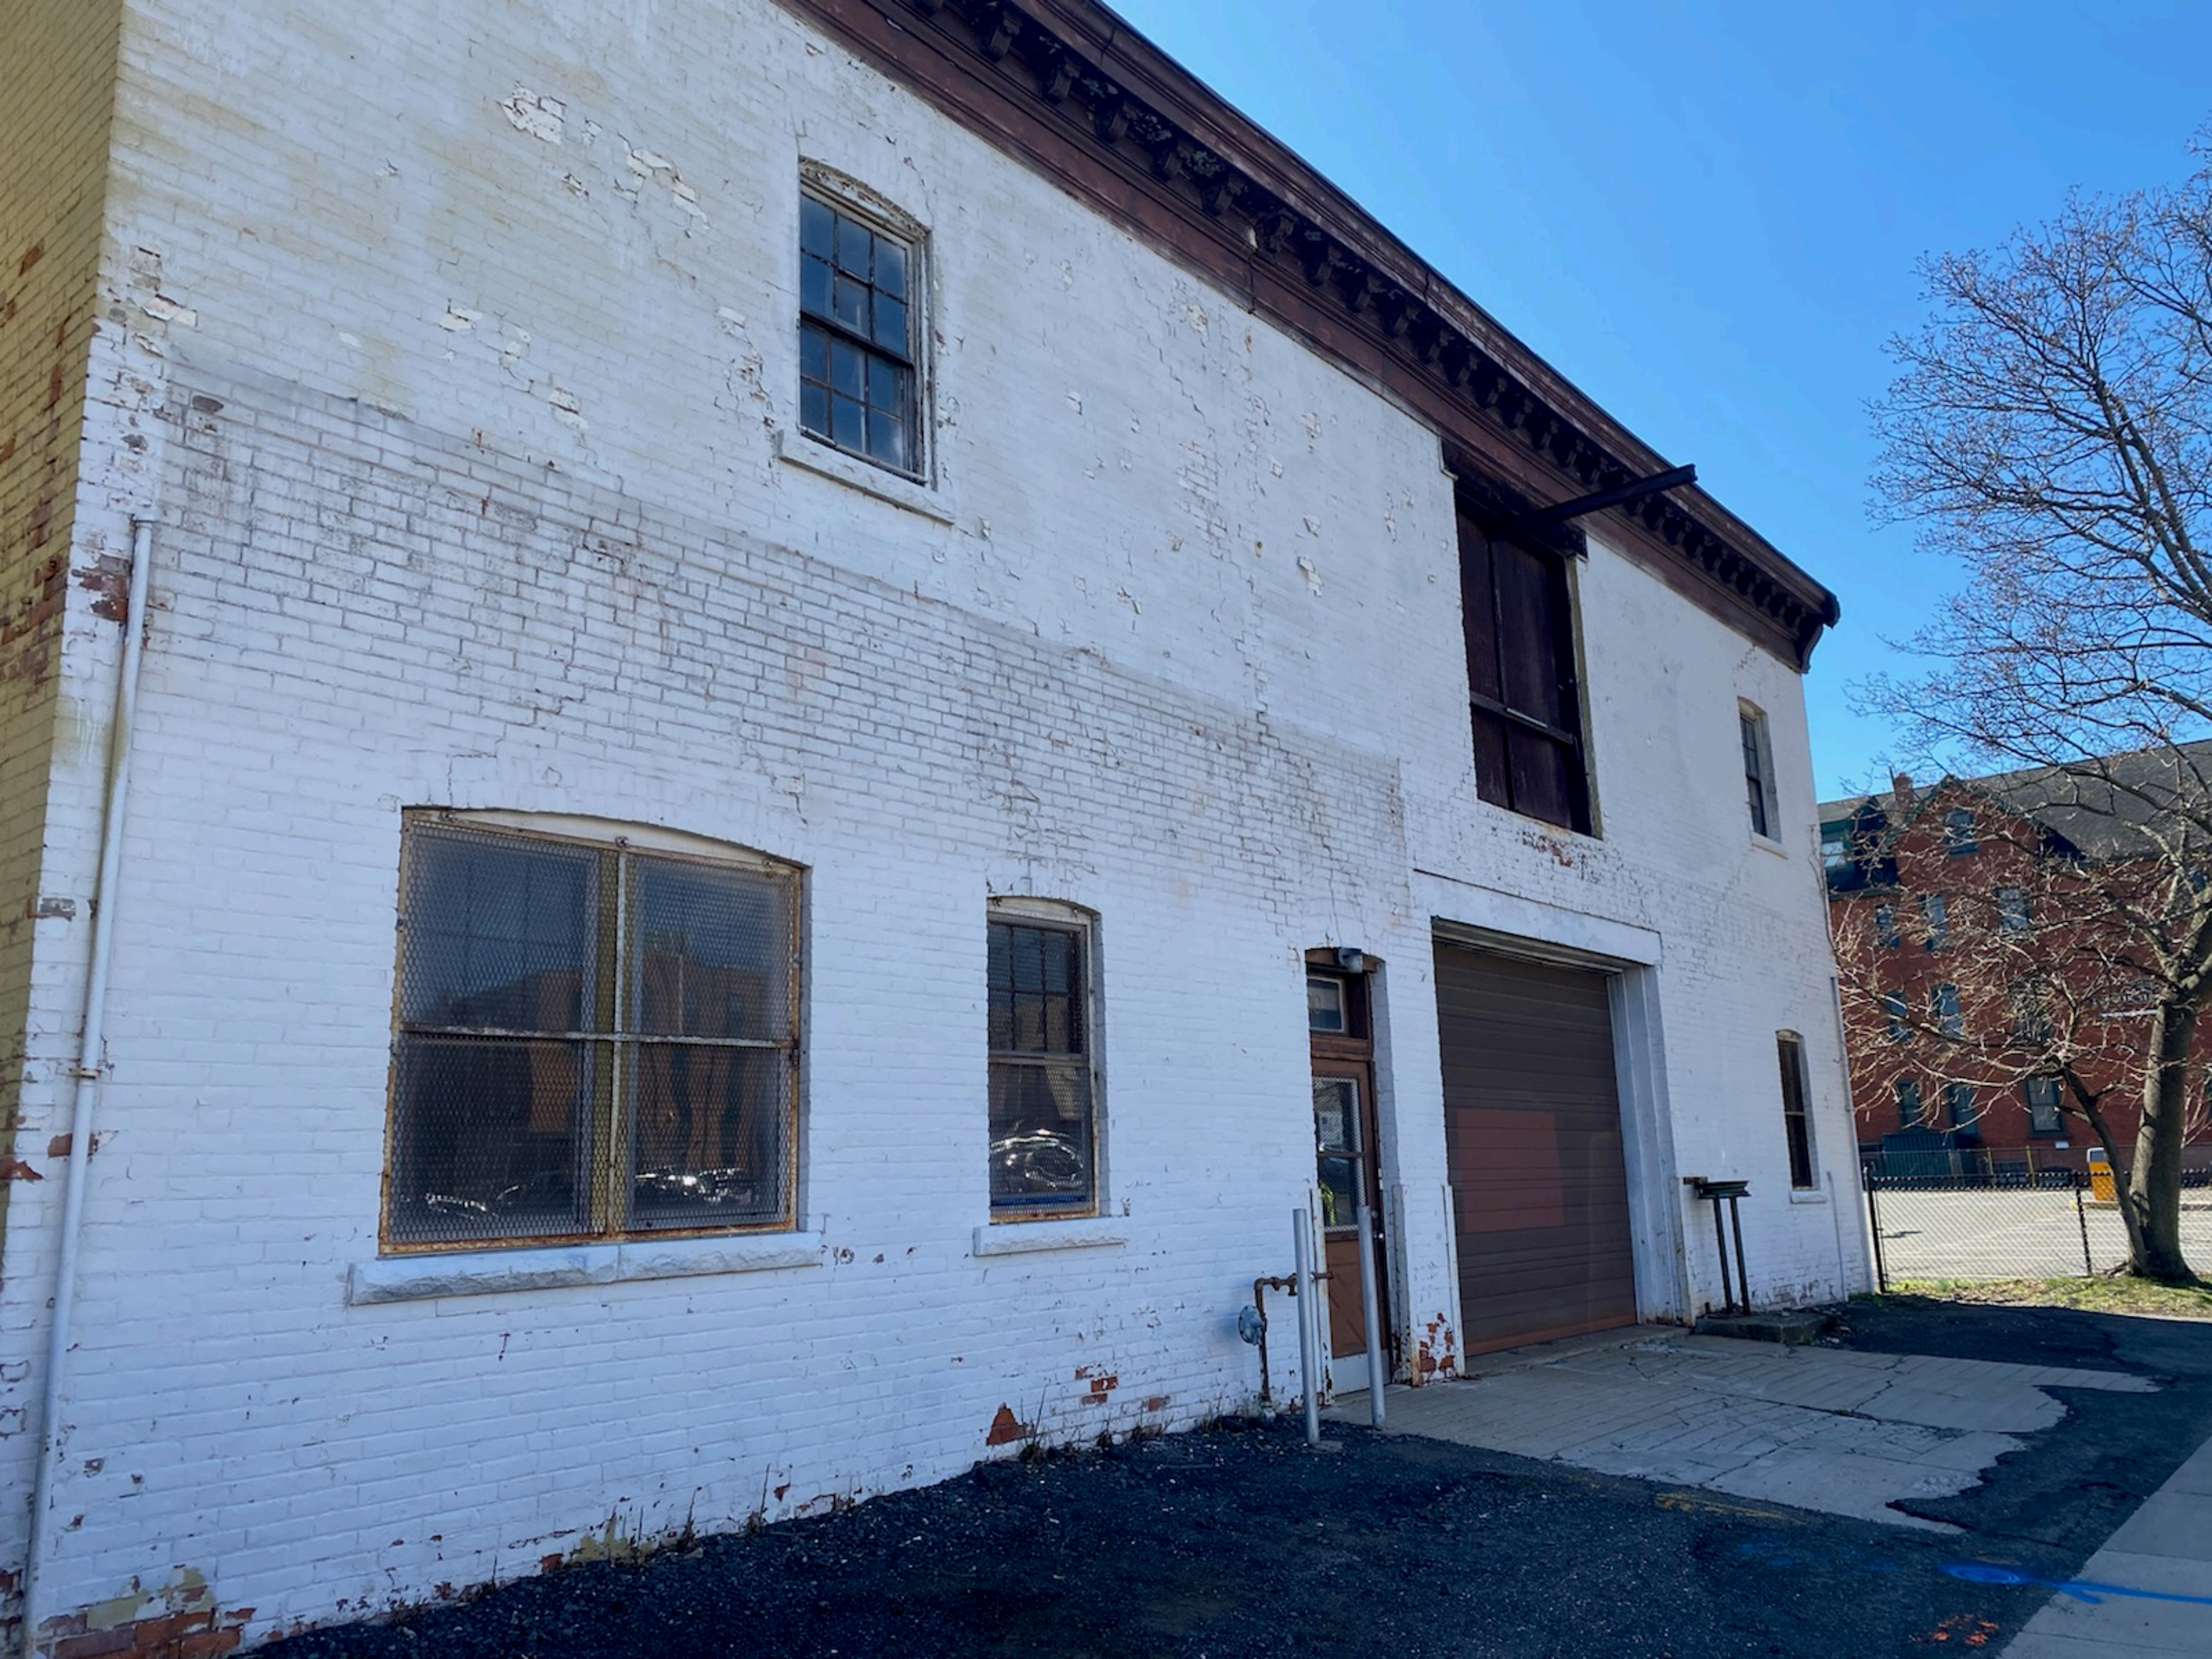
Corbel appears to have fallen off and been refastened. Gaps created by movement have been filled with expanding foam insulation. Soft wood behind the metal was observed in this area

While much of the galvanized sheet metal components of the cornice appear to be in decent condition the general alignment of the cornice along the face of the building is a concern. I feel the alignment issues and evidence of excessive movement are caused by deterioration of the structural components under the metal covering. For this reason, I suggest you monitor the cornice for any additional movement and remove it if any becomes evident.
