PZ-HIST-23-000053

Address: 224 WASHINGTON ST, HARTFORD, CT 06106

RE: Structural Condition Assessment
224 Washington Street, Hartford, CT
Fuss & O'Neill Reference No. 20221213.A10

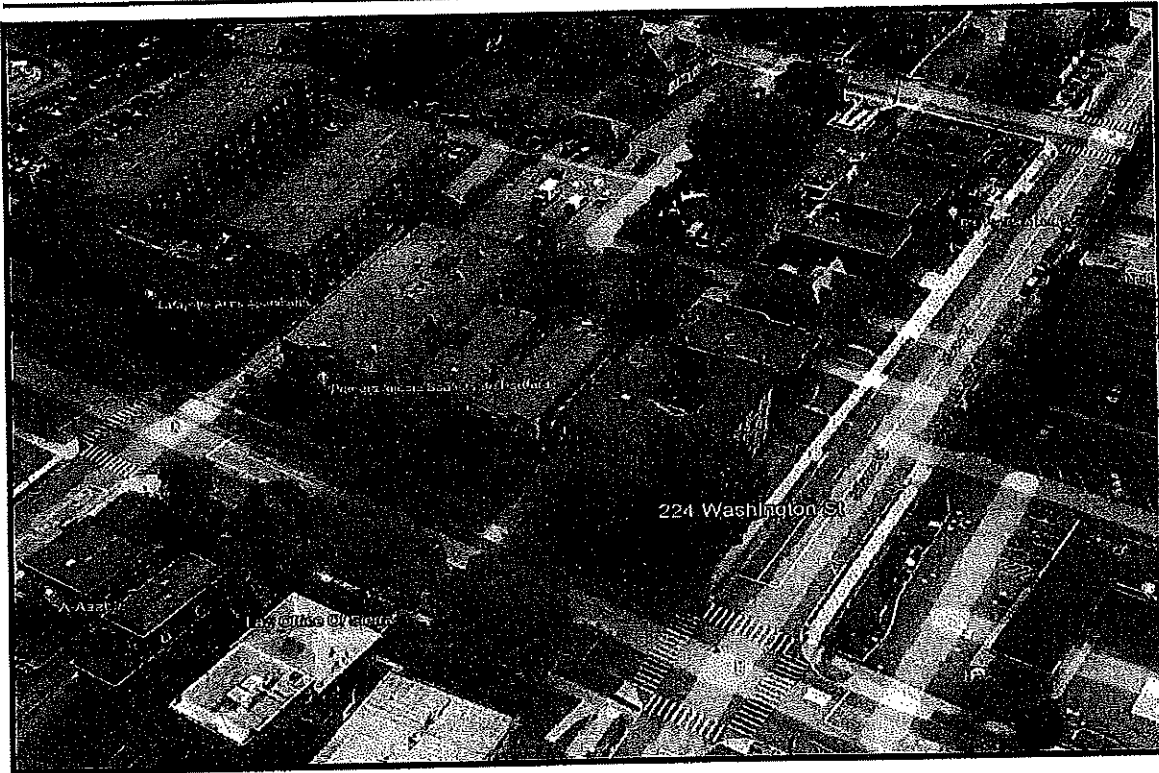
PHOTO 1: - Aerial View Looking East.

The two buildings are located at the corner of Jefferson and Washington Streets in Hartford, CT. See Photo 1.

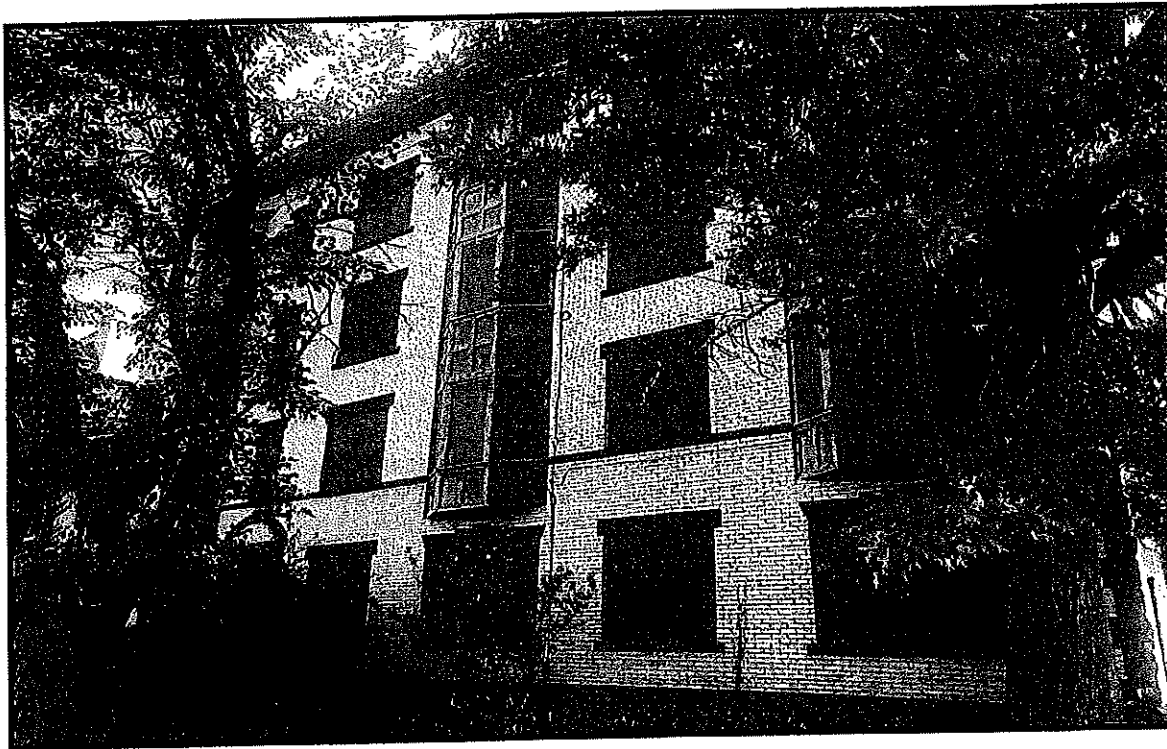
PHOTO 2: - 224 Washington Street West Elevation.

224 Washington Street is a 5-story structure constructed of timber framed floors and interior and exterior brick bearing walls. See Photos 2 & 3. The building has a gross area of approximately 15,500 sf and according to town records was constructed in 1913. The building contains a full below grade basement.

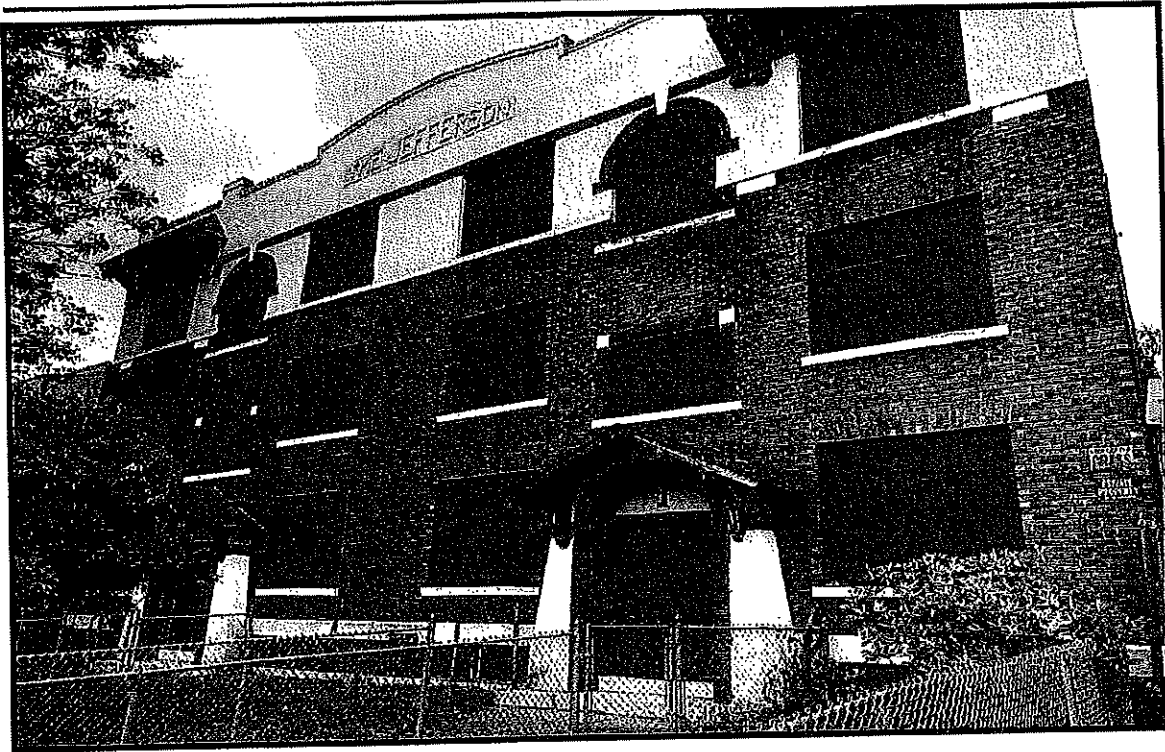
PHOTO 15: - 216 Washington Street West Elevation.

216 Washington Street is a 4-story structure constructed of timber framed floors and interior and exterior brick bearing walls. See Photos 15 & 16. The building has a gross area of approximately 12,800 sf and according to town records was constructed in 1915. The building contains a full below grade basement.
