DEPARTMENT OF DEVELOPMENT SERVICES – PLANNING DIVISION

REPORT: 100 Cedar Street, Hartford, CT 06106

STAFF REPORT

PROJECT: 100 Cedar Street
PARCEL ID: 247-447-003
ENERGOV ID: COMM-2021-0357

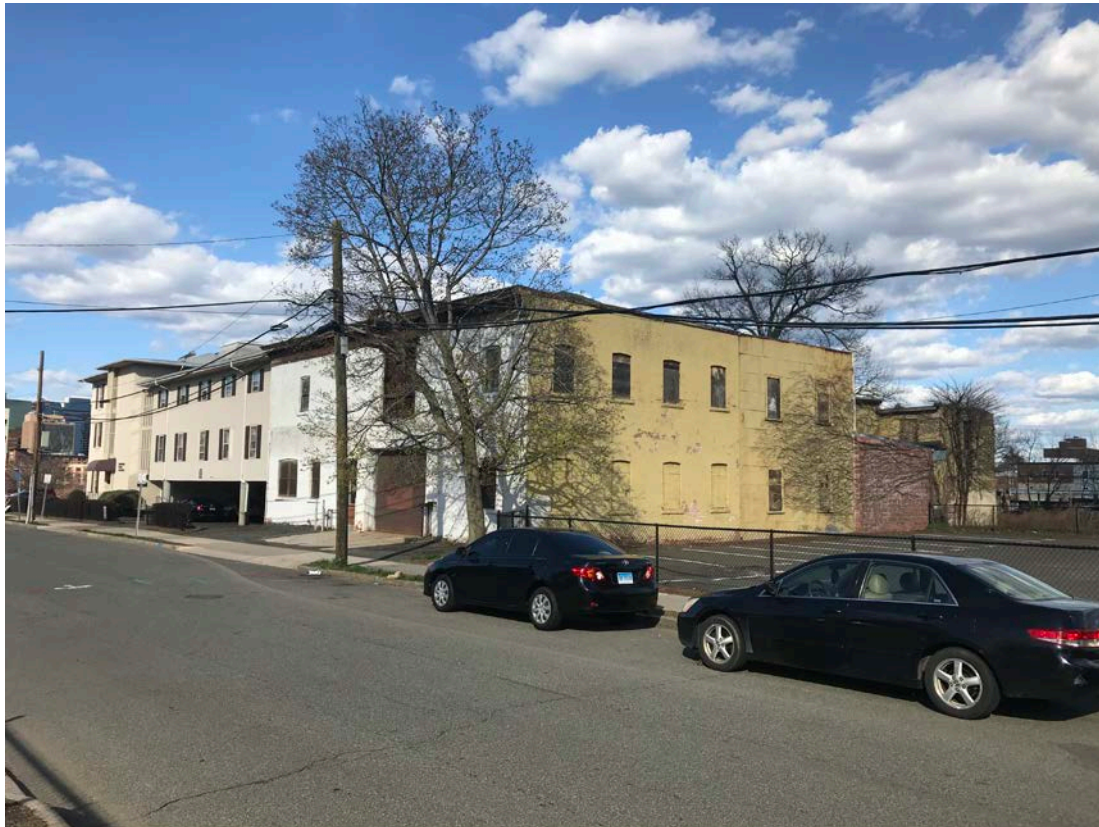
Current Conditions: The exterior of the building at 100 Cedar is in fair condition, though the paint on the brick and trim work is failing. Many of the windows are boarded. The cast iron cornice mentioned in the district nomination is still present on the front façade and portions of the rear. Many additions made over the years may have resulted in more of the cast iron cornice being removed or enclosed. The majority of the building is brick, though the rear additions have horizontal clapboard siding. The pictures provided by the applicant paint a different picture of the interior of the structure. The interior reveals that the building as a whole has been cobbled together by a variety of additions.

Fig.1 - 100 Cedar Street Front and Side (south) façade taken on April 13, 2021

Staff recommends denial of this application.
