REPORT: 60 Capen Street, Hartford, CT 06120

STAFF REPORT

PROJECT: 60 Capen Street

Proposed Project: The applicant seeks to replace the windows on all three floors of the building. The extent windows are constructed of wood and appear to be a mix of two over two and one over one in configuration. The applicant proposes to install white vinyl double hung windows in a one over one configuration. The applicant has provided specifications for the Crystal Series 100 windows proposed to be used in the project.

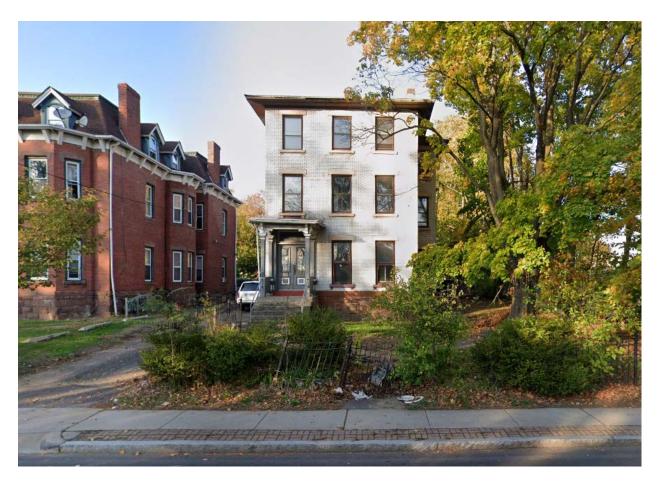
Current Conditions: The exterior of the building is in good condition, in particular the brick and the window sills and lintels.

Front Façade – Google Street View Image, October 2020

Staff does not find sufficient justification to support the use of vinyl windows in place of the wood windows that previously existed, and further finds that per the guidance of the historic guidelines, the replacement windows should be of a configuration (2 over 2) that matches the previous wood windows.

Staff recommends denial of the application.
