On March 29, 2021, environmental scientists with SLR International Corporation (SLR), on behalf of Empire Paving, visited the site at 180 John D. Wardlaw Way in Hartford to assess the condition of impacted wetlands in response to construction-related discharges resulting in unauthorized fill to a wetland and watercourse and to outline a recommended mitigation strategy to compensate for damages.

SLR has prepared the following Wetland Impact Assessment report for damages incurred by the construction of the Metropolitan District Commission (MDC) South Hartford Conveyance and Storage Tunnel project under contract by Empire Paving. A Notice of Violation (Case Code Number: Accela #9636459) was submitted by the City of Hartford's MDC related to offsite slurry waste associated with construction activities at Site DS-2 located at 611 Brookfield Street in Hartford, Connecticut. An inspection conducted by a City of Hartford Municipal Inland Wetlands Agent on February 26, 2021, revealed that a failure of the slurry wastewater containment pit caused waste material to migrate from the site and be deposited into the adjacent wetlands and upland review area without proper permits and approvals in

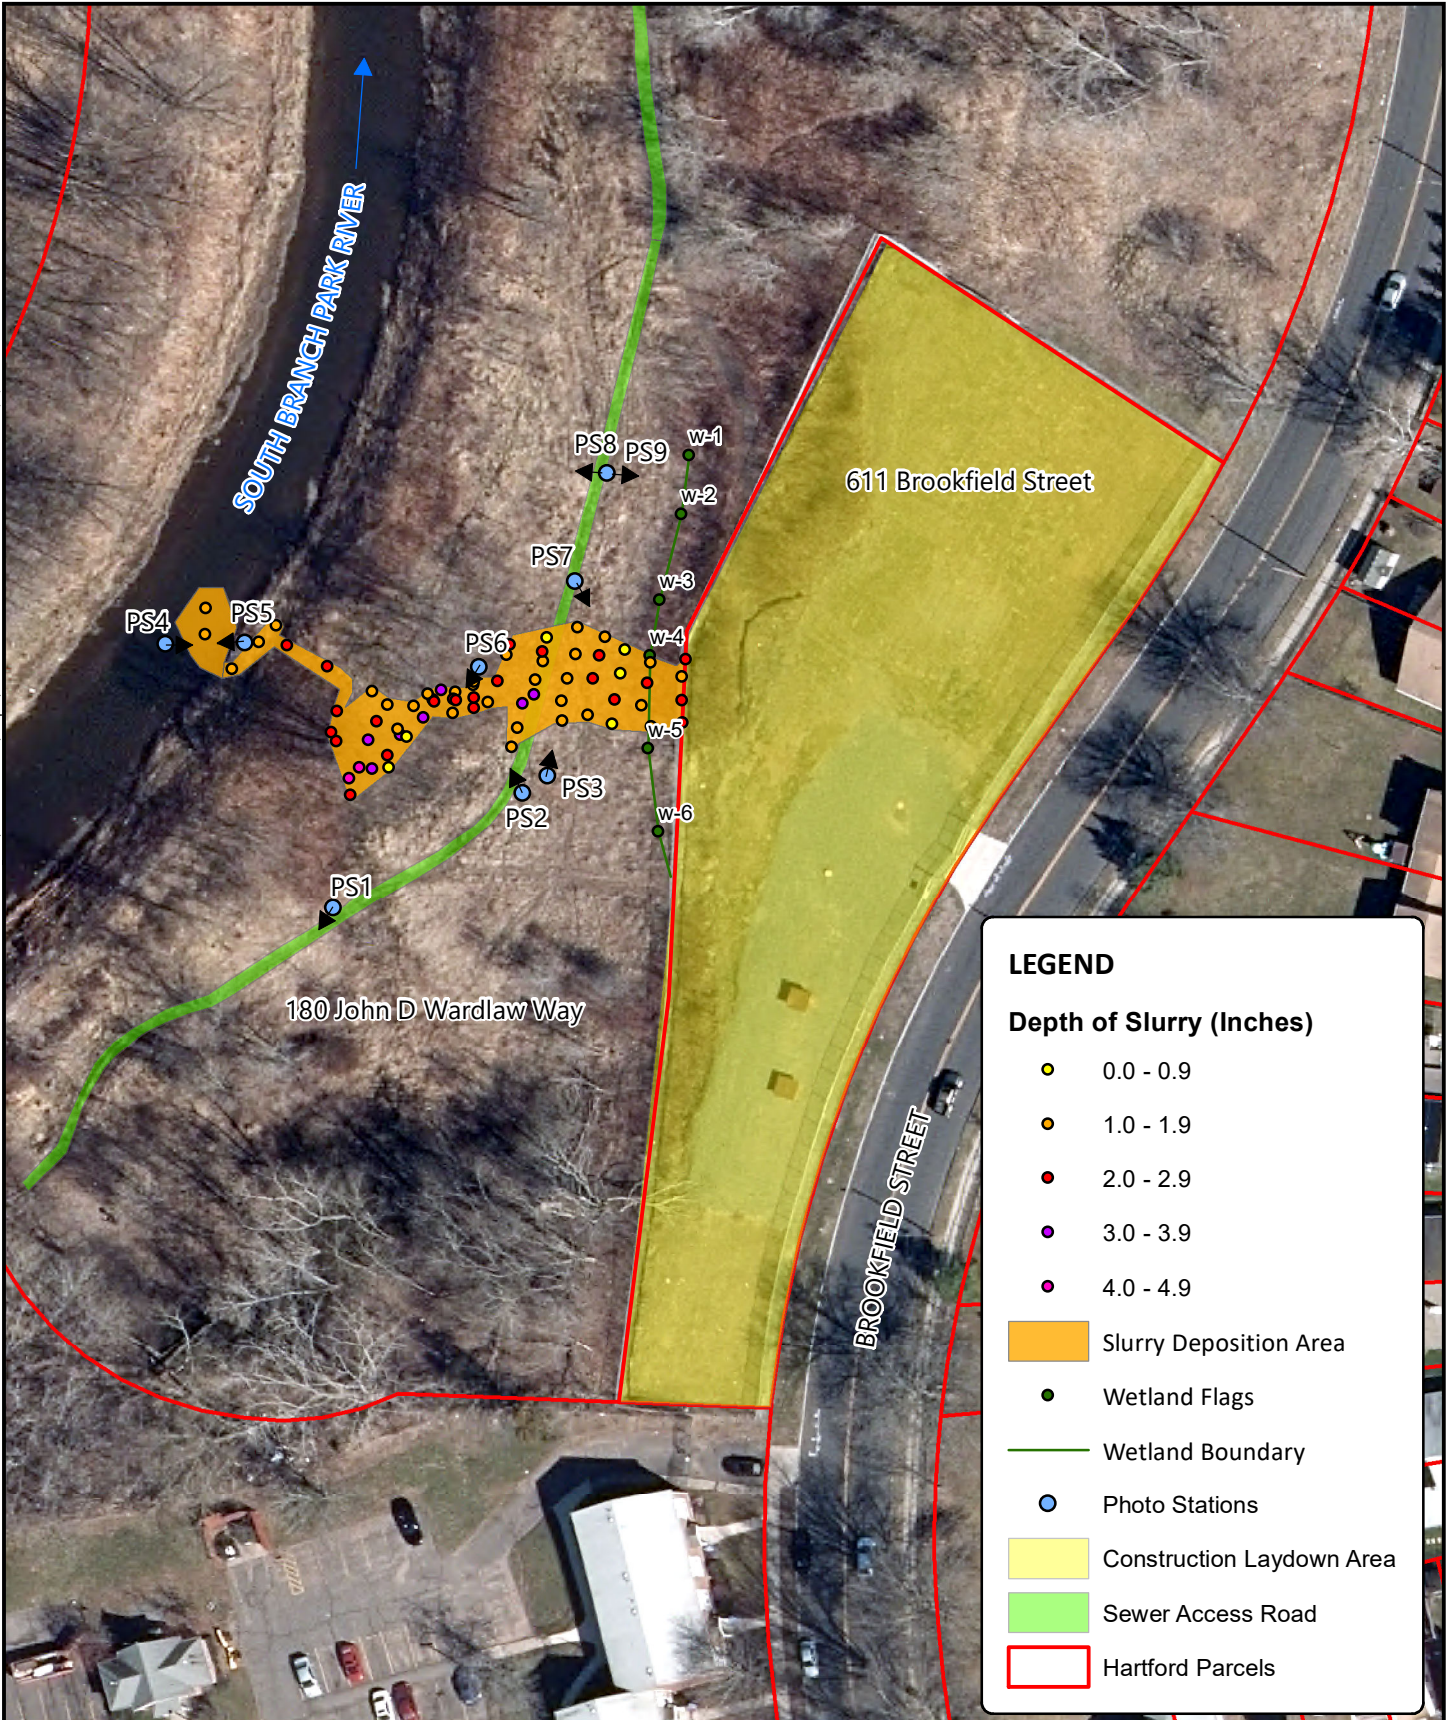
FIG. 1

The area of slurry deposition within the adjacent wetland and watercourse is approximately 4,710 square feet (as shown on Figure 1 in Appendix A) and consists of a silty slurry that covers existing herbaceous vegetation within the floodplain wetlands and watercourse. This slurry will impact short-term herbaceous growth within parts of the wetland and affect water quality within the South Branch Park River if left in place. Based on these impacts, our team has developed recommendations for remediating the conditions within the wetland resources. In summary, the unauthorized slurry deposition can be remediated through strategic material removal, seeding, and installation of sediment and erosion controls, followed by postrestoration monitoring of the advancement of natural vegetation recovery.

SLURRY DEPOSITION AREA

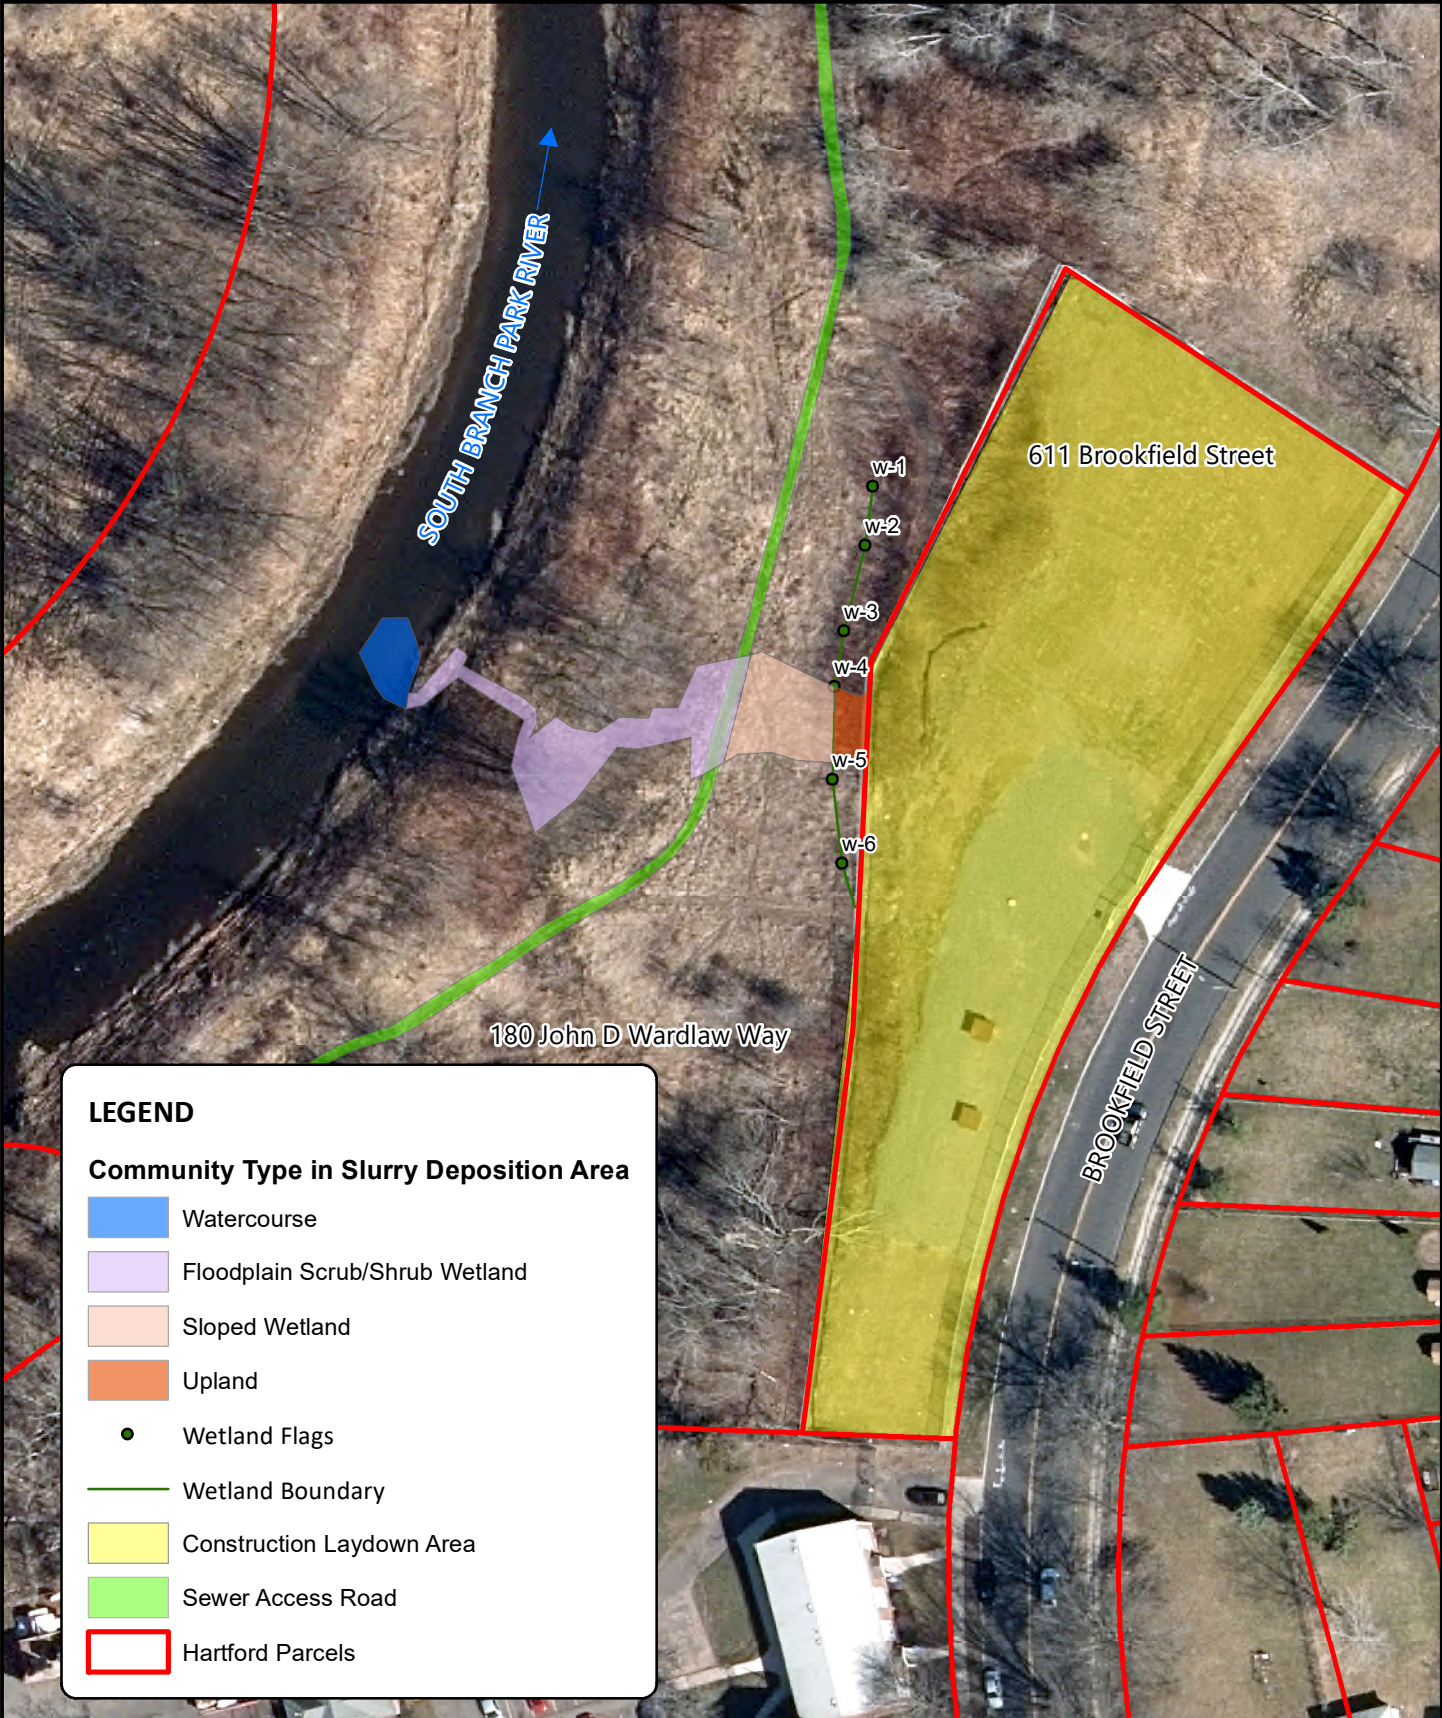
FIG. 2

The wet meadow/scrub-shrub floodplain wetland within the project area spans approximately 150 feet from the toe of slope to the South Branch Park River (see Figure 2 in Appendix A). This floodplain wetland has historically been manipulated by anthropogenic activities including creation of the river channel and floodplain bench, installation of sanitary sewer lines, and maintenance of access roads. This historical disturbance has shaped the vegetative communities observed within the project area. Three plant species indicate the historical disturbances including the presence of multiflora rose (*Rosa multiflora*), Japanese knotweed, and purple loosestrife. The wet meadow/scrub-shrub wetland plant community consists of black willow (*Salix nigra*), false indigo (*Amorpha fruticosa*), common box elder (*Acer negundo*), and silky dogwood. Herbaceous species observed include purple loosestrife, garlic mustard (*Alliaria petiolata*), rough cocklebur (*Xanthium strumarium*), wild onion (*Allium* sp.), common mullein (*Verbascum thapsus*), and various annual and perennial bunchgrasses (See Appendix B for a full plant inventory collected during the survey).

Community Type in Slurry Deposition Area

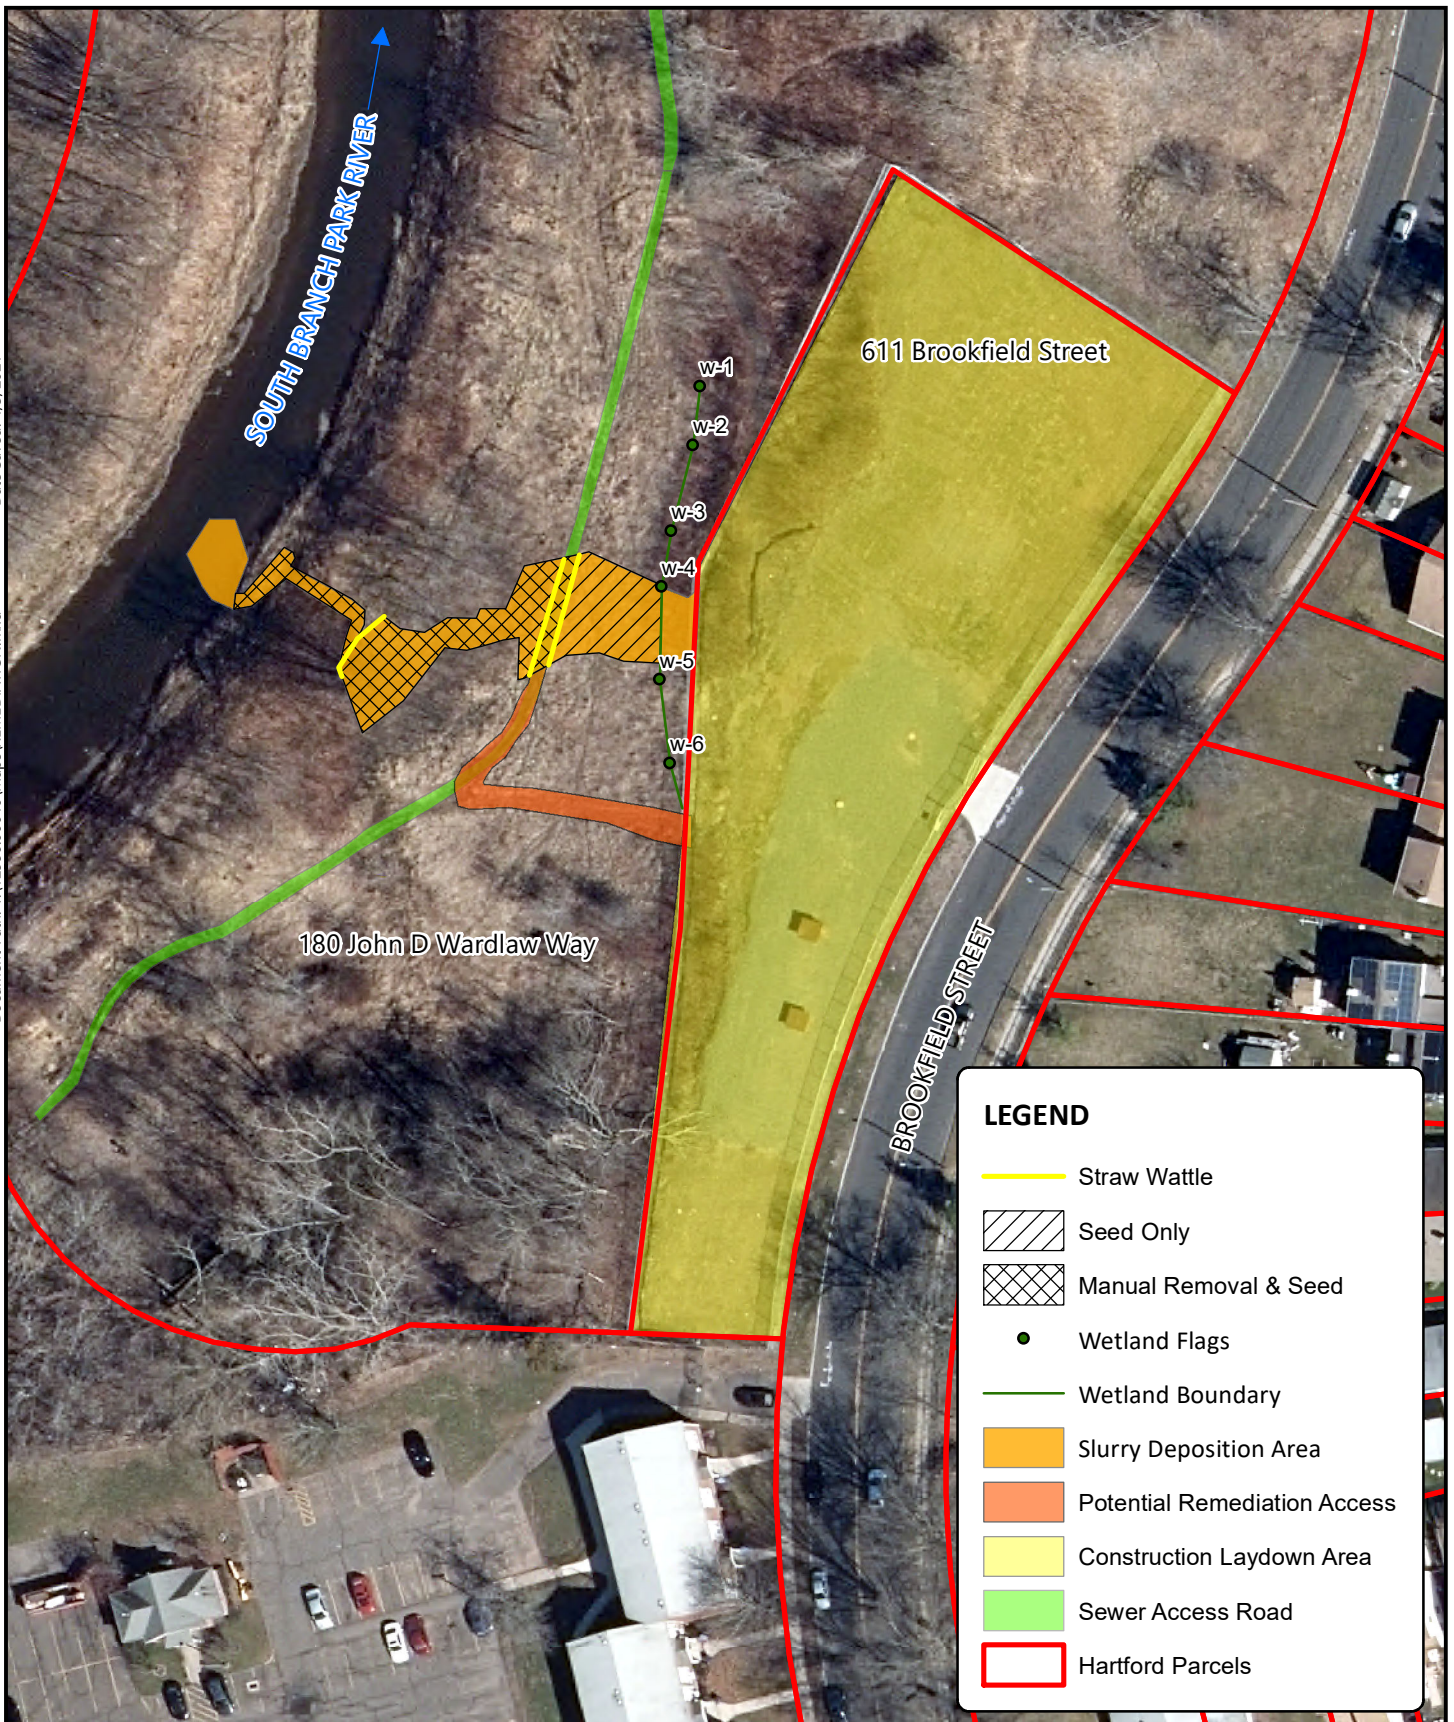
- Straw Wattle
- Seed Only
- Manual Removal & Seed
- Wetland Flags
- Wetland Boundary
- Slurry Deposition Area
- Potential Remediation Access
- Construction Laydown Area
- Sewer Access Road
- Hartford Parcels

For this site, SLR recommends a combination of alternatives be implemented to achieve appropriate restoration of impacted wetland functions and values. These recommended actions are subdivided into the wetland and watercourse remediation plans. The recommended remediation alternatives are depicted on Figure 3 (Appendix A).

The sloped wetland area has a relatively thin deposition layer. In addition, SLR observed herbaceous plant material beginning to poke through the surface cracks within this deposition layer. For this area, it is recommended that the thin slurry layer be left as is and allowed to revegetate through natural processes. To help speed the natural processes, SLR recommends adding a supplemental application of a seed mix New England Erosion Control for Moist Sites and Detention Basin to the thin layer of slurry present. The seed mix can be applied during the spring growing season April through early June. In addition, it is recommended that a straw wattle be added at the toe of the slope to allow for filtering of stormwater runoff until the vegetation has reestablished itself along this slope wetland. This minor action alternative will restore the nutrient, toxicant, and wildlife habitat function of this wetland.

The slurry deposits within this section of the impact area should be removed. The sediment is thickest in and around a black willow tree. Underlying herbaceous vegetation will have a difficult time poking through this thicker material. In addition, this material may impact the root interface zone of the existing trees and shrubs within this wetland. Removal of this material is recommended. The density of shrubs within this area prevents the use of mechanical means of slurry removal. This slurry should be removed by hand. This removal will not be easy given the sticky properties of this slurry and the density of the shrubby vegetation present. Cutting of the shrubby vegetation is not recommended. The use of rubber matting, plywood, and/or timber planks placed over the wetland and slurry will allow workers to access the material. A skid steer can access the site using the sanitary sewer access road or may gain access from the adjacent laydown area. A rubber-tracked skid steer would be the most appropriate machine to gain access to the site while minimizing rutting within the wetland and sanitary sewer road. The slurry material will need to be removed by hand shovels and metal rakes. Wheelbarrows and/or 5-gallon buckets can be used to wheel or carry the excavated material out to the skid steer. The slurry should be removed until the

underlying herbaceous vegetation is observed. Leaving some thin deposits within the wetland is acceptable. After removal of the sediment, the existing silt fence that has been placed within the wetland should be removed and replaced with straw wattles. The New England Erosion Control seed mix for Moist Sites/Detention Basins should be applied to the slurry removal area. The slurry removal work should be overseen by a wetland specialist to confirm appropriate remedial requirements have been achieved.

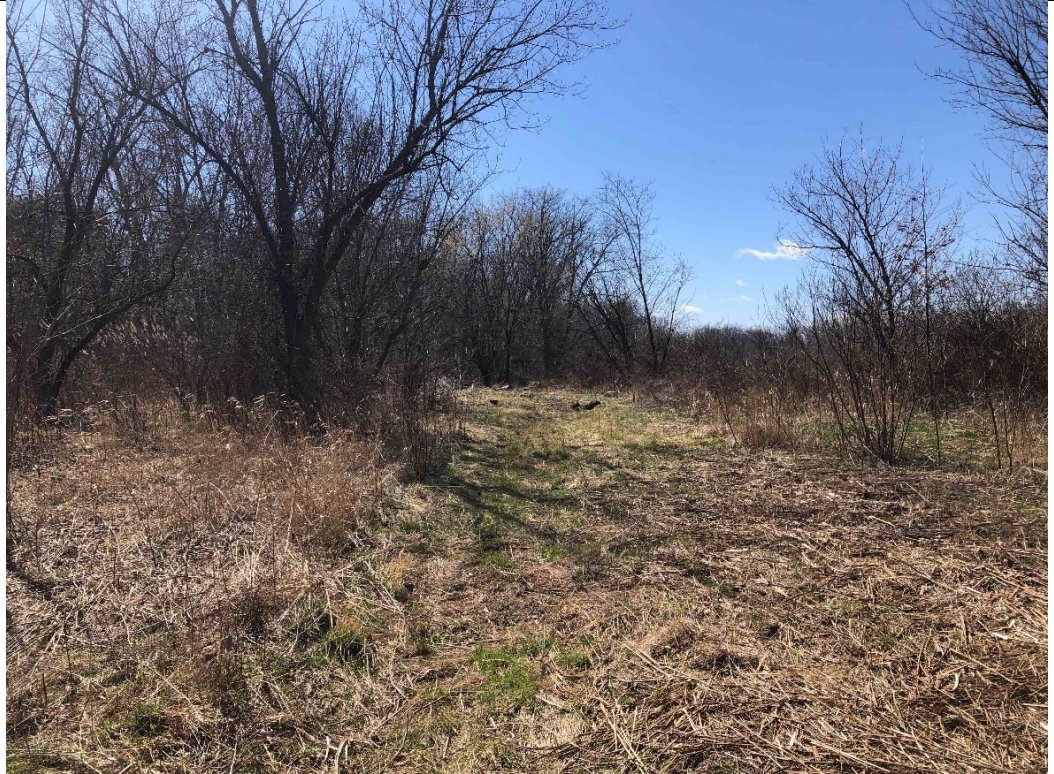
Photo No.
4

Description:
Photo Station 2
View from sewer access road
looking downgradient
towards the impacted
floodplain scrub/shrub
wetland.

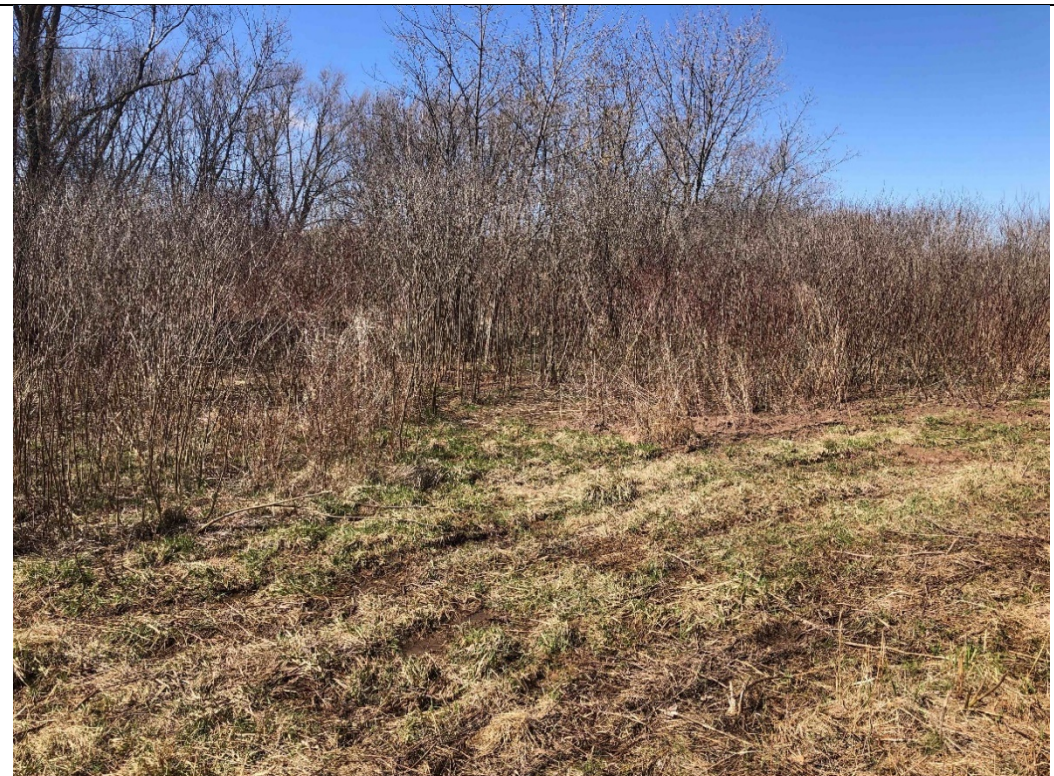
Description:
Photo Station 3
View from access road
looking upgradient towards
the sloped wetland and
upland.

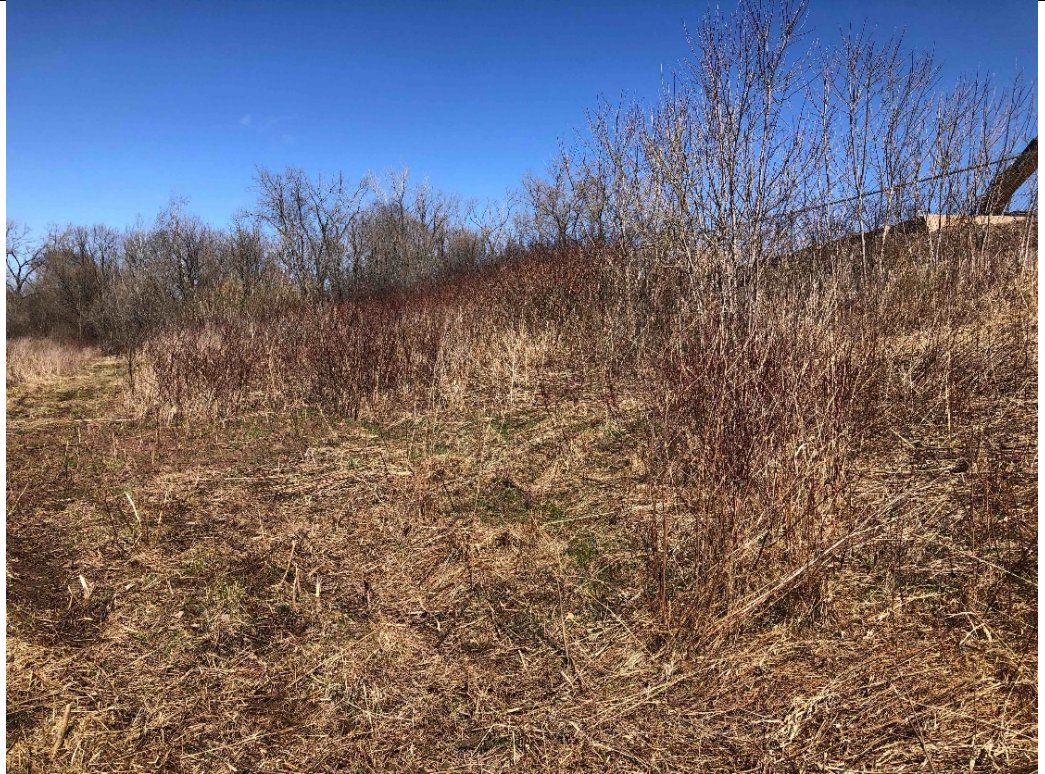
Photo No.
6

Description:
Photo Station 4
View of South Branch Park
River looking towards the
eastern bank. The area
within the channel that is a
light tan color is the slurry
deposition area.

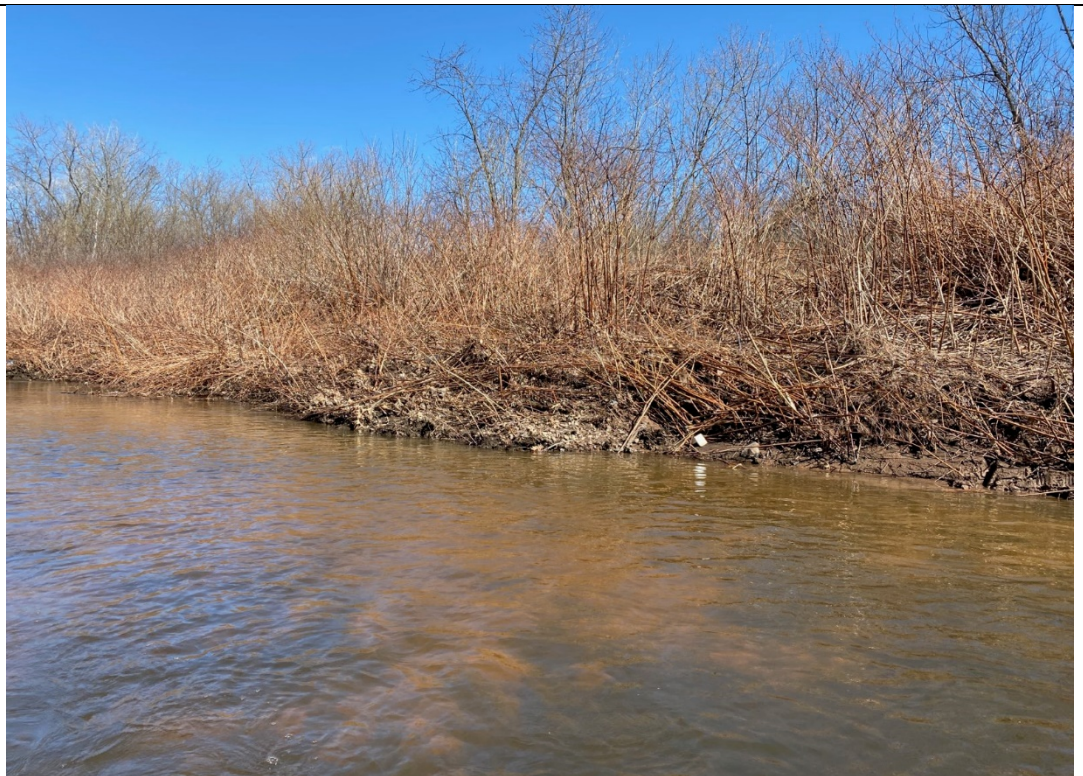
Photo Station 5

View from eastern bank of the South Branch Park River looking into the impacted watercourse. The area within the channel that is a light tan color is the slurry deposition area.

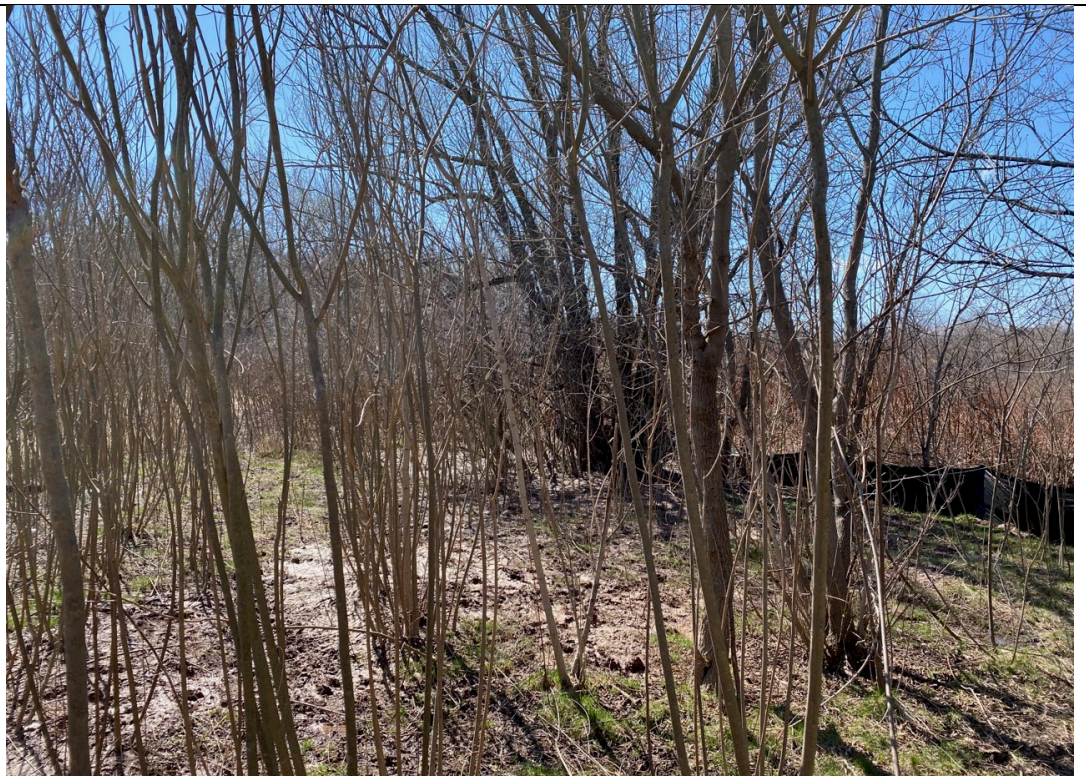
Description:
Photo Station 7
View from sewer access road
looking upgradient towards
the sloped wetland and
upland.

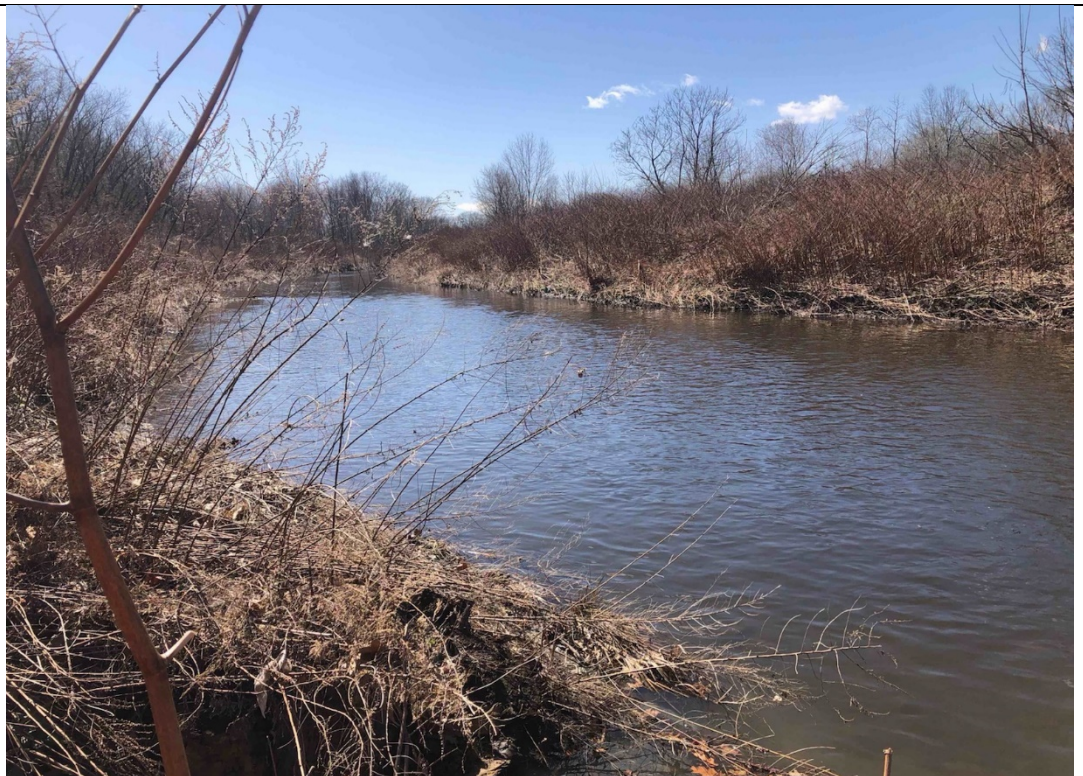
Turbidity curtain installed within the South Branch Park River. The curtain runs parallel along the eastern bank to limit further deposition of slurry into the watercourse.

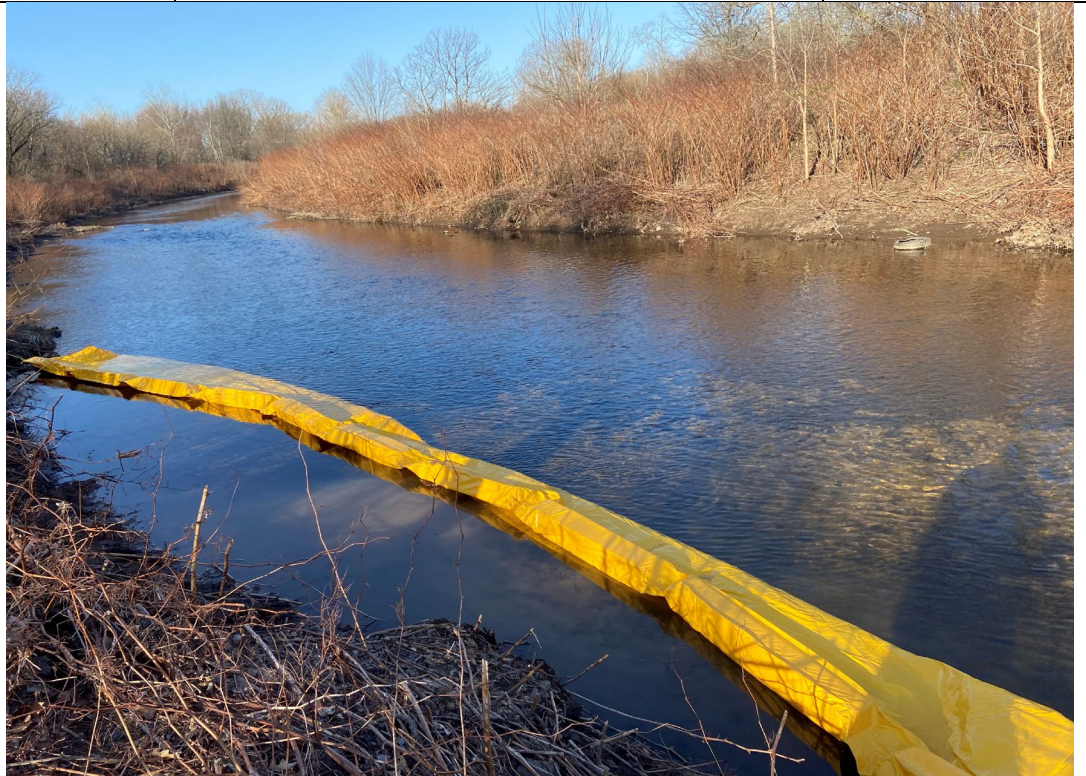
Photo No.
14

Approximately 4 inches of tan-colored slurry (beginning at measuring tape) collected and measured above local soil material within the area of deepest deposition on site using a Dutch auger.

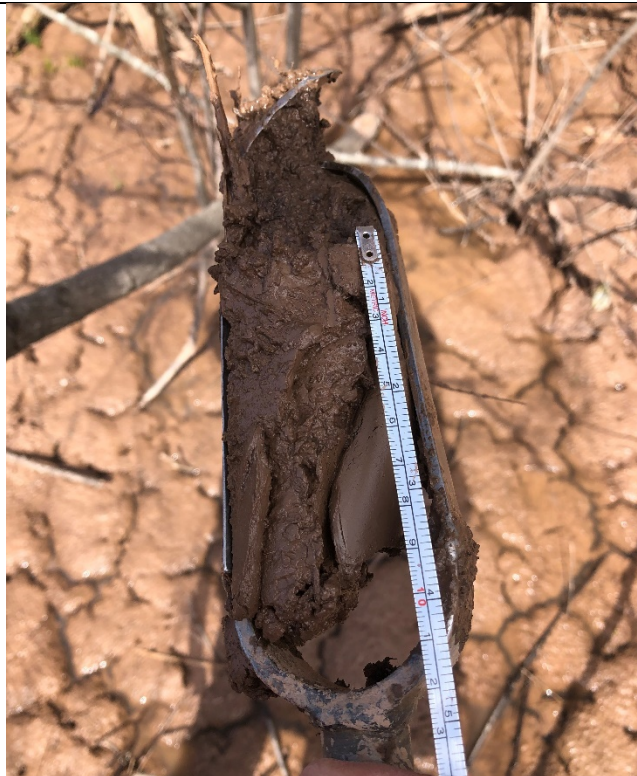
Bunches of perennial grass stalks from previous year's growth (dead) with current year's new growth coming up through deposited slurry on site.

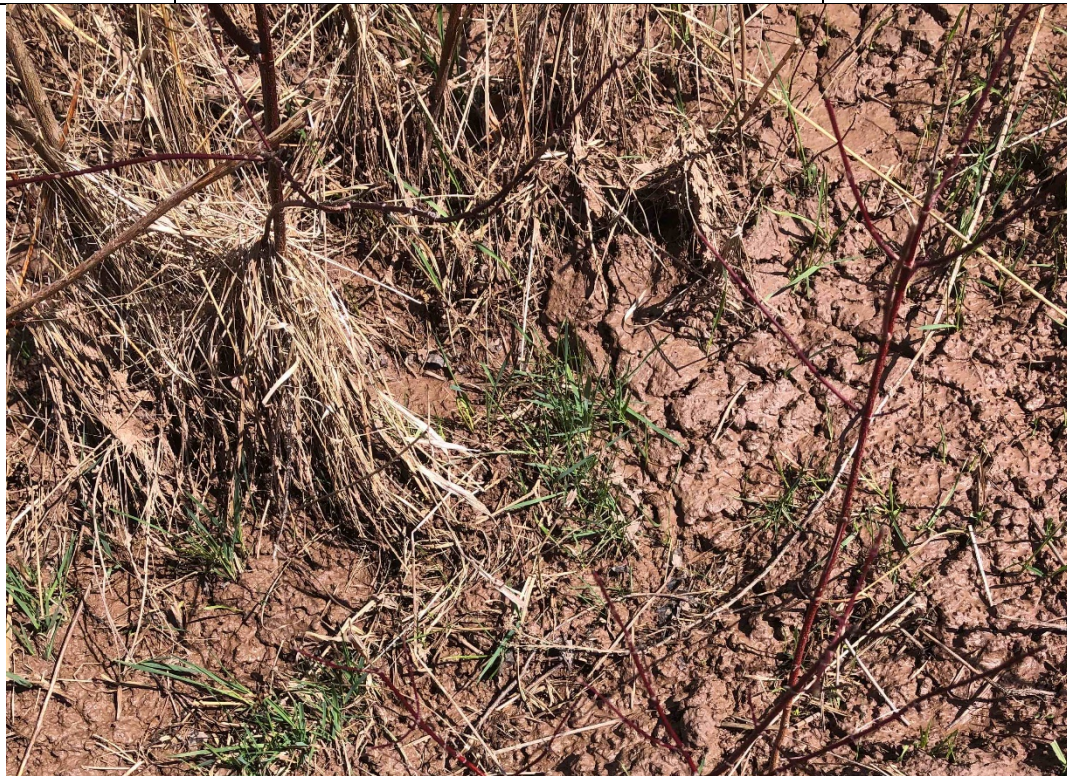
Photo No.
16

View from within floodplain wetland upslope (east) of silt fence. Foreground: dense shrub canopy (at least 85% total cover) composed mostly of false indigo (*Amorpha fruticosa*) and Japanese knotweed (*Fallopia japonica*). Background: view upslope (east) toward upland community and construction site/slurry spill source.

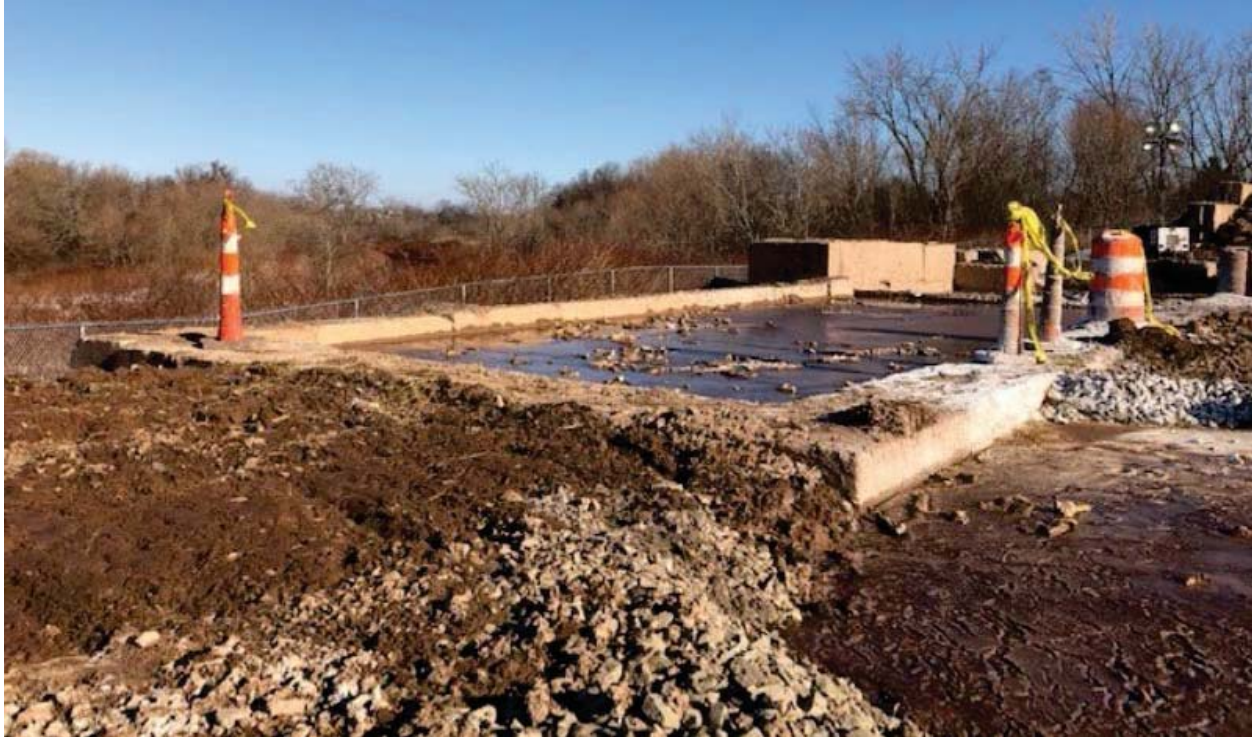
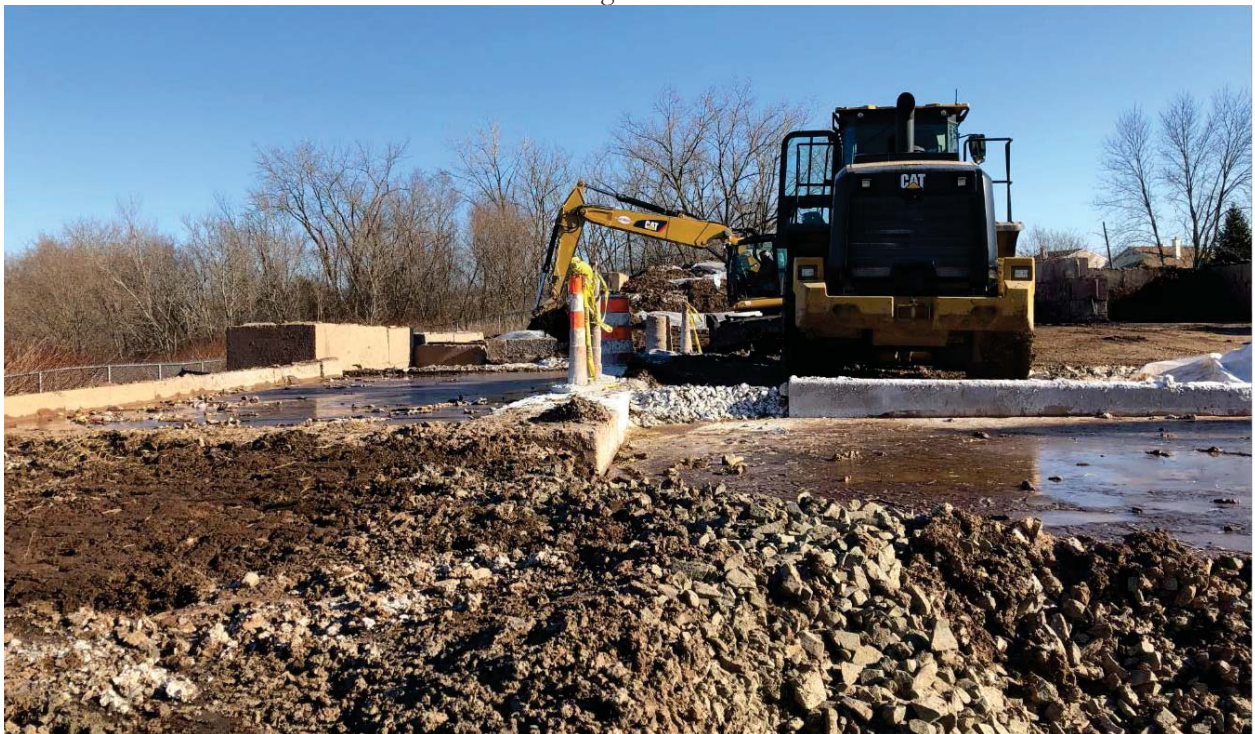
Figures 2 & 3. Photographs of slurry containment pits at 611 Brookfield St. Per contractor, Empire Paving, an earthen containment area was established adjacent to the concrete pit, which ultimately failed and caused slurry waste to migrate off-site onto adjacent land containing wetlands, watercourse, and upland review area.
